COMANDO DA AERONÁUTICA
CENTRO DE INVESTIGAÇÃO E PREVENÇÃO DE
ACIDENTES AERONÁUTICOS

FINAL REPORT
A - 034/CENIPA/2014

OCCURRENCE:	ACCIDENT
AIRCRAFT:	PT- WBO
MODEL:	PA-25-235
DATE:	23FEB2017

This is the Final Report of the 23FEB2017 accident with the PA-25-235 aircraft, registration PT-WBO. The accident was classified as “[LOC-I] Loss of Control in Flight”.

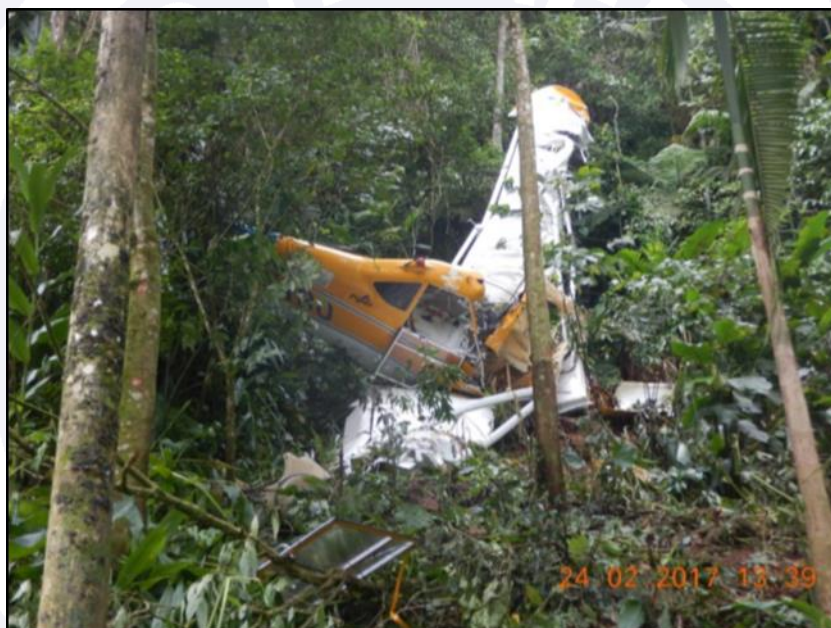
Figure 1 - Aircraft at the accident site.

The aircraft had substantial damage to the propeller, engine, wings and fuselage.

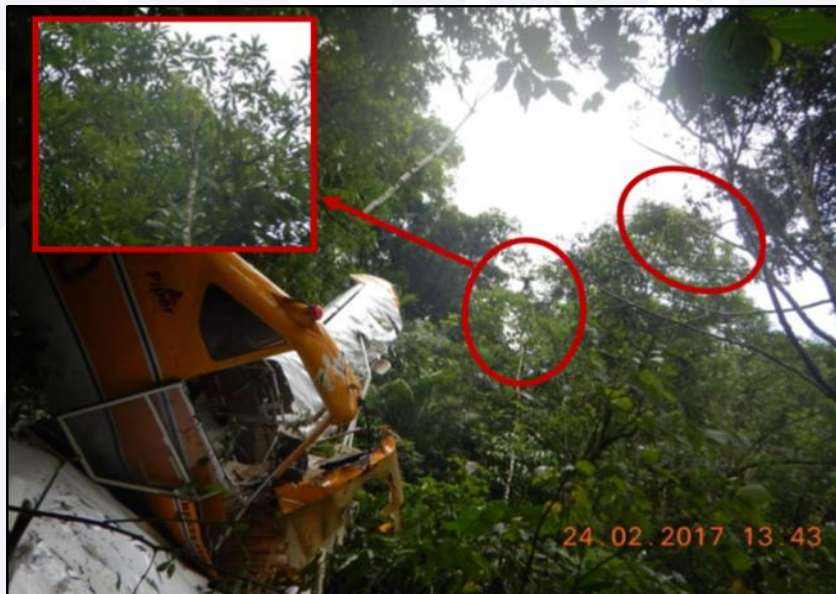
The vegetation at the site of the accident was a little damaged by the aircraft, denoting that the collision against the ground was with a pitch down attitude at approximately 80° (Figure 2).

Figure 2 - View of the location of the aircraft collision and impacts on the vegetation.

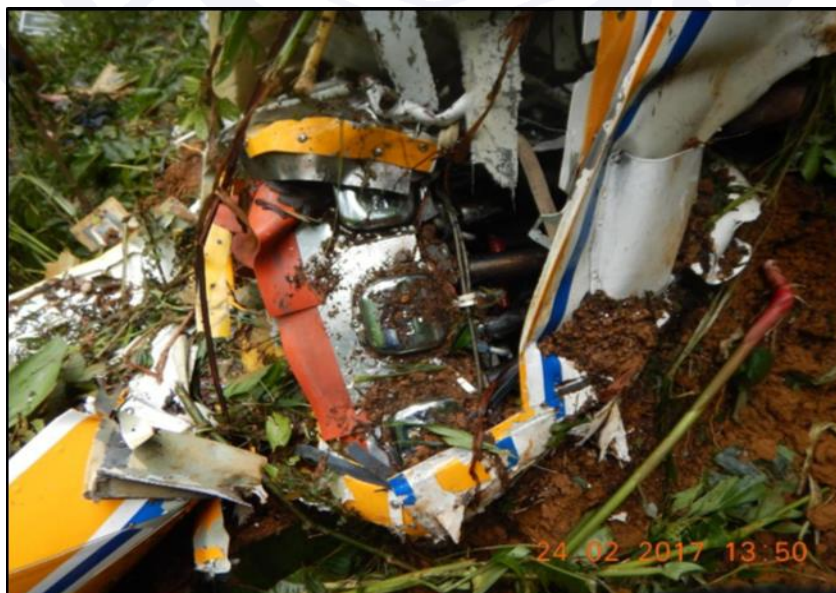
The propeller was completely buried in the ground, corroborating the hypothesis of a practically vertical collision (Figure 3).

Figure 3 - View of the engine with the propeller buried in the ground.

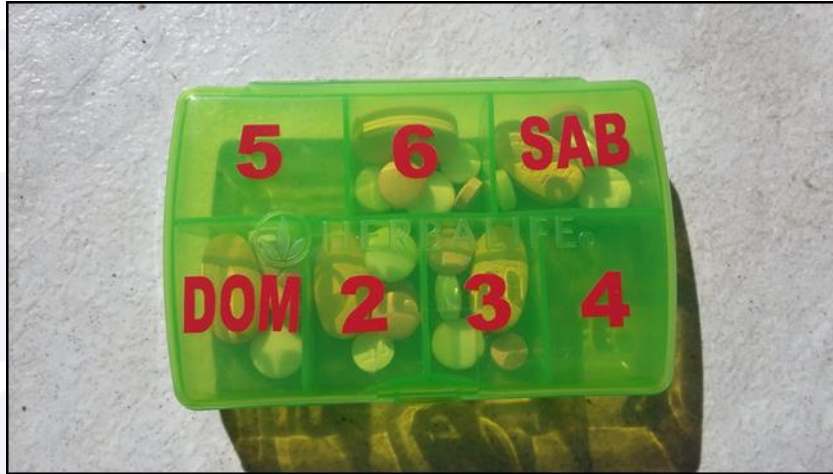
Figure 4 - Box with medications.

About the contents of the box, four drugs were identified: XigDuo XR® 10/1000 mg, Carduran XL® 4 mg, Enblex® and Atacand® 16 mg.

It occurs that the combination of XigDuo XR® 10/1000 and Nebilet® medications is not recommended for pilots as it can mask the body's reaction to hypoglycaemia and jeopardize the safety of the operation.

Disseminate the lessons learned in the present investigation, in order to alert the Brazilian civil aviation pilots to the risks arising from drug interactions that are incompatible with air activity, as well as modifications made to the aircraft without the proper knowledge and approval of the ANAC.

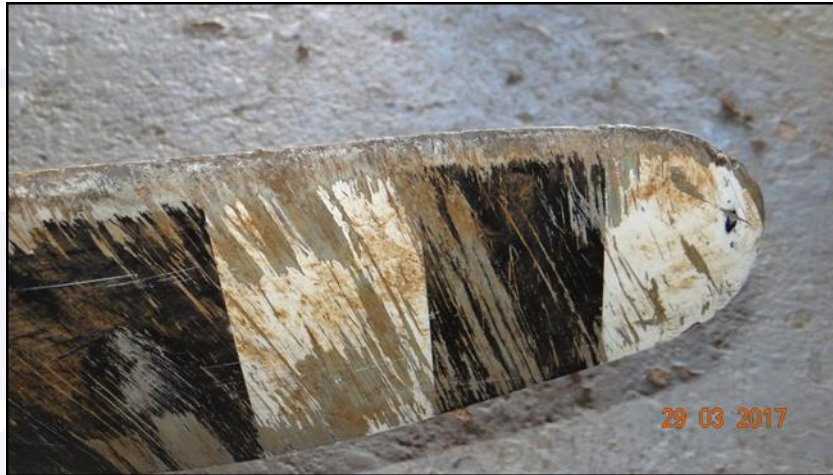
The analysis of the propeller blades showed a slight folding forward, impact marks on the leading edge of one of them, as well as transversal hazards in the other, indicating that the engine was working at the moment of impact (Figure 5).

Figure 5 - Impact marks on the leading edge and transversal hazards on the back of the blade.

Also, the evidence found in the analysis of the propeller indicated that the engine had normal operation at the moment the aircraft collided.

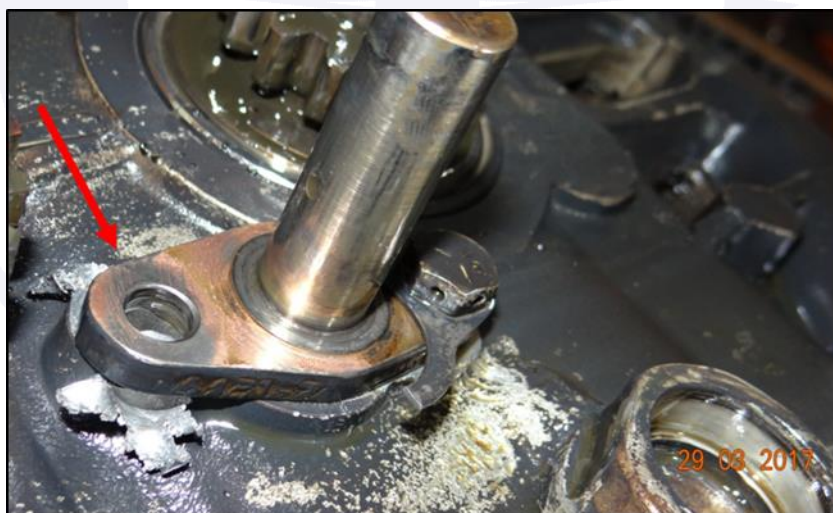
During the analysis of the engine, it was found that the screw and stud used for the fixing of the left magneto drive gear and valve control shaft had abnormal wear during the vibration engine operation.

With the detachment of the stud, the shaft remained fixed only by the screw, which did not allow the release of the gear (Figure 6). If the screw breaks, the shaft would release the gear, which could leave its housing and cause the engine to stop synchronizing, which would cause it to stop immediately.

Figure 6 - Detail of the absence of the fixation stud of the left magneto drive gear and the valve control.

However, since this shaft was still in its normal operating position, this deficiency did not cause a fault in the engine.

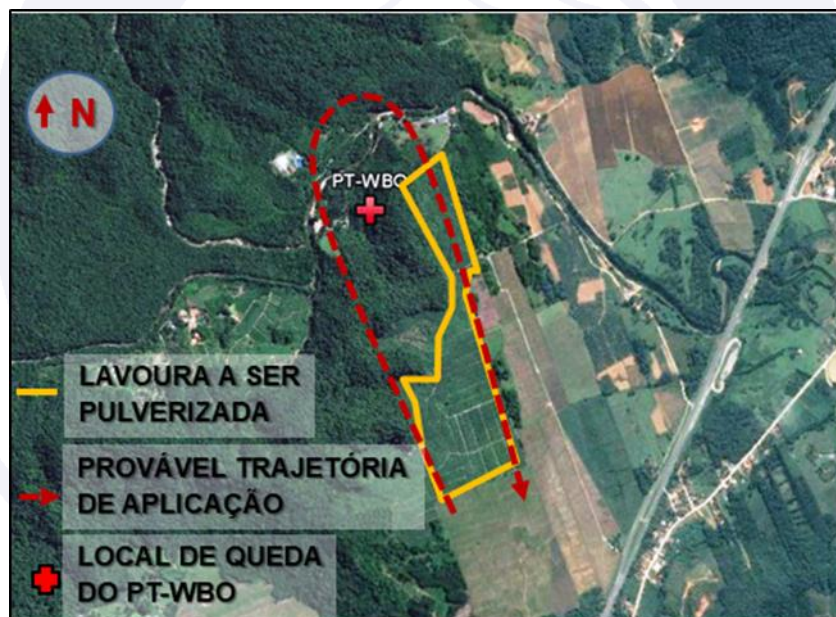
The crop in which the pulverization service was performed was situated on the slope of a hill and required constant attention from the pilot, as it was necessary to get around the elevation for repositioning between the spray passages. However, the degree of difficulty was not as high as in other areas of the pulverization region, located on rough terrain (Figure 7).

Figure 7 - Sketch with the location of the accident.
