COMANDO DA AERONÁUTICA
CENTRO DE INVESTIGAÇÃO E PREVENÇÃO DE
ACIDENTES AERONÁUTICOS

FINAL REPORT
A - 079/CENIPA/2017

OCCURRENCE:	ACCIDENT
AIRCRAFT:	PT-WPD
MODEL:	PA-34-220T
DATE:	28MAY2017

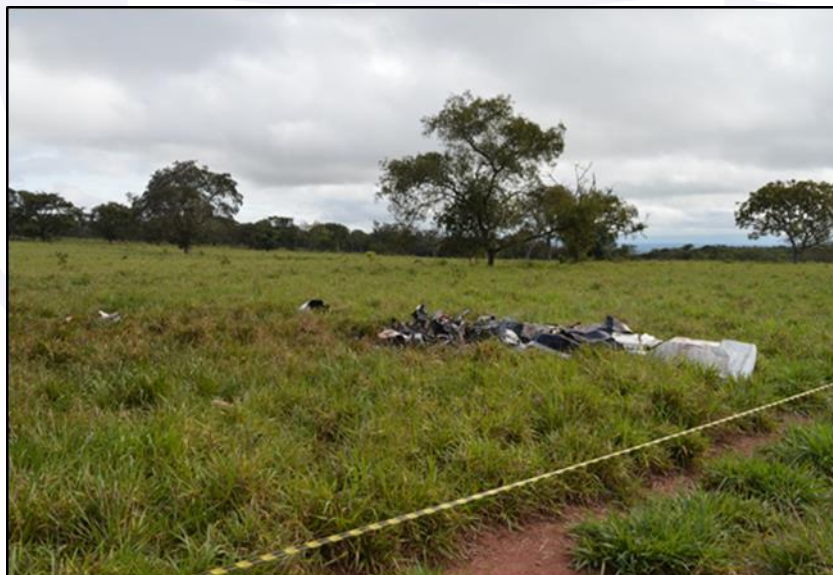
According to the nearest meteorological information services, meteorological radars and observer reports, the visibility was over 10km. There was moderate cloudiness, and it was not possible to accurately state the base of the layer (Figure 1).

Figure 1 - Weather conditions on the day of the accident.

There was no evidence that the weather contributed to the accident.

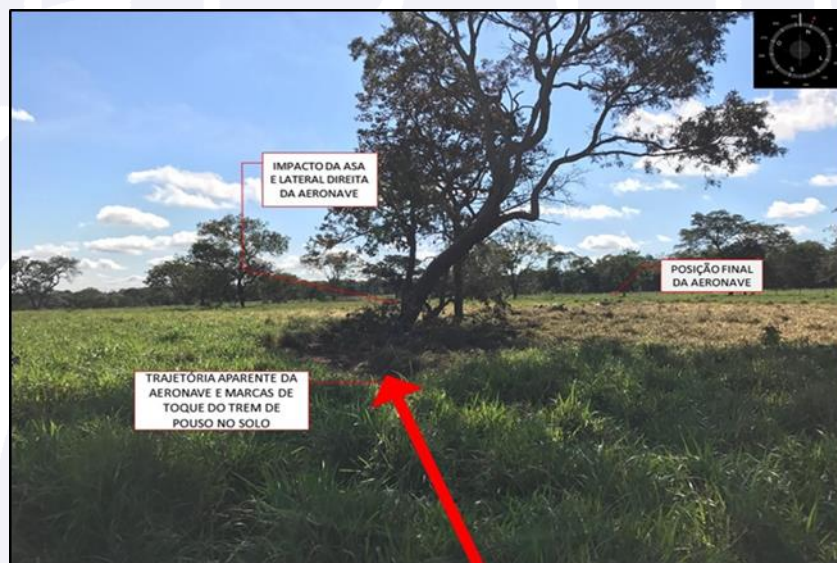
It was observed that, initially, the aircraft collided against the stem of a tree, approximately 1m high (Figures 2 and 3). The first point of impact on the aircraft was on the wing and right engine, with their separation from the rest of the aircraft and the presence of fire on the impact, evidenced by the burning of the tree parts and portions of the right wing.

Figure 2 - Aircraft trajectory and impact.

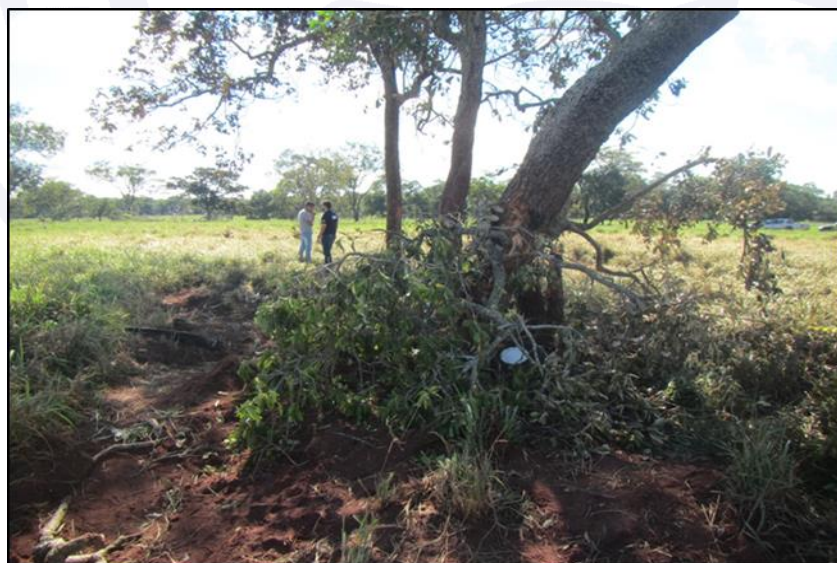
Figure 3 - First impact point.

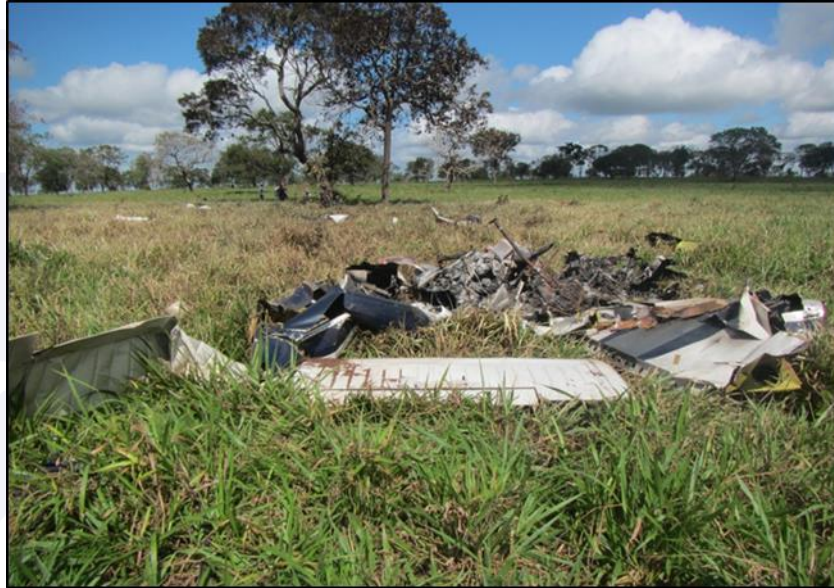
The fuselage, tail cone, engine (separated from the mounting but connected to the aircraft by cables) and the inner section of the left wing, followed by approximately 30m where they stopped, upside down (Figure 4).

Figure 4 - Final position of the aircraft.

The fire consumed the cabin and caused fatal injuries to its occupants. The tail cone and the inner section of the left wing were not damaged by fire.
