**COMANDO DA AERONÁUTICA**  
**CENTRO DE INVESTIGAÇÃO E PREVENÇÃO DE**  
**ACIDENTES AERONÁUTICOS**

**FINAL REPORT**  
**A - 044/CENIPA/2017**

<b>OCCURRENCE:</b>	<b>ACCIDENT</b>
<b>AIRCRAFT:</b>	<b>PT-YHH</b>
<b>MODEL:</b>	<b>206B</b>
<b>DATE:</b>	<b>17MAR2017</b>

This is the Final Report of the 17MAR2017 accident with the 206B aircraft, registration PT-YHH. The accident was classified as “[FUEL] Fuel Related”.

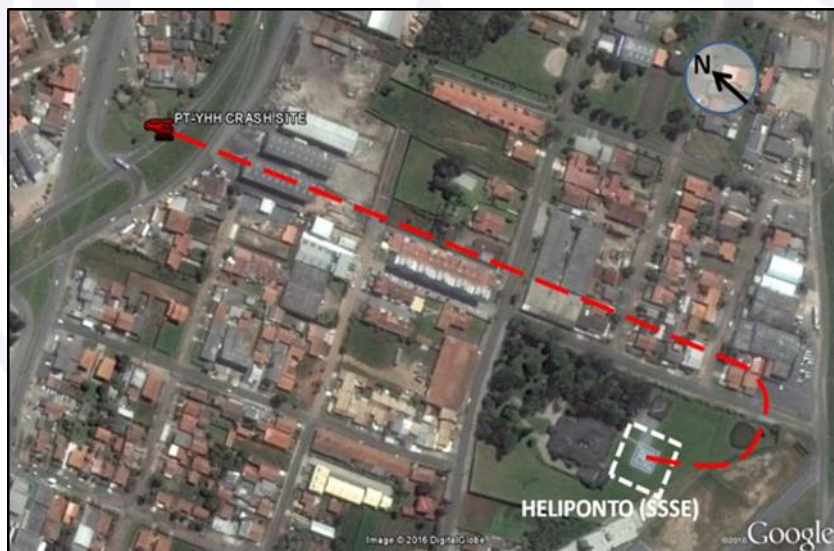
Figure 1 - Sketch of the approximate trajectory of the aircraft.

Soon after takeoff, when crossing 300ft Above Ground Level (AGL), the pilot turned left to proceed upwards to 500ft AGL, when he noticed a drop of approximately 5% RPM of the rotor.

The crewmember reduced the collective lever and regained RPM. However, when applying power, both the rotor (NR) and the power turbine (N2) decreased rapidly, triggering the LOW RPM sound and visual alarm when the NR dropped below 90%.

The helicopter lost altitude and crashed into the ground.

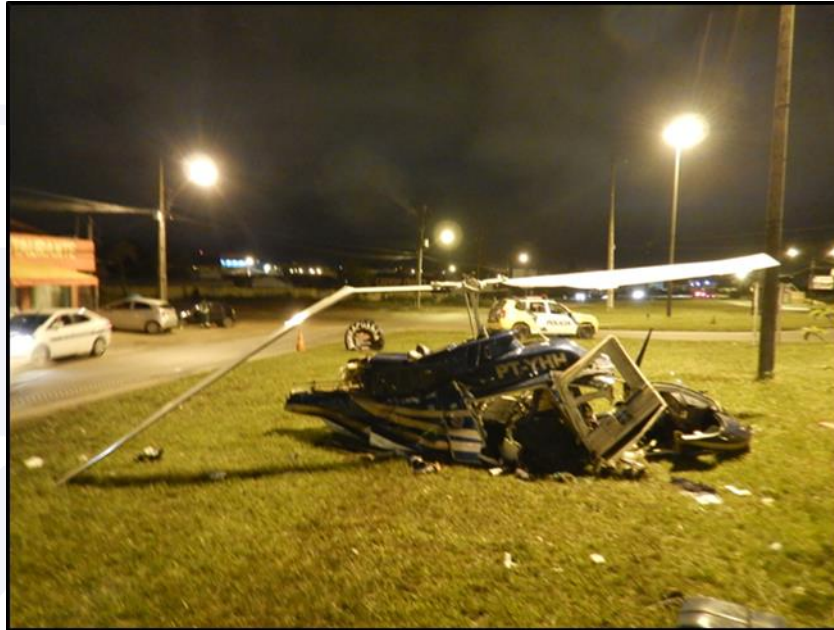
Figure 2 - Right side view of the aircraft.

The aircraft had substantial damage. There was loss of the tail cone, breakage of one of the main rotor blades, breakage of the landing gear, damage to the lateral and bottom of the fuselage (Figure 2).

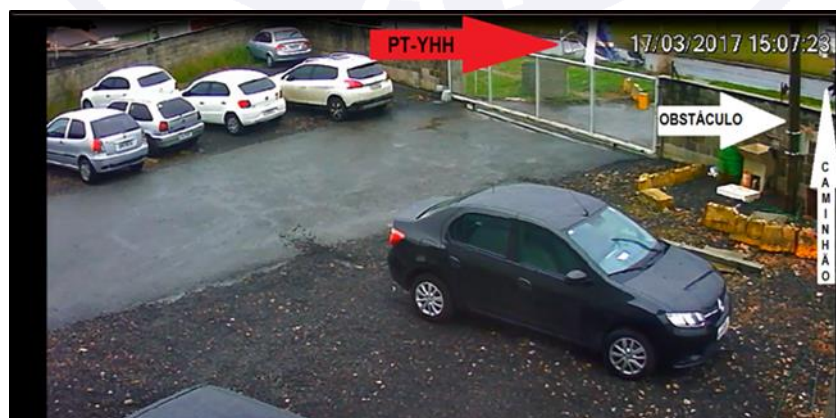
Figure 3 - Image of the security camera.

The impact was recorded by a local commerce security camera (Figure 3).

The impact occurred in a pitch up attitude (approximately 20°) and without lateral slope, causing the tail cone fracture and the breakage of the landing skis.

A security camera filmed the moment the aircraft hit the ground. In the image (Figure 3) it was observed the presence of electric poles and a truck that had passed by moments before the collision.

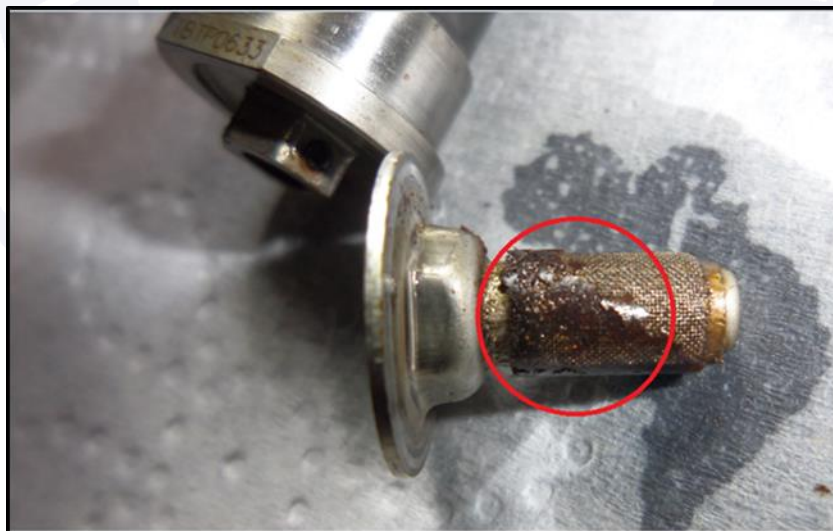
Figure 4 - Contaminated Fuel nozzle highlighted.

Thus, the fuel nozzle was disassembled, where a large amount of the same contaminating material found on the first nozzle was identified. This material was collected and sent to the IAE chemistry laboratory to try to identify it.

The chemical analyzes did not identify similarity between the material of the aircraft's fuel hose and the contamination found in the nozzles. The IAE laboratory was also unable to identify precisely the contamination, even compared to possible contaminants: ardrex, diesel and other substances.

As the engine had no severe damage, it was translated for functional testing on the IAS test bench. During the tests, particles of contamination were found in the remaining QAV-1 in the fuel filter and the fuel nozzle last chance filter.

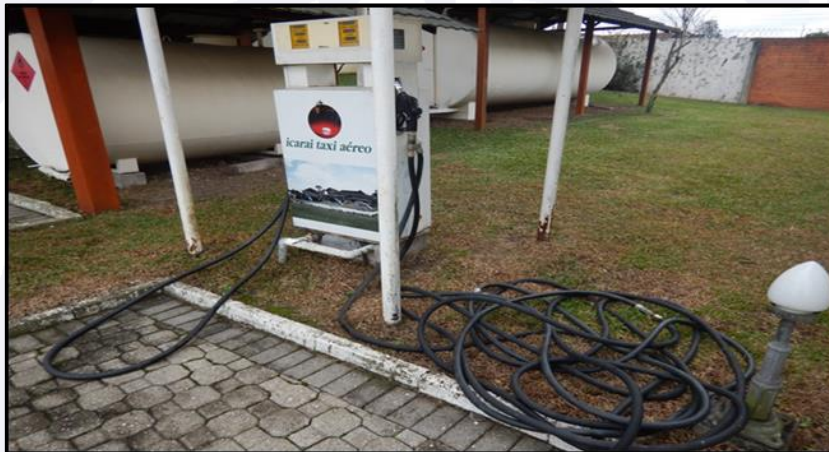
Figure 5 - Fuel reservoirs of SSSE.

At the back of the residence, there was a heliport, a hangar and two tanks for fuel storage (Figure 5), one with a capacity of 4,000 liters and another of 15,000 liters, where the QAV-1 was stored.

The tanks had the valves opened by the resident himself to show that there was no fuel. After being questioned by the agent, the former owner acknowledged that he had not previously informed the ANP of the existence of fuel tanks in the area.

These reservoirs, with storage capacity of 15,000 liters and 4,000 liters respectively, were not registered with the ANP, which may indicate a lack of compliance with the requirements of the regulatory standards, evidencing inadequate oversight, by the organization's management, of planning and execution activities in the administrative, technical and operational areas.

The hypothesis is that the contaminant present in the aircraft fuel comes from continued fueling from the reservoirs of the aircraft operating company. This hypothesis is reinforced by the fact that these reservoirs are not registered at the ANP, and their maintenance is carried out by the air taxi company itself or by third parties, failing to comply with the requirements established in the norms in force.

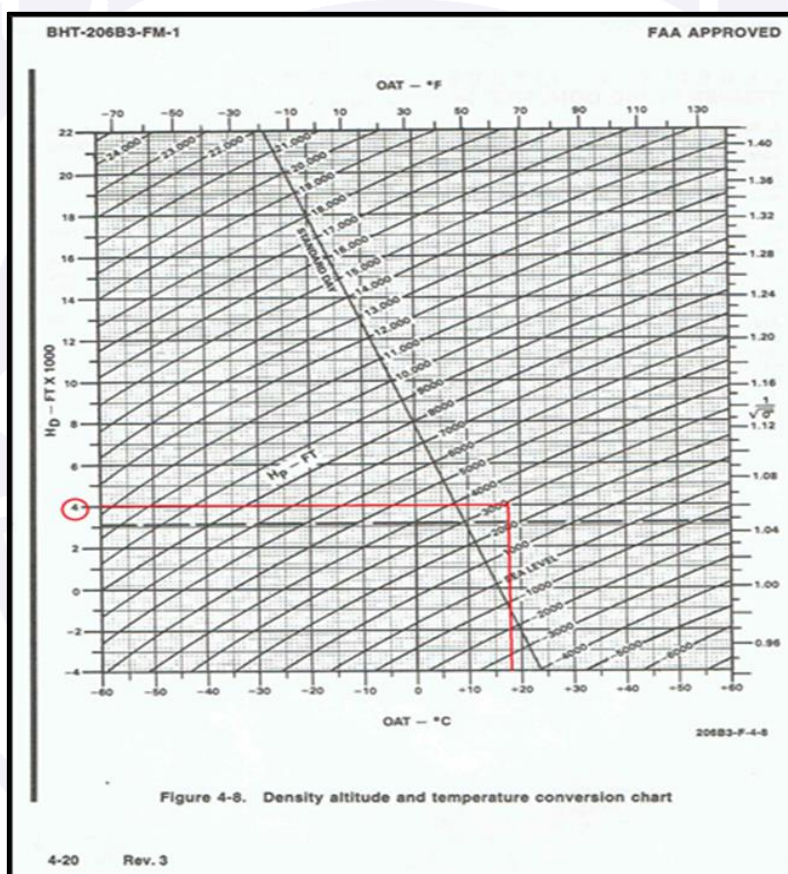
Figure 7 – Density Altitude.

Considering that the temperature by the METAR of SBCT was of 18°C and that the altitude of the heliport was of 2.972ft, it was obtained the density altitude of 4,000ft (Figure 7).

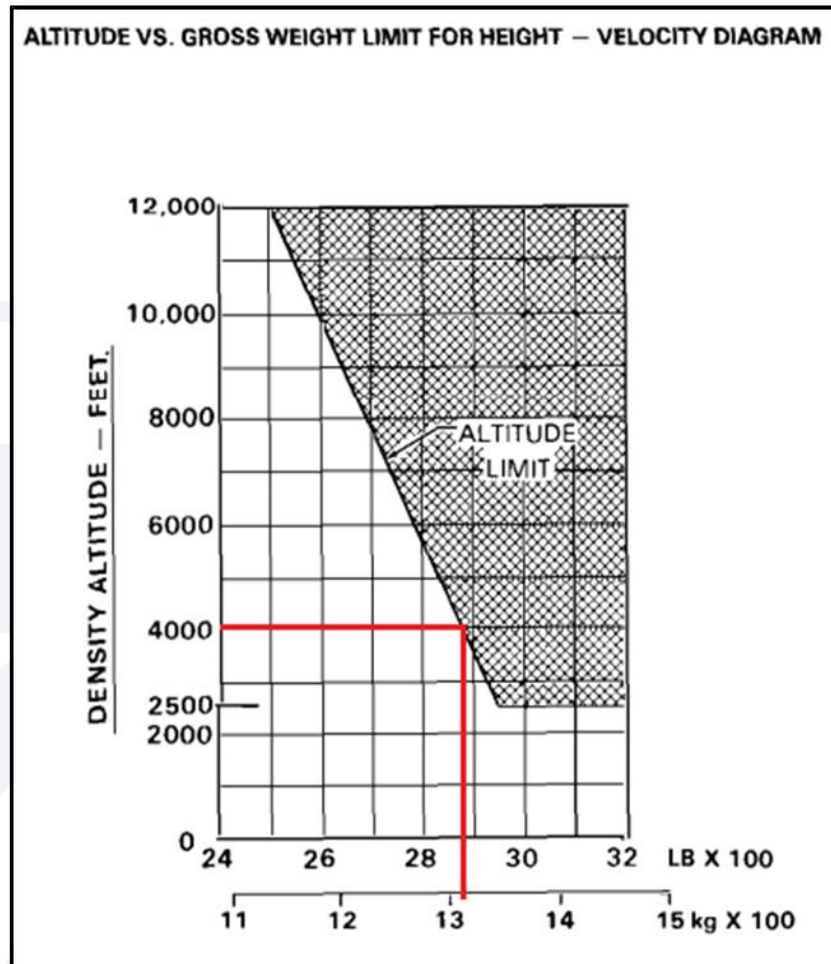
Figure 8 - Graph Altitude vs. Gross weight limit for Height - Velocity Diagram.

Considering that the weight of the aircraft at the time of the loss of power was of 1.456,86 kg and that the calculated density altitude was of 4.000ft, it was concluded that the aircraft did not meet the performance requirements in the graph of Figure 8, since the maximum weight for these conditions would be approximately of 1.320kg.

It is inferred in this way that the flight planning did not take into account the altitude density that is calculated as a function of the altitude pressure x temperature.

This inadequacy was translated by a take-off performed with the aircraft above the maximum weight allowed for those conditions (1.320 kg), evidencing the non-observance of aspects related to flight planning.
