COMANDO DA AERONÁUTICA
CENTRO DE INVESTIGAÇÃO E PREVENÇÃO DE
ACIDENTES AERONÁUTICOS

FINAL REPORT
A - 507/CENIPA/2018

OCCURRENCE:	ACCIDENT
AIRCRAFT:	PT-YON
MODEL:	R44
DATE:	10SEPT2010

This is the Final Report of the 10SEPT2010 accident with the R44 aircraft, registration PT-YON. The accident was classified as “[CFIT] Controlled Flight into Terrain”.

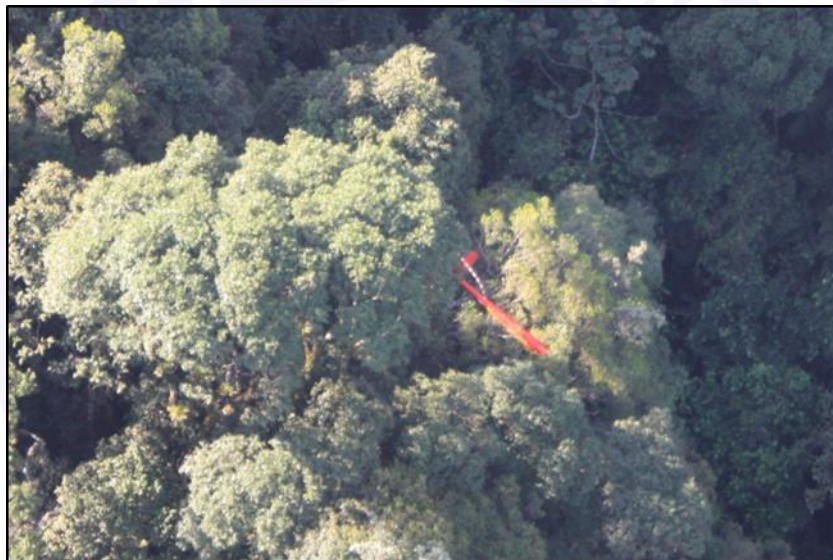
In the collision, the tail cone separated from the rest of the aircraft, getting stuck at the top of the trees.

Figure 1 - Tail cone of the aircraft trapped on the top of trees.

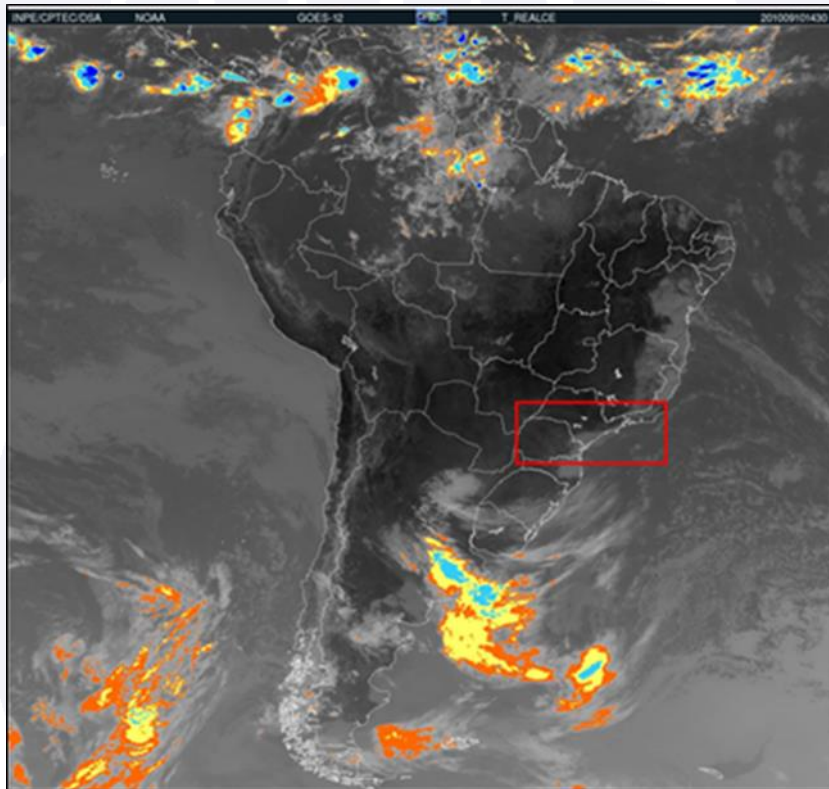
In the satellite image in the section between SSMW and SBMT, there was a strip of clouds (dense) over the coastal region, but on the city of São Paulo it was already much less dense (Figure 2).

Figure 2 - Satellite image.

The clouds seen in the images are low (between 800ft and 2.500ft), there were Stratus, and Stratocumulus clouds over the Serra do Mar.

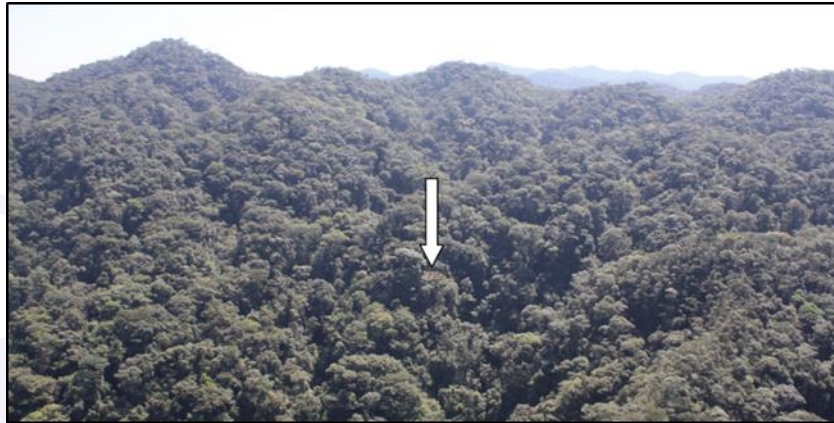
The tail rotor was attached to the treetops at a height of approximately 30m and at a distance of approximately 300m from the cabin. The rear drive has separated, as well as

Figure 3 - The wreckage was located through the tail cone, which was at the top of the trees.

The cutting characteristic of the top of the trees as well as the deformations found in the blades of the main rotor and the tail rotor denoted normal rotation and consequently normal engine power.
