FINAL REPORT
A - 030/CENIPA/2019

OCCURRENCE:	ACCIDENT
AIRCRAFT:	PT-HPG
MODEL:	206B
DATE:	11FEB2019

This is the Final Report of the 11FEB2019 accident with the 206B aircraft model, registration PT-HPG. The accident was classified as “[SCF-PP] System/Component Failure or Malfunction Powerplant – Engine Failure in Flight”.

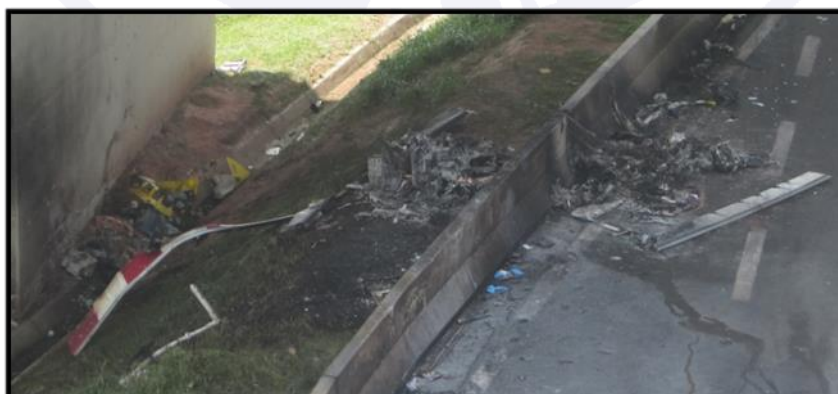
The main Gearbox (CTP), the blades, the engine and the fuselage were severely damaged by the impact and the action of fire (Figure 1).

Figure 1 - Wreckage of the main Gearbox (CTP), the blades, the engine and the fuselage.

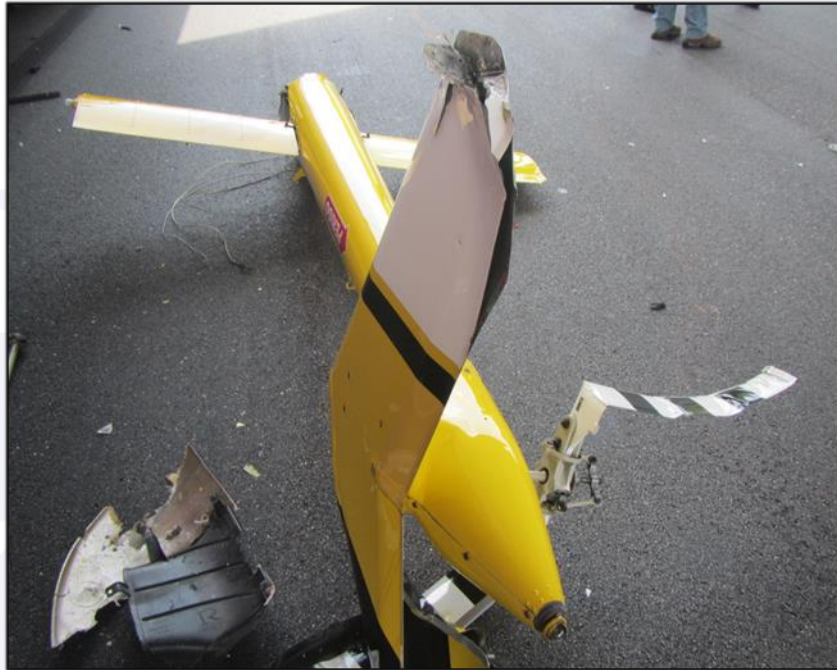
The tail boom was sectioned due to the impact and did not suffer the action of fire (Figure 2).

Figure 2 - Sectioned tail boom.

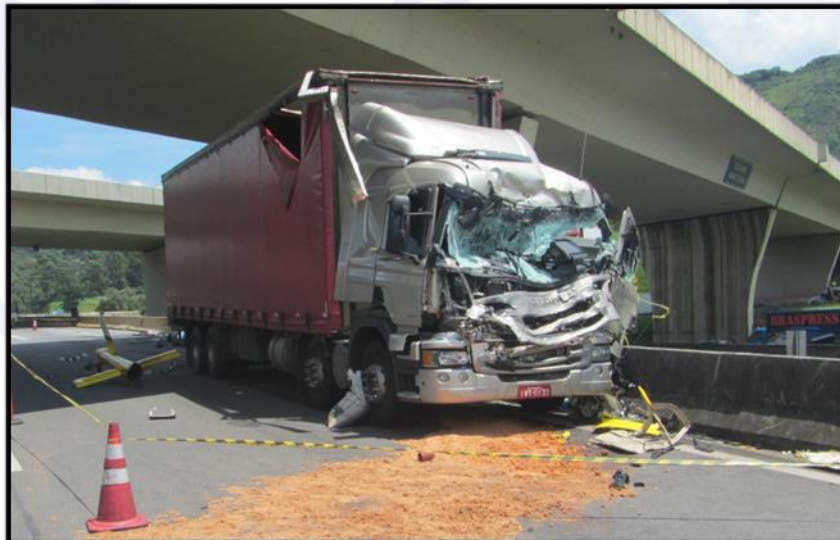
A truck-type vehicle had substantial damage to the cabin, specifically in the upper front portion, front grille and windshield (Figure 3).

Figure 3 - View of the damaged vehicle after the collision with the aircraft.

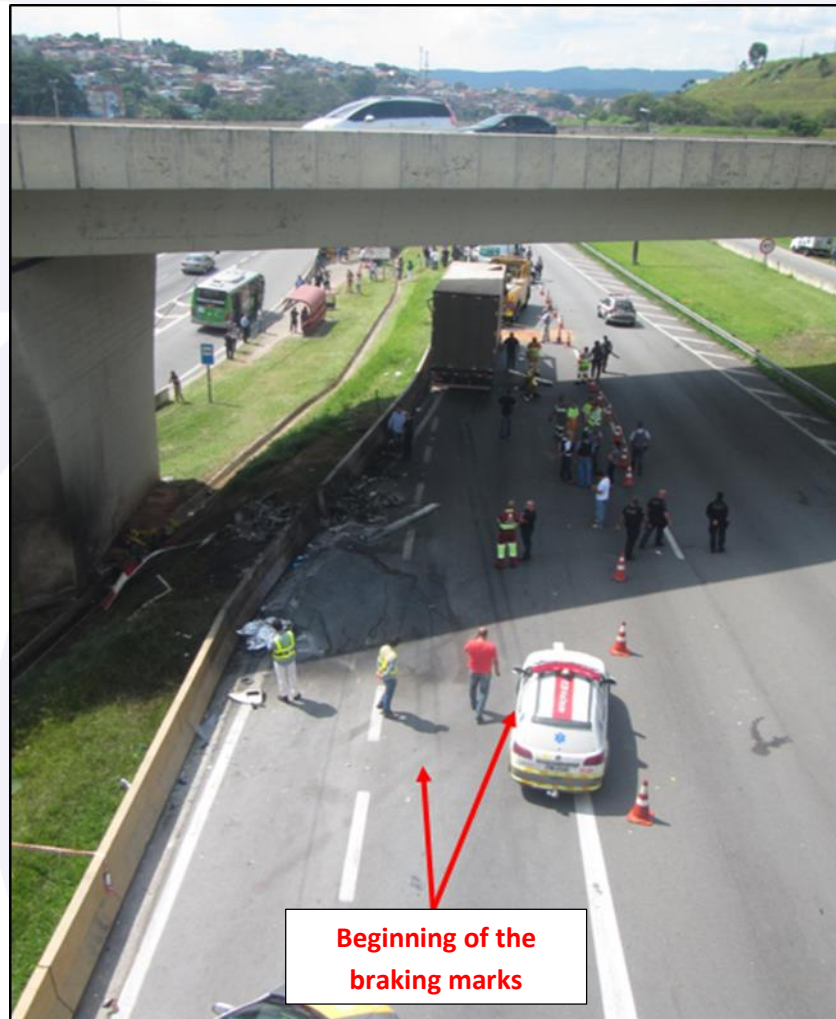
The truck's braking marks identify where the vehicle would have hit the aircraft. It is clear that the approach of the helicopter for the attempted autorotation was very close to the highway protection wall (Figure 29).

Figure 29 - Approximate impact location.

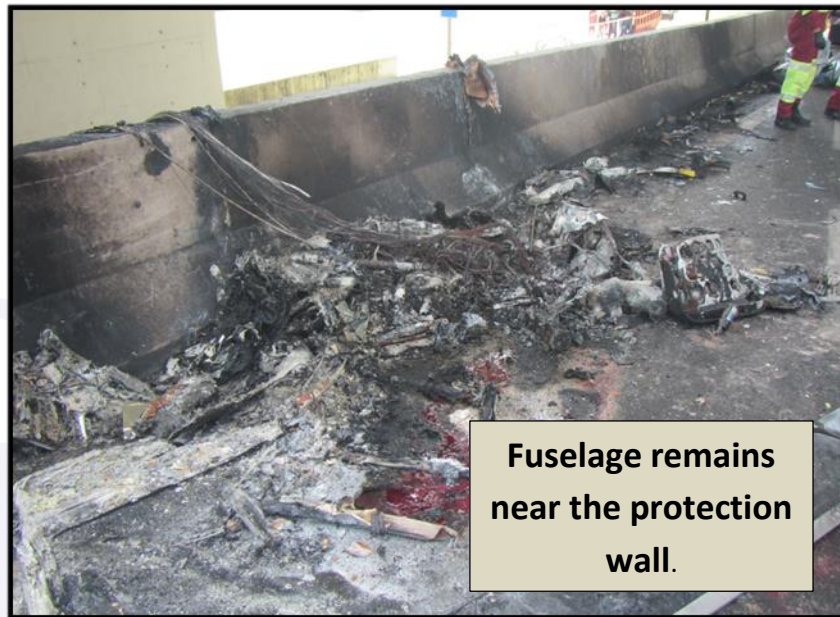
The wreckage was divided by a concrete wall (Figure 33)

Figure 33 - View of the fuselage remains and the soot marks on the concrete wall.

The fuselage was consumed by the fire and the marks left by the soot on the wall showed a random burning, compatible with fire after the impact.

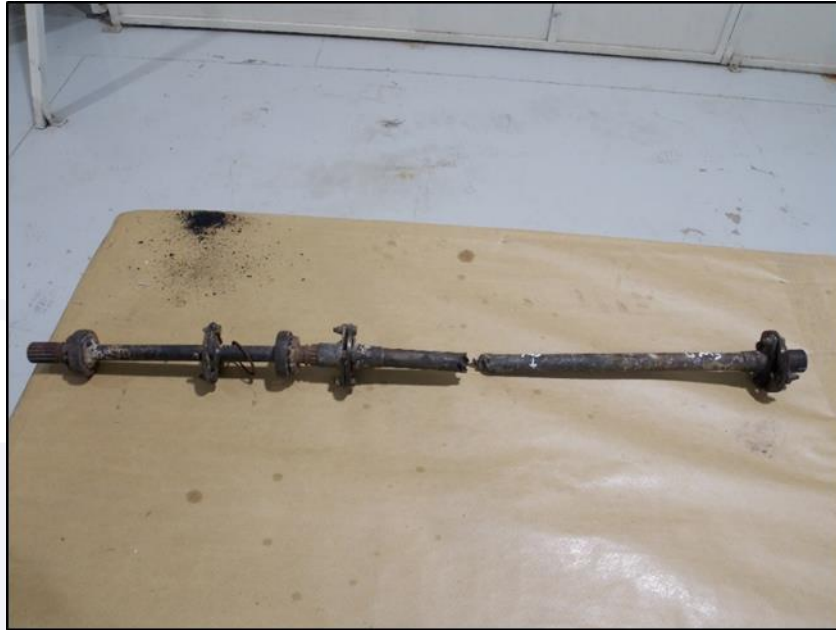
The connecting shaft of the engine accessories box to the tail rotor (Figure 34) was found sectioned and the part was sent for fracture analysis at the DCTA.

Figure 34 - Connecting shaft between the “Gearbox” and the tail rotor.

The results of the tests, carried out at the IAE’s AMR, based at the DCTA, indicated, after visual and stereoscopic examinations, rupture due to overload applied to the material.

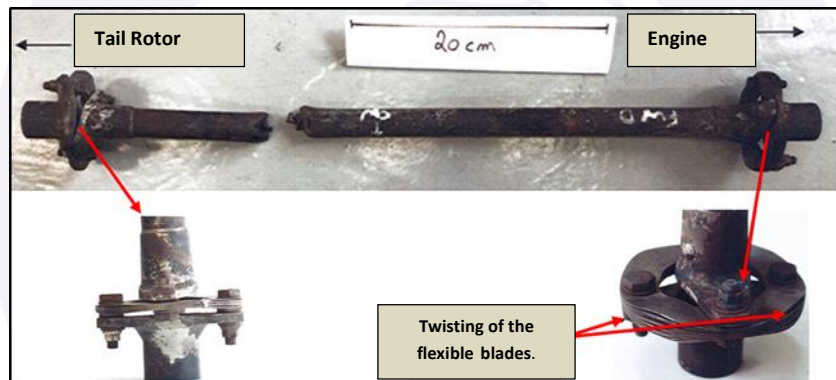
The flexible blades had different aspects between the side referring to the tail rotor and that one of the freewheel outlet (Figure 35).

Figure 35 - Twist of the flexible coupling blades of the tail rotor/Gearbox connection shaft.

The conditions found, showed a possible locking of part of the shaft connected to the tail rotor and a continuous rotation of part of the shaft connected to the Gearbox and, consequently, to the freewheel assembly.

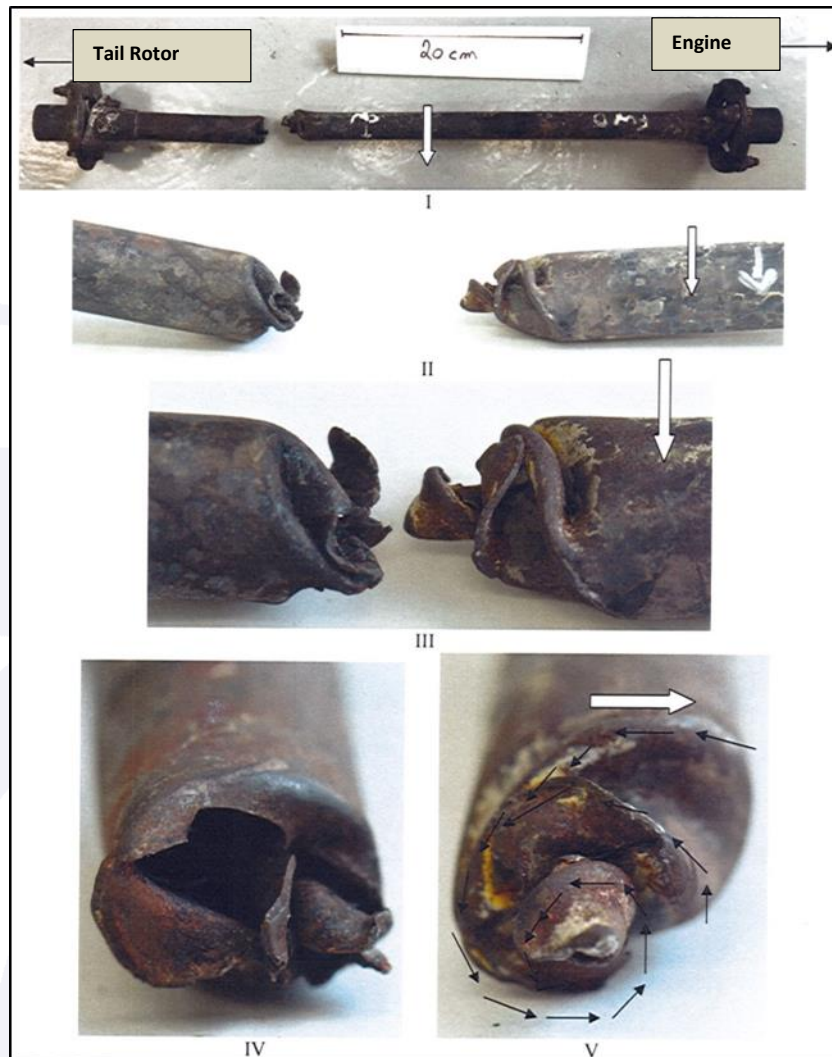
The fractures found in the connection shaft of the engine Gearbox to the tail rotor had different morphologies. The side referring to the tail rotor showed a morphology called fish mouth (Figure 36 - IV), while the engine side showed a spiral morphology (Figure 36 - V).

Figure 36 - Connecting shaft between the "Gearbox" and the tail rotor.

The morphology of the connection shaft fracture, with rupture without helical deformation on the connection side with the tail rotor and with deformation on the output side of the Gearbox, indicated that the shaft was rotating at the moment of the collision with the truck. The rotation of the axle did not necessarily indicate engine operation, since the freewheel system kept the rotation of the shaft while the main rotor was spinning, even with the engine inoperative.

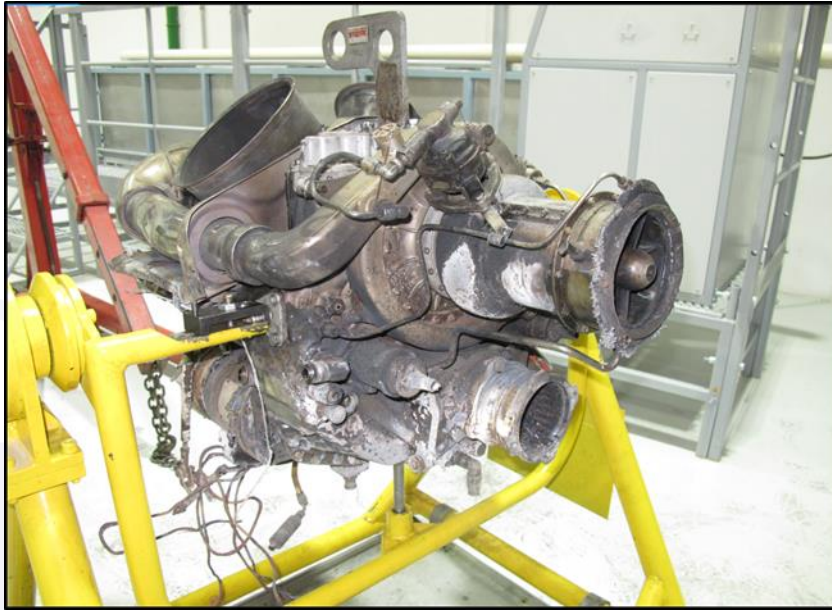
During the analysis of the general condition of the engine, it was observed that it was locked and its color showed that it was exposed to high external temperature (Figure 37).

Figure 37 - External condition observed in the engine that equipped the PT-HPG aircraft.

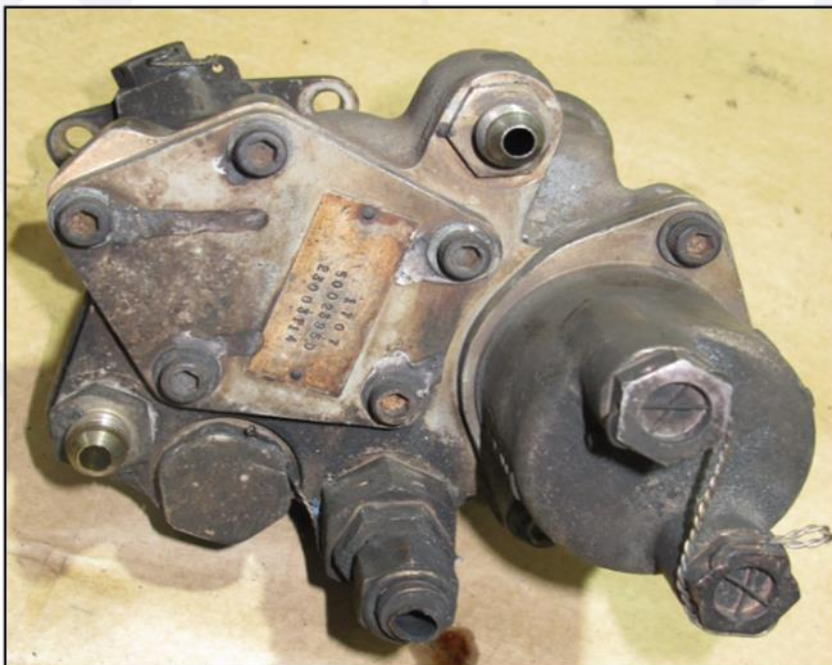
The fuel pump was exposed to high temperatures, as evidenced by its color, and was blocked, possibly by exposure to fire. (Figure 38).

Figure 38 - Fuel Pump.

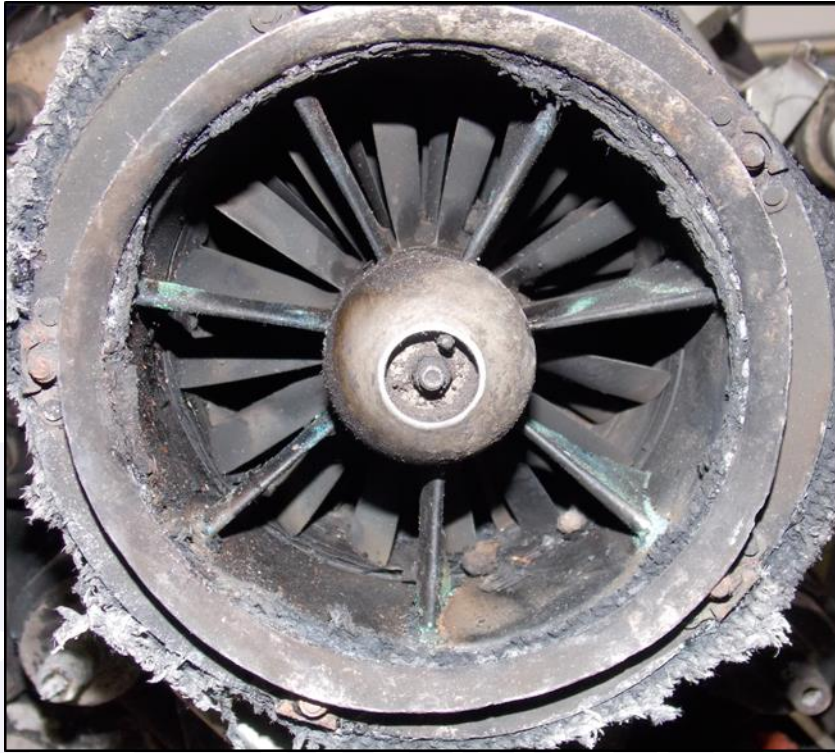
When disassembling and analyzing the compressor section, no sign of material ingestion was found and, even after separating the compressor module from the Gear Box, the compressor remained locked (Figure 39).

Figure 39 - Front view of the axial compressor air intake.

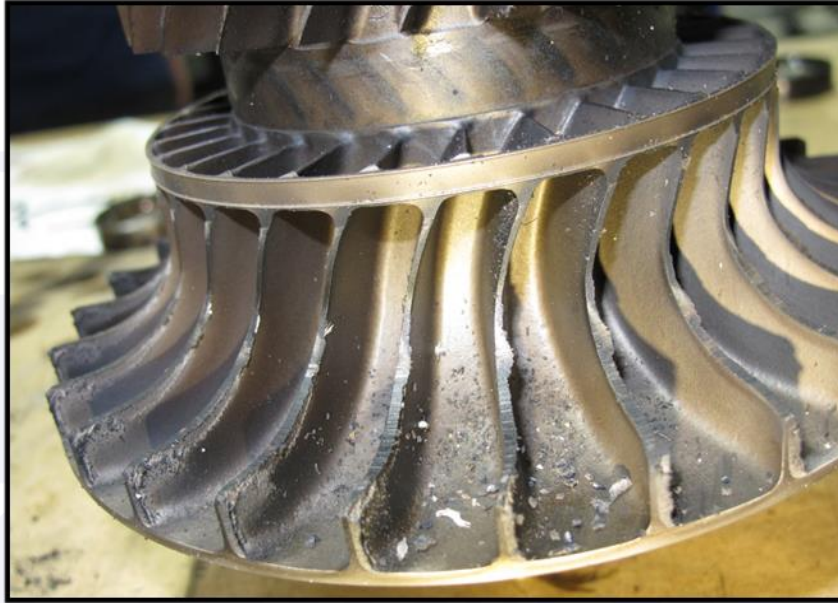
The impeller of the centrifugal compressor showed material loss in part of the disc diameter (Figure 42) and rubbing in part of the carcass (Shroud) that surrounded the impeller (Figure 43).

Figure 42 - Loss of material from the centrifugal compressor impeller.

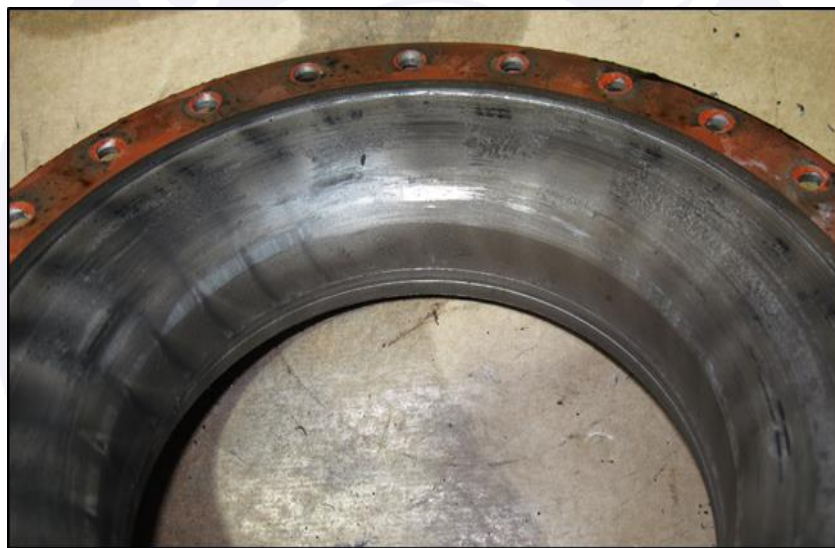
Figure 43 - Scratch marks on the centrifugal compressor housing (Shroud).

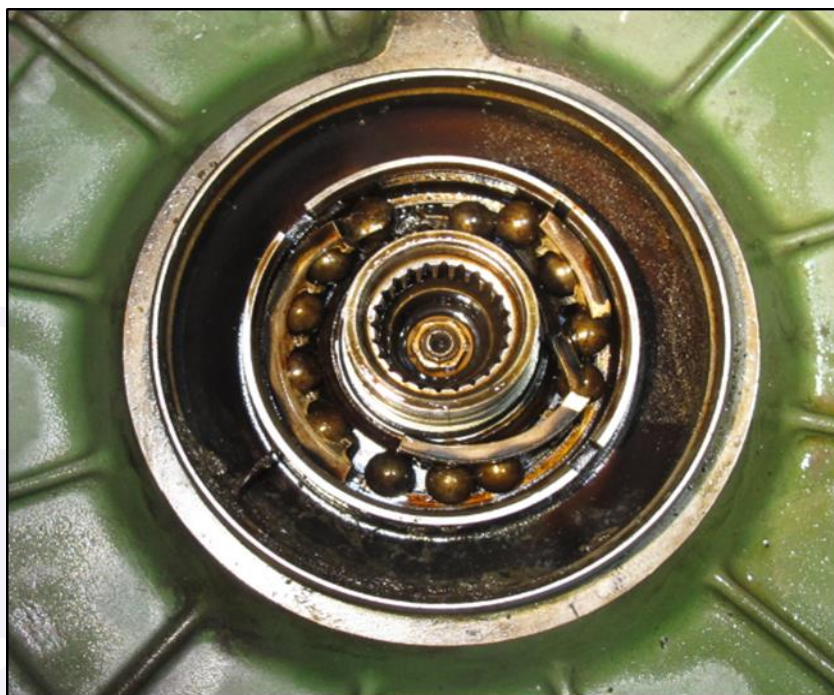
During the separation of the compressor section and the Gearbox, bearing n° 2 was found locked and with the ball separator fractured in several parts (Figures 44 and 45).

Figure 44 - Bearing nº 2 with the fractured ball separator.

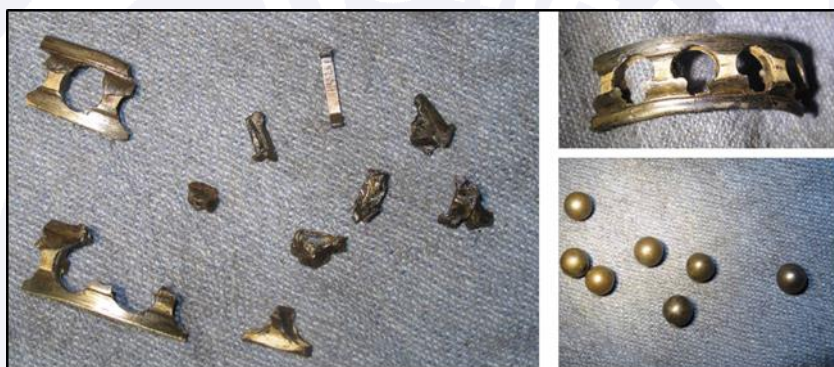
Figure 45 - Fractured ball separator.

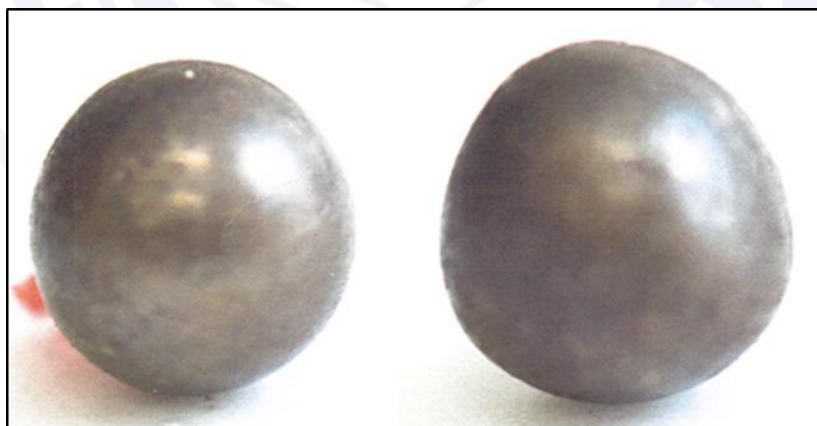
The balls of bearing nº 2 showed abnormal wear and were ovalized (Figure 46).

Figure 46 - Balls of bearing nº 2 worn and ovalized.

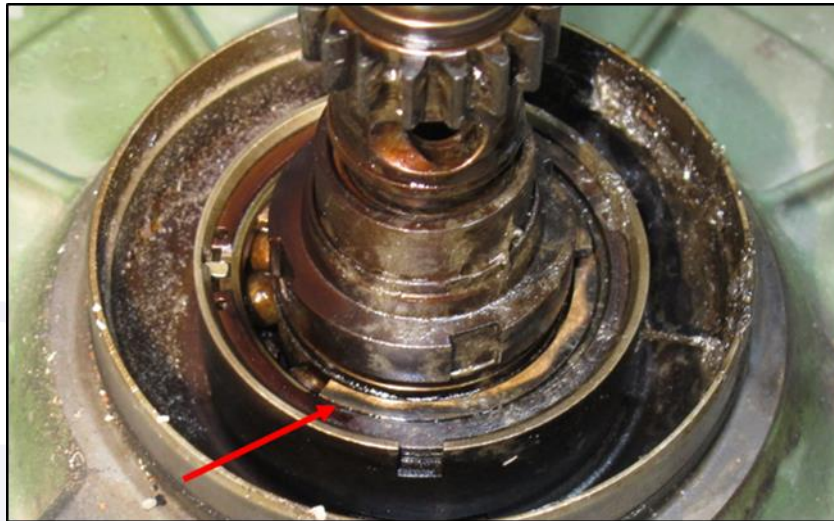
Color variation was visually observed in the ball separator of the bearing (Figure 47).

Figure 47 - Color change due to exposure to high temperatures.

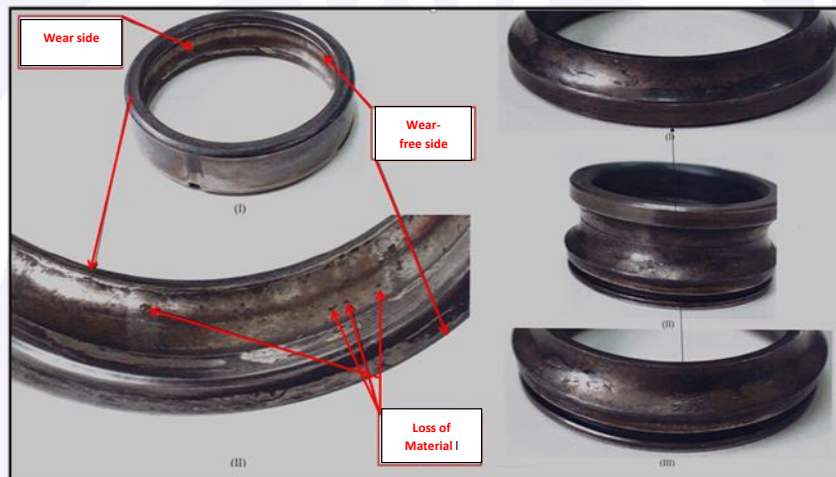
Bearing nº 2 was subjected to stereoscopic examinations at the DCTA, and it was evidenced wear and loss of material in the external and internal bearing tracks (Figure 48).

Figure 48 - External and internal tracks with wear and loss of material.

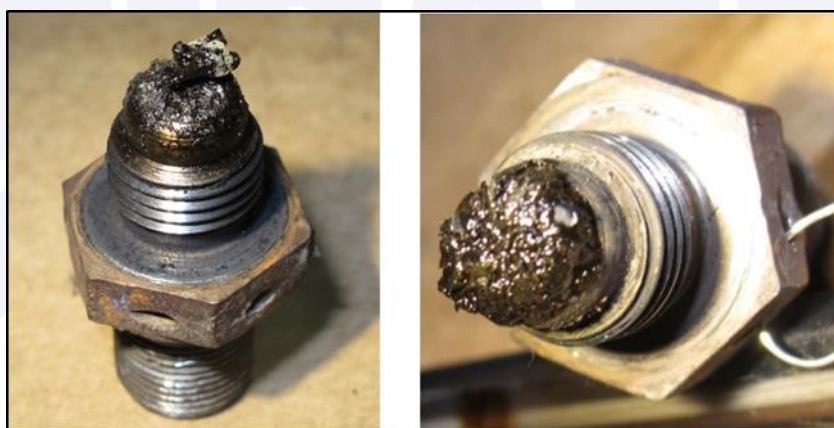
The upper and lower Magnetic Chip Detectors contained a significant amount of apparently ferrous material, covered by an oily substance similar to gel (Figure 50).

Figure 50 - Metallic material deposited on the Magnetic Chip Detectors.

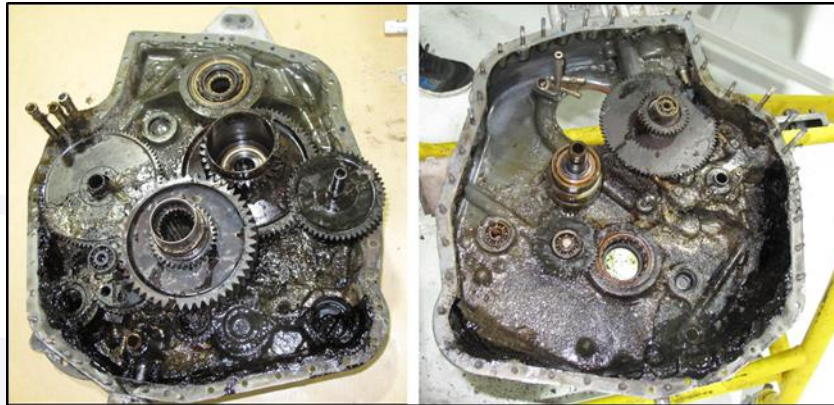
The Gearbox had thermal damage on its bottom exterior. It was opened and burnt oil residues, dark colored in its internal components, were observed (Figure 52).

Figure 52 - Gearbox.

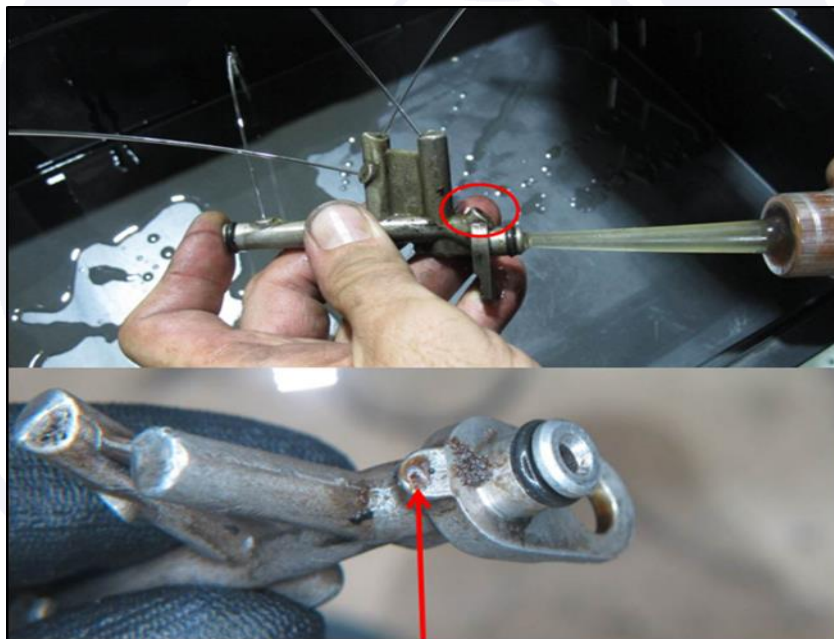
A test was carried out, introducing oil at low pressure, and it was verified that there was no fluid coming out of the hole that directed the lubrication to bearing 2 (Figure 53).

Figure 53 - The oil delivery tube with blocked orifice.

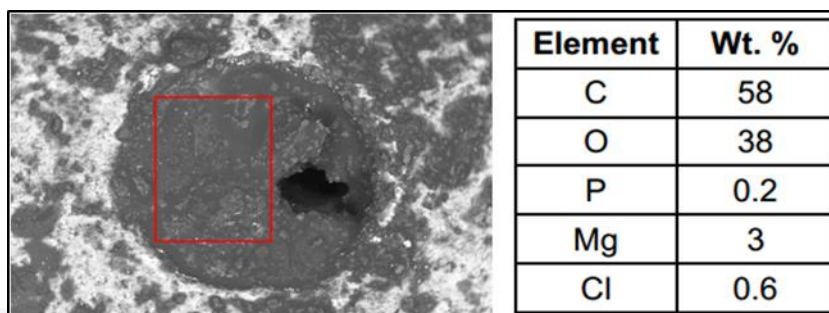
The material was examined by X-Ray Spectroscopy (EDS) and the results indicated that the blocking material was carbonaceous (Figure 54).

Figure 54 - Results of the EDS analysis.

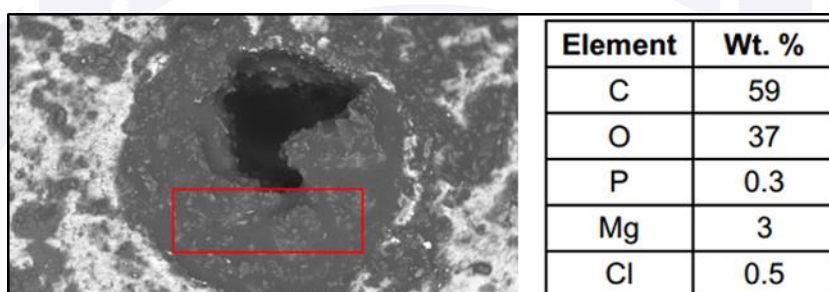
An additional analysis was performed after the morphological alteration and there was no considerable compositional difference in the material. Traces of phosphorus and approximately 3% of magnesium were found in the material (Figure 55).

Figure 55 - Results of the EDS analysis of the material that blocked the orifice of the oil delivery tube for bearing n° 2, after exposure to vacuum.

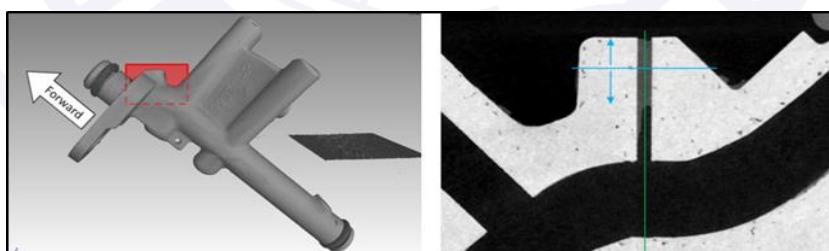
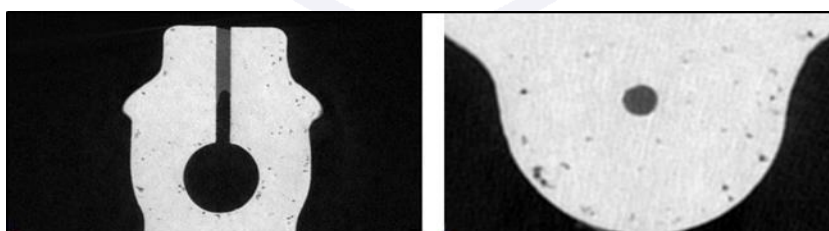
The block found in the oil delivery tube filled the entire cross-sectional area and approximately half the length of the oil passage duct for bearing n° 2. There were no variations in intensity on the TC that could have suggested variation in the composition or block density along its length (Figures 56 and 57).

Figure 56 - Result of TC performed on the oil delivery tube. A 2D section along the red plan is shown in detail.

Figure 57 - 2D sections along the plans shown in Figure 56.

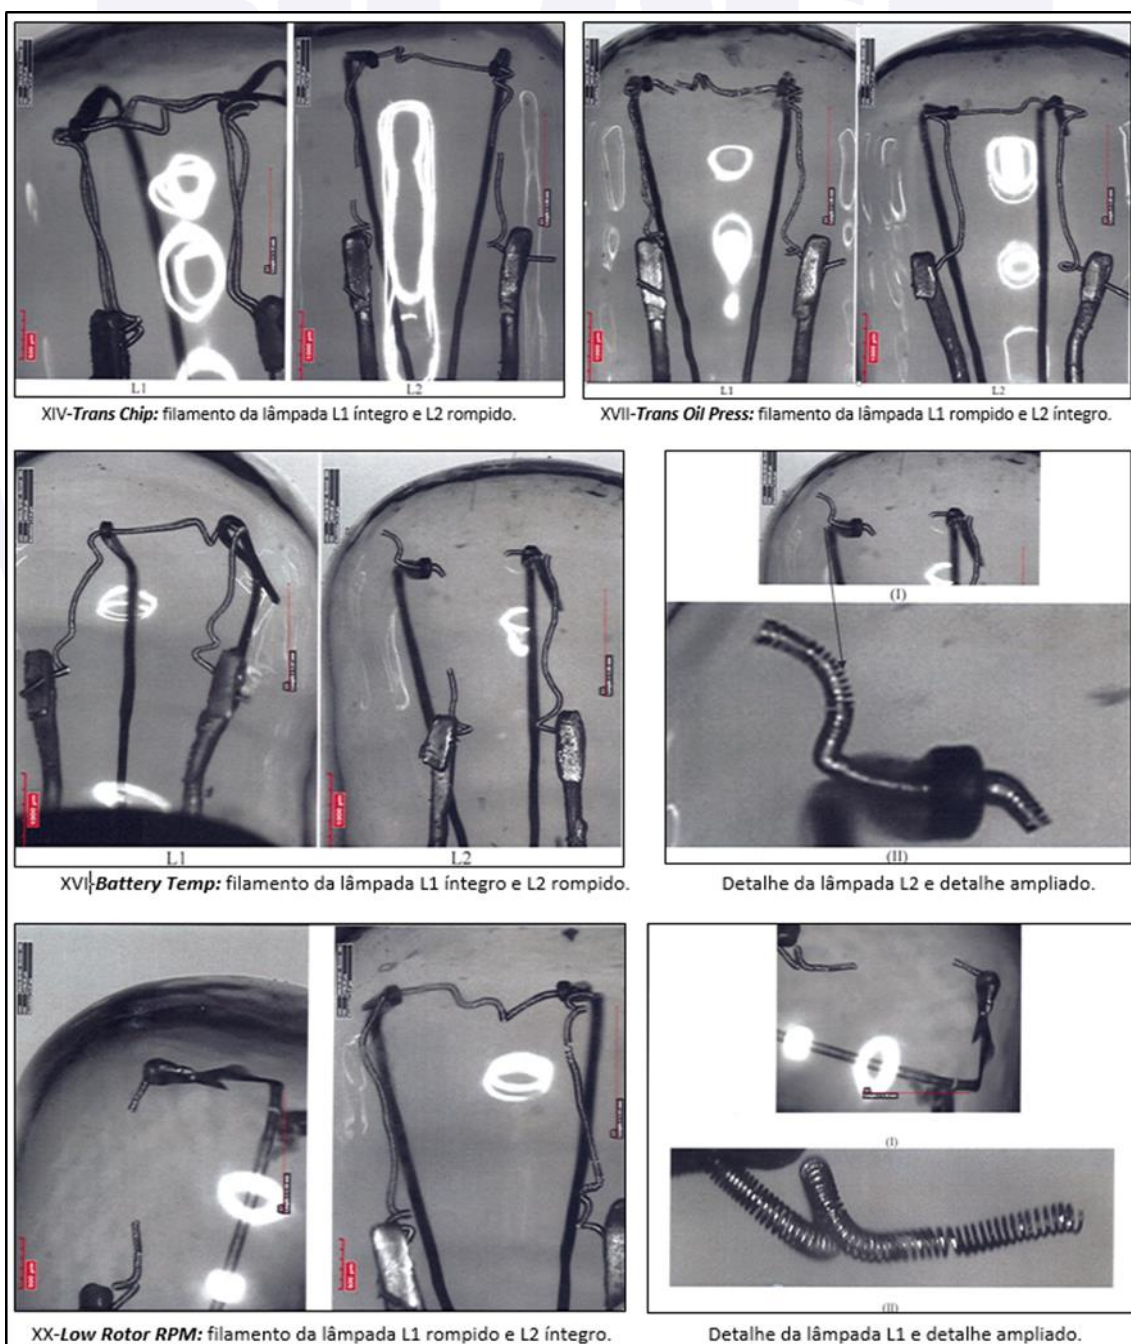
It was observed that one of the lamps in the XIV-Trans Chip, XVI-Battery Temp, XVII-Trans Oil Press and XX-Low Rotor RPM slots showed a filament rupture (Figure 67).

Figure 67 - Slots that presented one of the two lamps with broken filament.

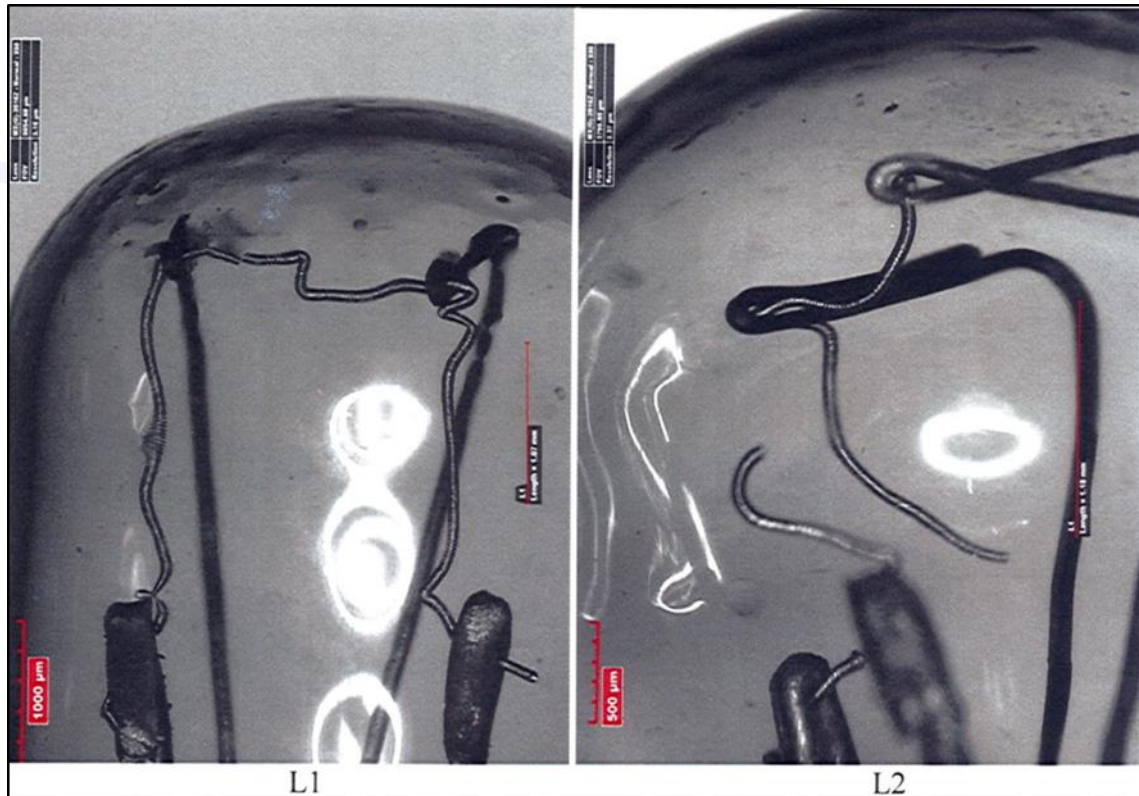
The two lamps in the slot referring to the XIII-Eng Chip position had their filaments broken with no sign of elongation (Figures 68 and 69).

Figure 68 - L1 and L2 lamps in slot XIII-Eng Chip with broken filaments.

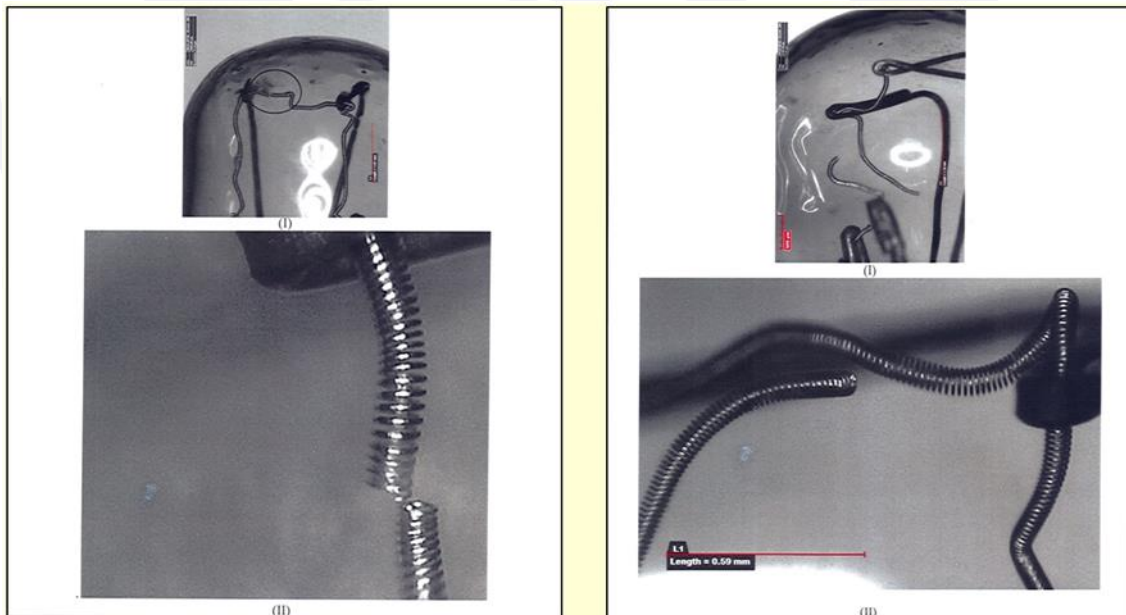
Figure 69 - Details of the broken filaments of the L1 and L2 lamps in slot XIII-Eng Chip.
