**FINAL REPORT**  
**A - 088/CENIPA/2015**

<b>OCCURRENCE:</b>	<b>ACCIDENT</b>
<b>AIRCRAFT:</b>	<b>PT-YDY</b>
<b>MODEL:</b>	<b>206B</b>
<b>DATE:</b>	<b>16JUN2015</b>

This is the Final Report of the 16JUN2015 accident with the 206B aircraft, registration PT-YDY. The accident was classified as “[CFIT] Controlled Flight into Terrain”.

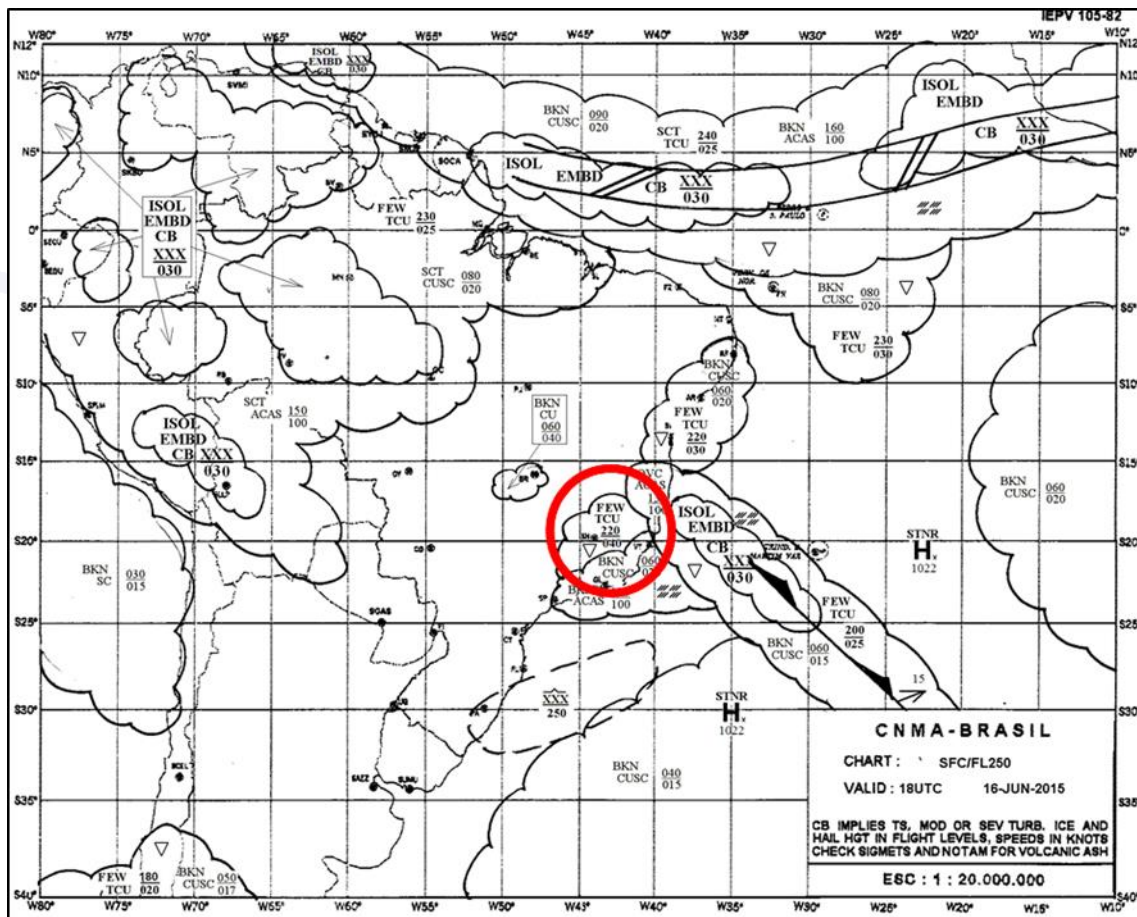
Figure 1 - SIGWX Weather Chart.

The SIGWX, valid until 1800 (UTC), illustrated the presence of few Towering Cumulus (TCU) clouds, based on 4,000ft and top on the FL220 (Figure 1).

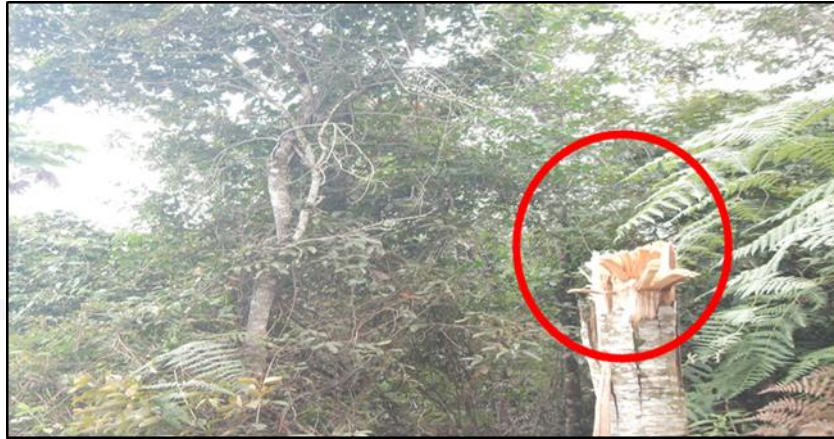
Figure 2 – Cut-off point in the vegetation.

The aircraft initially crashed into the vegetation and just after into the terrain. At the place of the occurrence, sectioned vegetation was identified, with cut-off points between two and three meters, showing the aircraft passage until the final stop (Figure 2).

The trail left by the aircraft in the vegetation indicated a trajectory with a high impact angle against the ground, but in practically level flight, due to the extremely steep characteristic of the elevation.

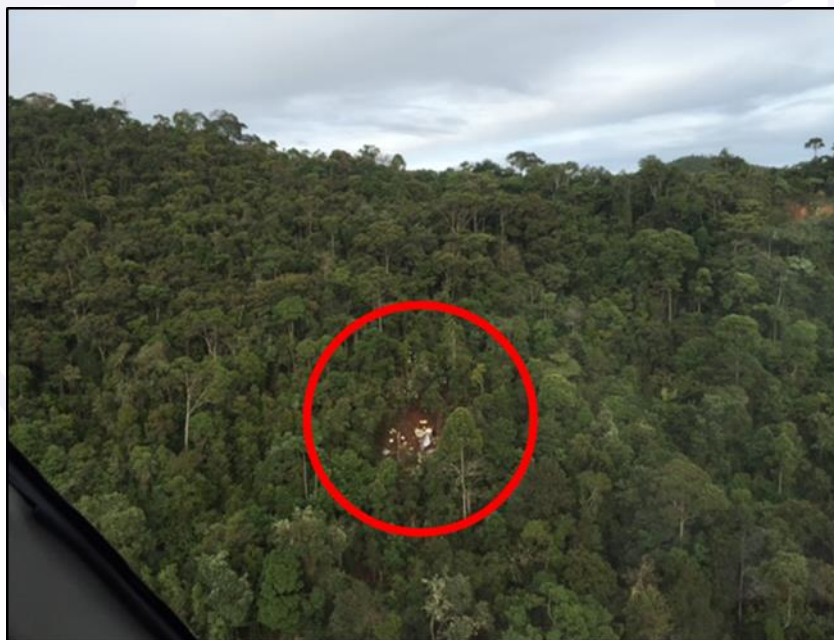
Figure 3 - Air image of the occurrence place.

The crash site of the aircraft was difficult to reach, of dense forest, on steep terrain and high tree tops, at an altitude of approximately 4,092ft (1,229m).

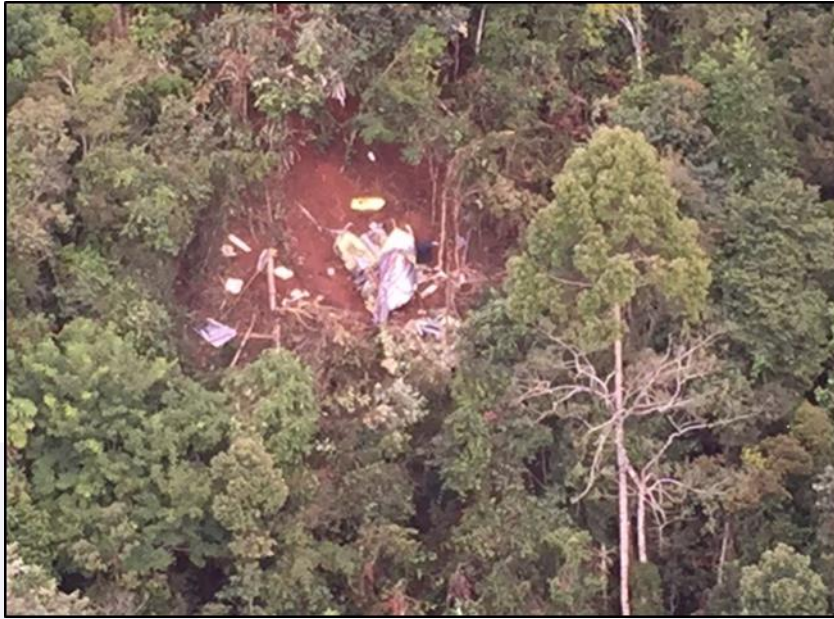
Figure 4 - Air image of the wreckage concentration.

The wreckage of the passengers' cabin and tail section was concentrated in one place, while the main rotor, rear rotor, and transmission hub parts were 10, 7, and 6 meters away from the passengers' cabin respectively.

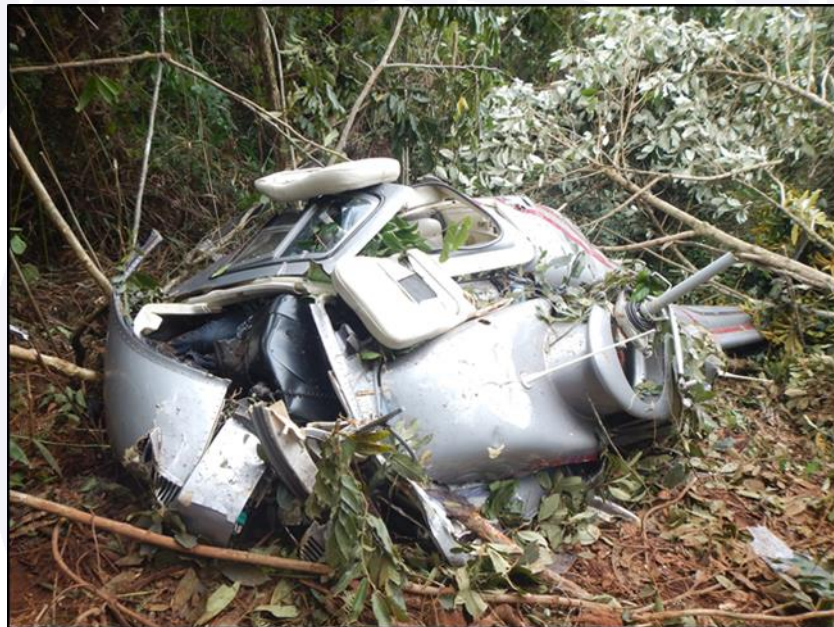
Figure 5 - Core of the aircraft wreckage.

The aircraft was found tipped to the left side of the fuselage with the bodies of three occupants still positioned inside, with belts fastened: the pilot and one passenger were in the front seats and another passenger in the right rear seat.

No evidence of fire was found.
