**FINAL REPORT**  
**A - 060/CENIPA/2017**

| <b>OCCURRENCE:</b> | <b>ACCIDENT</b> |
| <b>AIRCRAFT:</b> | <b>PT-YZM</b> |
| <b>MODEL:</b> | <b>AS 350 B2</b> |

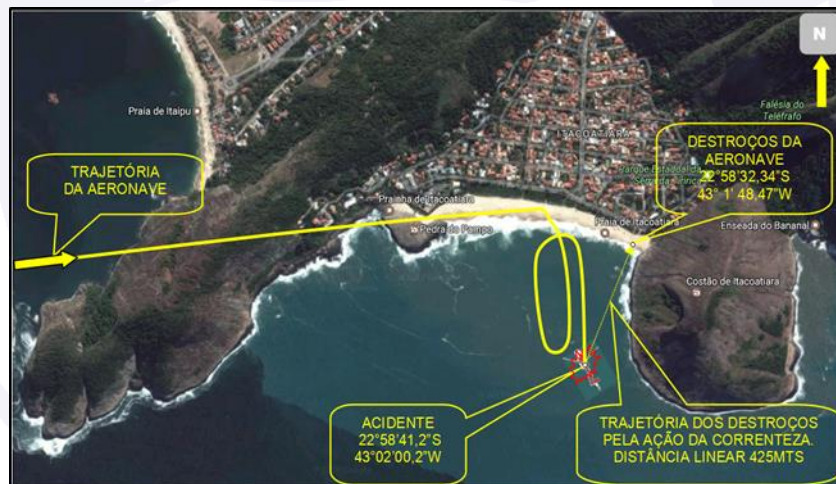
Figure 1 - Sketch of the occurrence.

The type of damage identified in the wreckage pointed to a lateral collision of medium intensity, with a low angle and low speed trajectory.

After that first impact, the aircraft spun around its longitudinal axis and the tail cone broke after its rotor touched the water.

With the loss of the tail cone, the helicopter became uncontrollable and the cabin crashed into the water's surface.

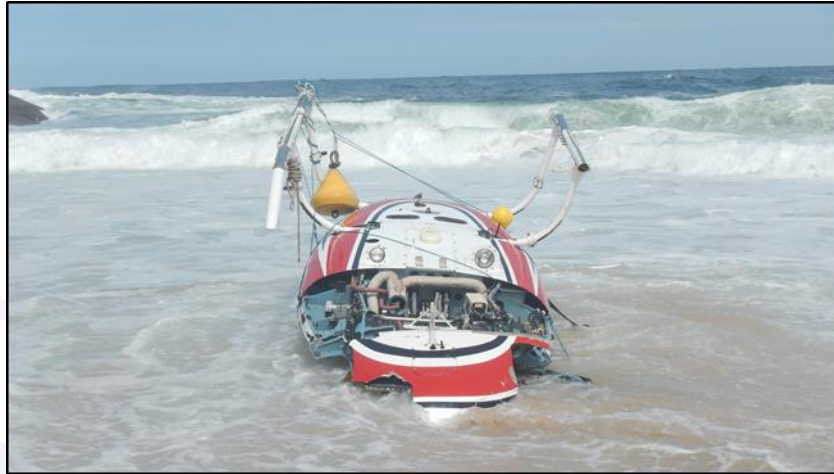
However, on 18APR2017, six days after the accident, the aircraft dawned on Itacoatiara beach, having been brought in by the force of the sea current (Figures 2 and 3).

Figure 2 - Aircraft on the beach, after being brought by the sea current.

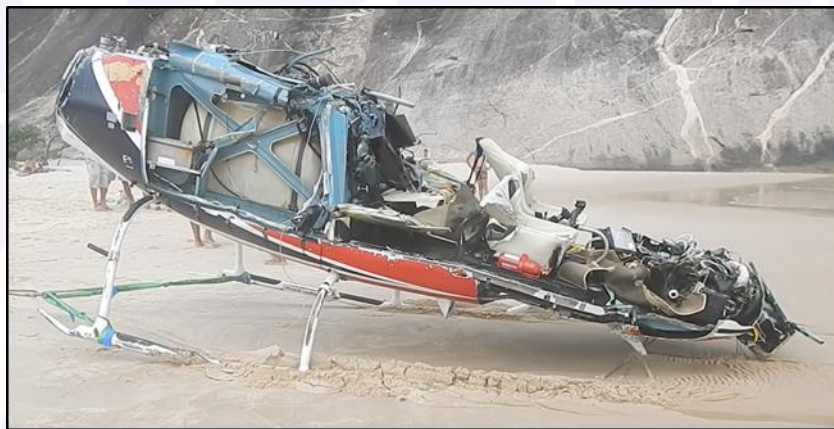
The aircraft had damage along its entire length, including fuselage, tail cone, skis, engine, main rotor and tail rotor.

Figure 3 - General view of the aircraft on the beach, after being removed from the sea.
