COMANDO DA AERONÁUTICA
CENTRO DE INVESTIGAÇÃO E PREVENÇÃO DE
ACIDENTES AERONÁUTICOS

FINAL REPORT
A-009/CENIPA/2014

OCCURRENCE:	ACCIDENT
AIRCRAFT:	PT-YRE
MODEL:	AS 350 BA
DATE:	10 FEB 2010

This is the Final Report of the 10 February 2010 accident with the AS350 aircraft, registration PT-YRE. The accident was classified as “system or component failure”.

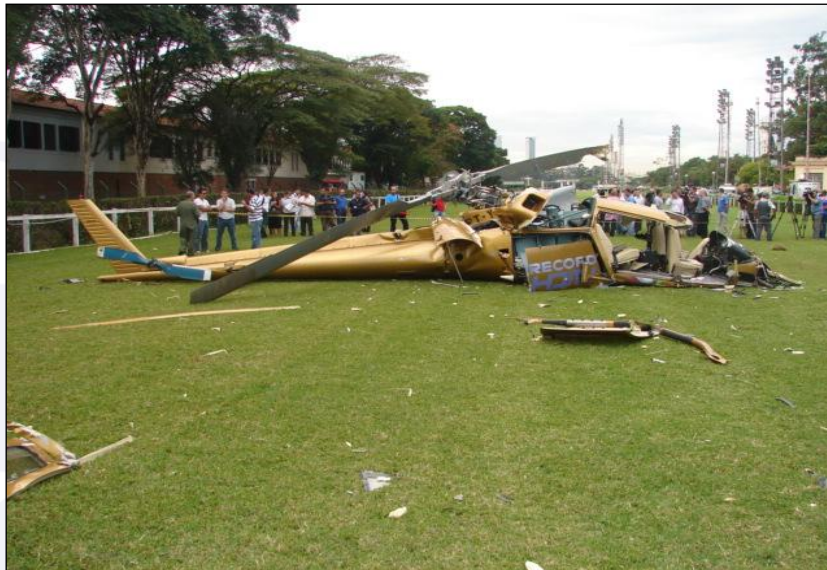
Figure 1 – General view of the wreckage in the crash site.

The characteristics of the wreckage indicated that the collision of the aircraft with the ground had a high degree of energy. The cabin floor sank and the structure supporting the pilot seat was deformed.

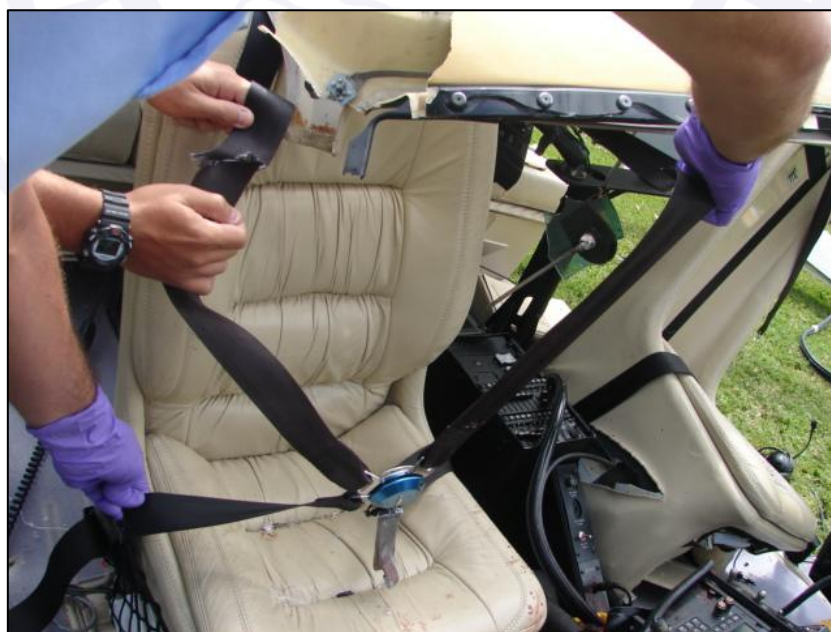
The pilot perished in the crash on account of a traumatism in the region of his right eye. His head was violently whipped downward and hit his own knee. The sinking of the seat on the floor loosened the seat belt and rendered the suspenders ineffective.

Figure 2 – Aspect of the pilot's seat belt after the impact.

The seat of the pilot was not one of the anti-crash type, and the points of attachment were located on the aircraft floor.

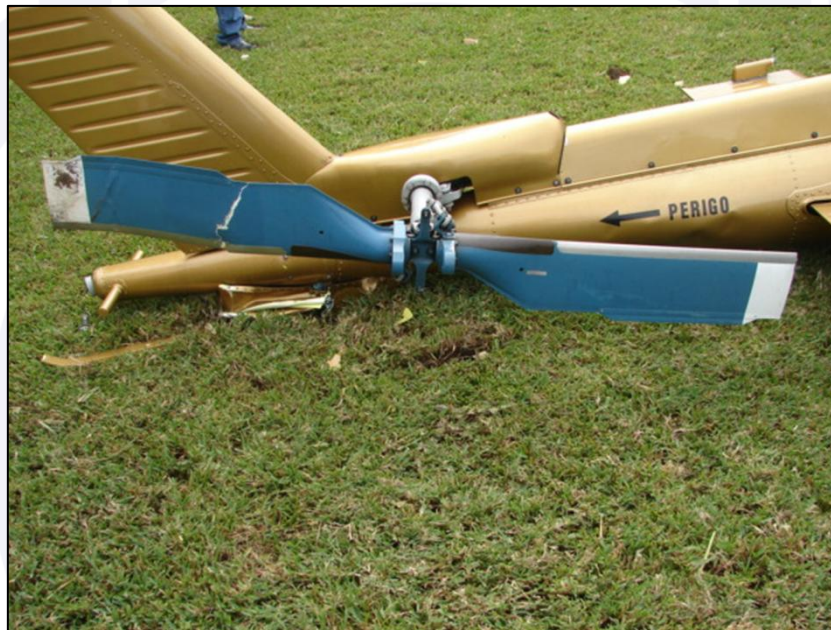
Figure 3 – Tail rotor blades.

The blade in worse condition had signs of earth and damage to the tips, a probable consequence of hitting the ground. This is corroborated by the absence of significant damage to the other blade.

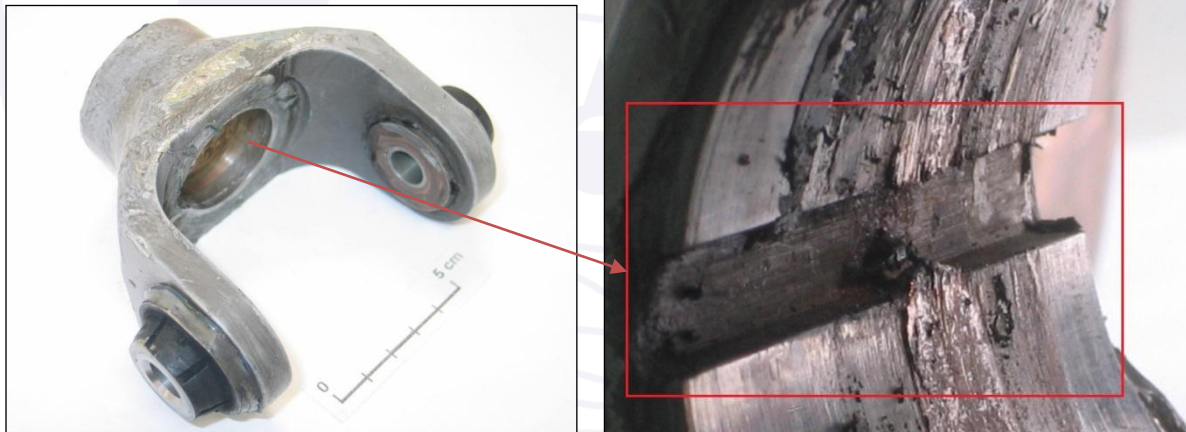
Figure 6 – Support fork of the PT-YRE blades (left). On the right, the inner surface of the fork, showing the groove for the 'tongue' in highlight.

When there is a sudden stop of the tail rotor, (resulting from a collision of the blades with the ground or obstacle, for example) the 'tongue' is broken, but the fork does not make a complete revolution around the conical shaft. In relation to the 'tongue', it is expected that the broken part will stay in the interior of the fork groove.

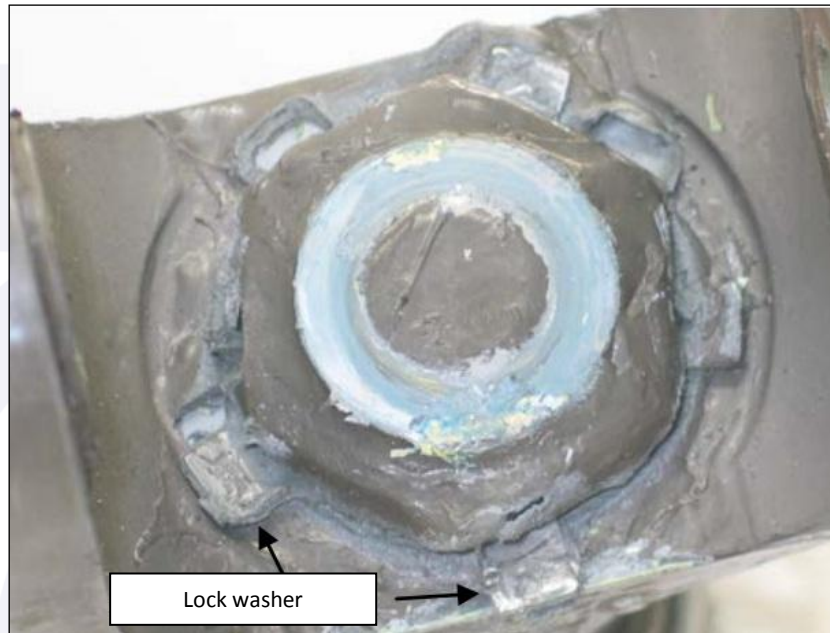
When the technicians analyzed the bolt that fastened the fork to the conical shaft, they found out that the lock washer was outside of its original position, and that the bolt had almost no torque. It is estimated that they needed only 2 kgf.m to remove the bolt. They found, also, circular blue color marks on the head of the bolt. These marks were caused by friction between this bolt and the bolts limiting the flapping of the tail rotor blades, as illustrated in Figures 7 and 8. They also found circular friction marks on the underside of the head of the fastening bolt (Figure 9). All this evidence indicated that the bolt rotated in relation to the fork.

Figure 7 – Bolt for fastening the fork to the conical shaft. It is possible to observe that the lock washer is outside of its original position, and that there is a blue circular mark around the head of the bolt.

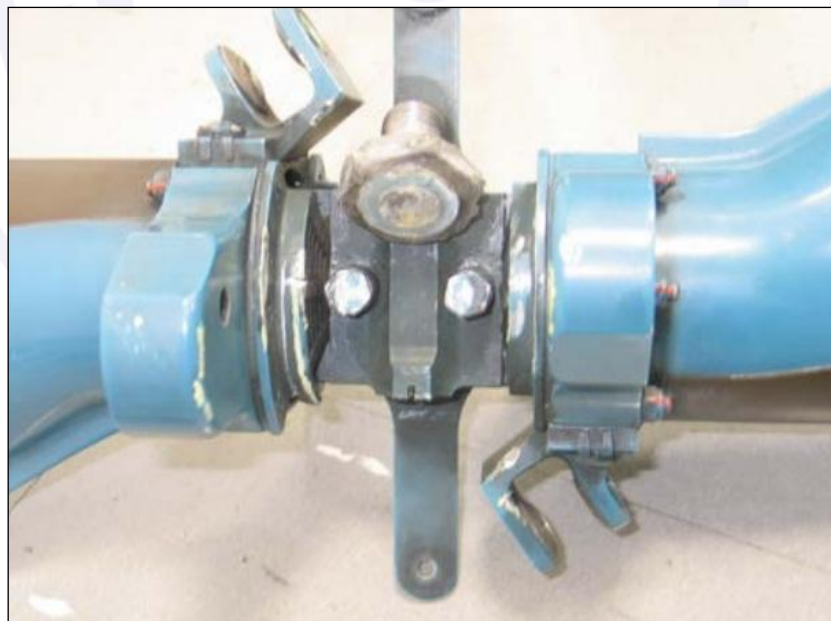
Figure 8 – Bolts for limiting the flapping of the tail rotor blades. The bluefish mark on the fastening bolt was caused by friction between the fastening bolt and the two bolts which limit the flapping.

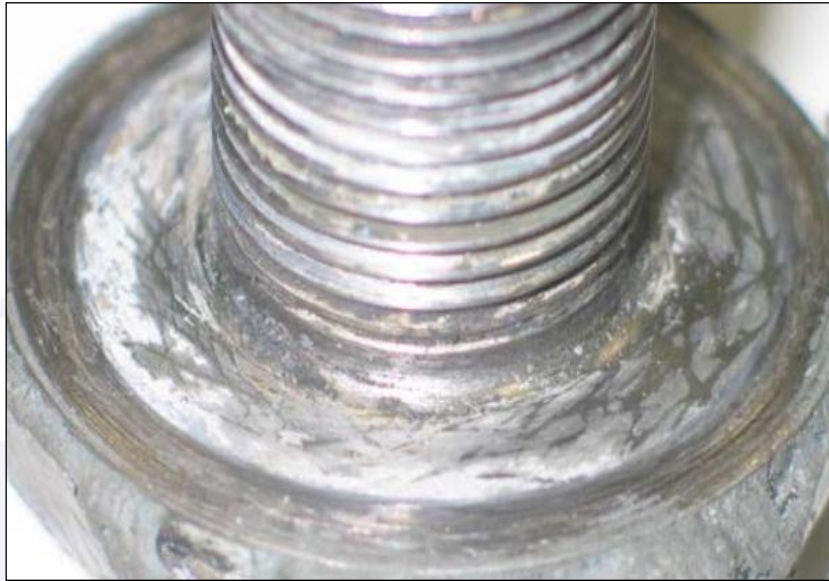
Figure 9 – Mark of circular friction on the lower part of the fastening-bolt head.

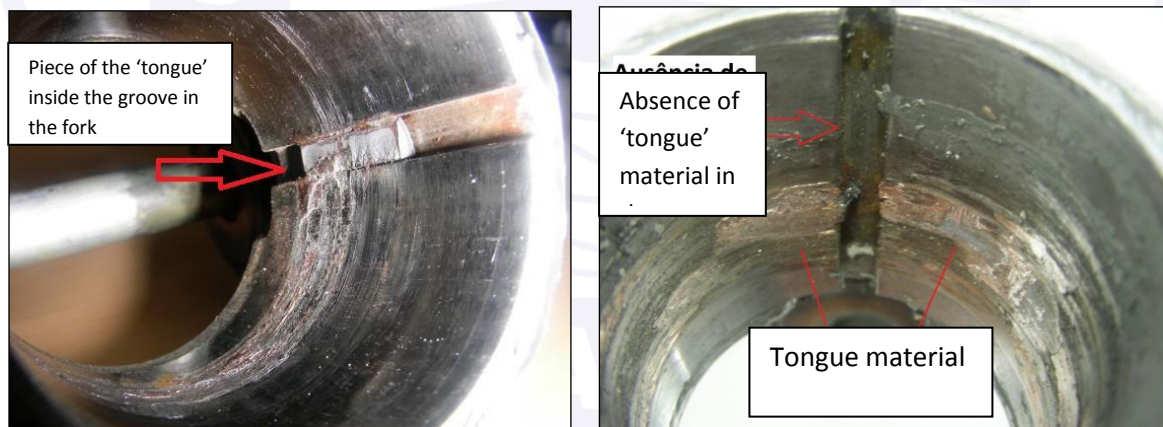
An analysis of the internal surface of the blade support-fork showed circumferential marks of friction at the point of connection with the conical shaft. In addition, the presence of worn down encrusted 'tongue' material was detected on the whole internal circumference of the fork. There were no signs of this material inside the groove. Finally, presence of the sealant material was also detected on the internal surface of the fork.

Figure 10 makes a comparison between the internal part of a fork with fracture of the 'tongue' caused by an abrupt stop (left picture), and the fork of the PT-YRE (right picture). In the left picture, it is possible to observe that a piece of the fractured 'tongue' remained in the groove, something that did not happen in the PT-YRE (on the right)

Figure 10 – Comparison between a fork with fracture of the 'tongue' on the left, and the fork of the PT-YRE on the right.

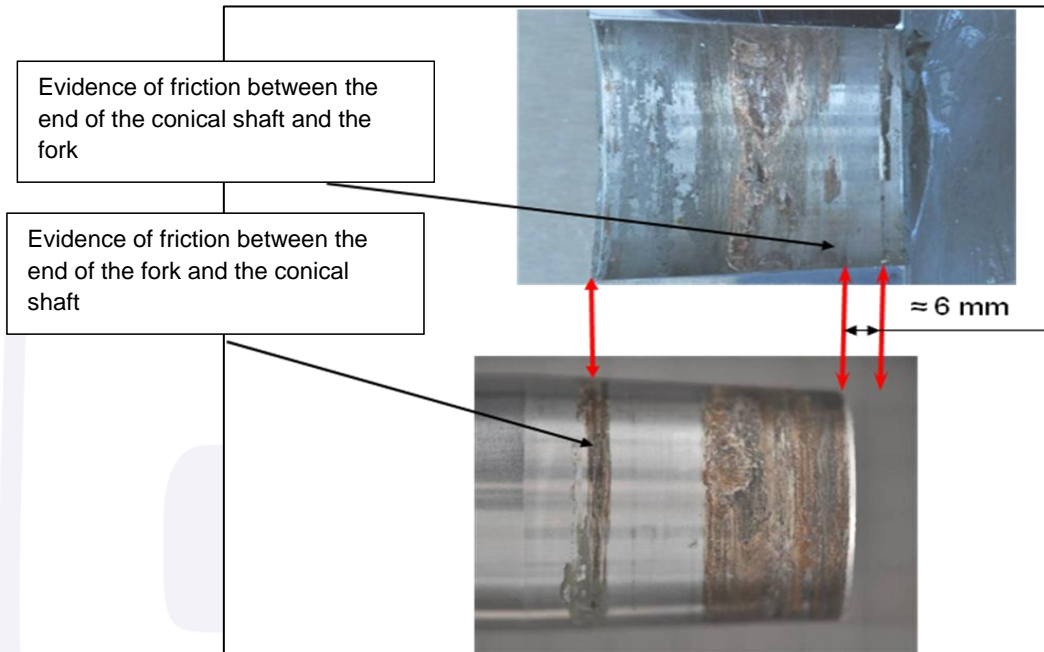
Figure 11 – Evidence of disconnection between the conical shaft and the fork.

All the pieces of evidence indicate that there was relative rotation between the conical shaft and the fork.

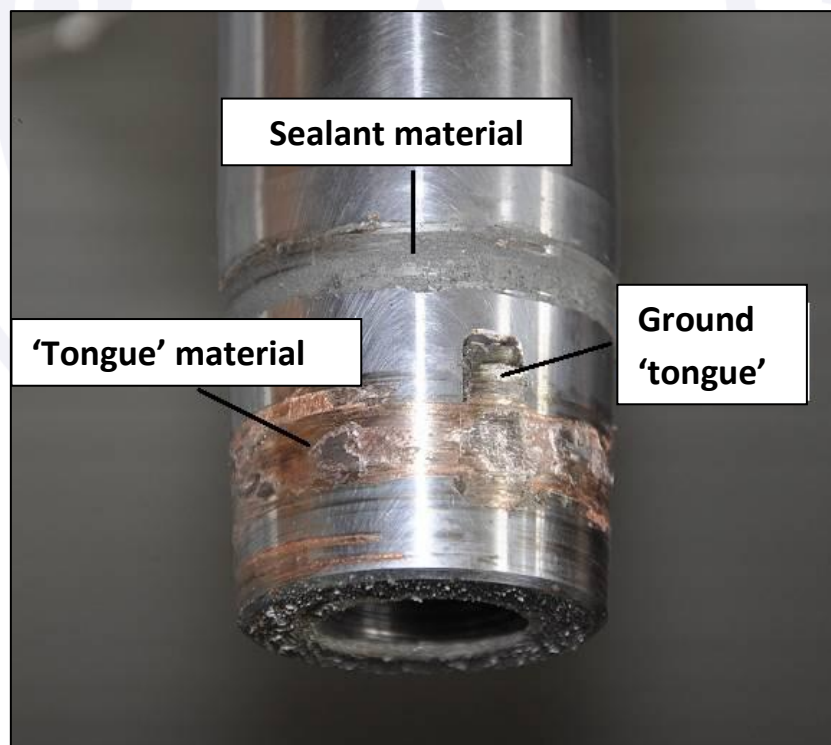
Upon analyzing the conical shaft, the commission verified that there were circumferential marks of friction on its surface. The 'tongue' had sustained total wear, and there was 'tongue' and sealant material around the circumference of the shaft, as shown in the figure below.

Figure 12 – Conical shaft of the PT-YRE, as seen after disassembly.

All pieces of evidence indicate that there was relative rotation between the conical shaft and the fork.

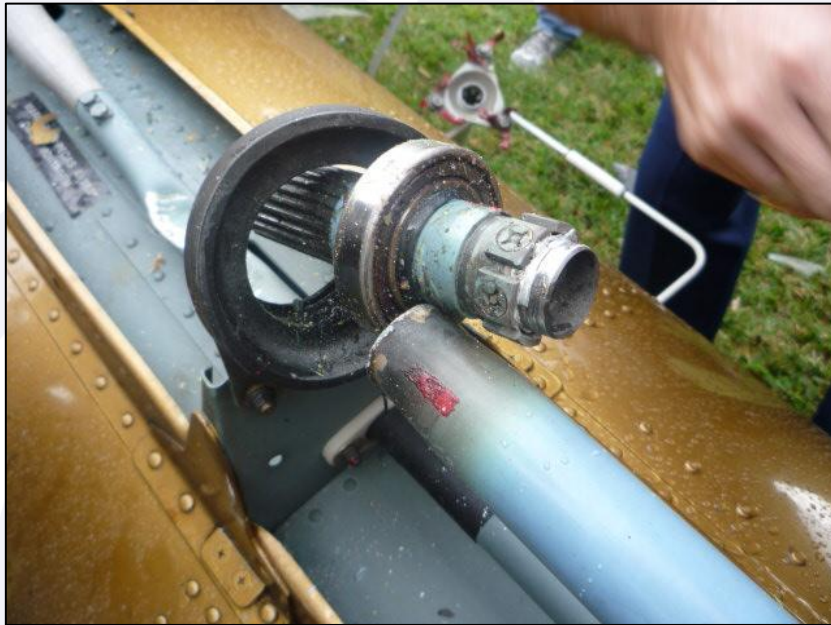
During the Initial Action in the crash site, it was observed that there was a breakage in the tail rotor transmission tree, and at the connection between the long and short shafts.

There was failure of the long shaft in the region of the attachment bolts. The marks found correspond to a shear fracture in torsion due to overload, probably caused by blocking. Tests performed in the parts anterior to the tail rotor drive shaft did not show any problems capable of causing a blocking of the drive shaft.

Figure 13 – Rear transmission, as found at the Initial Action.

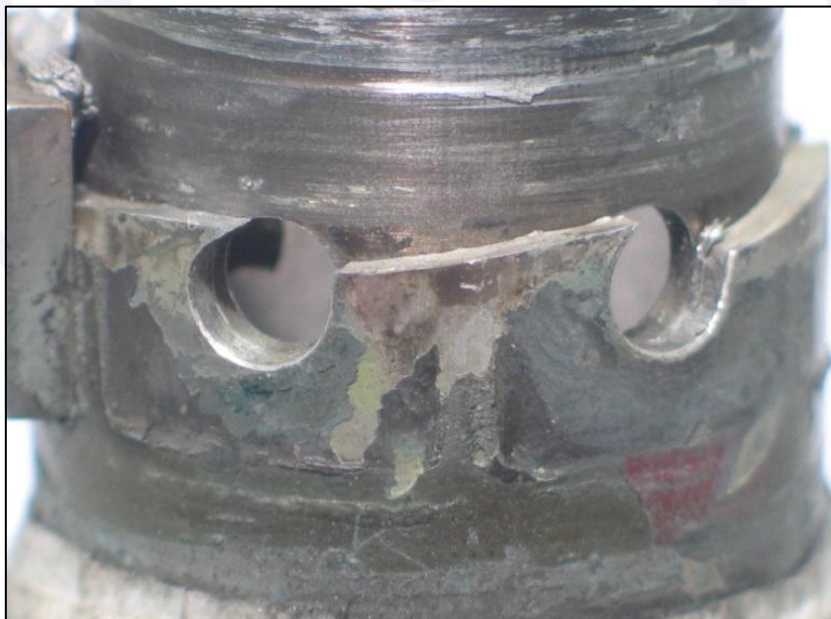
Figure 14 – Failure observed in the long shaft. The slope of the fracture indicates that there was overload due to torsion.

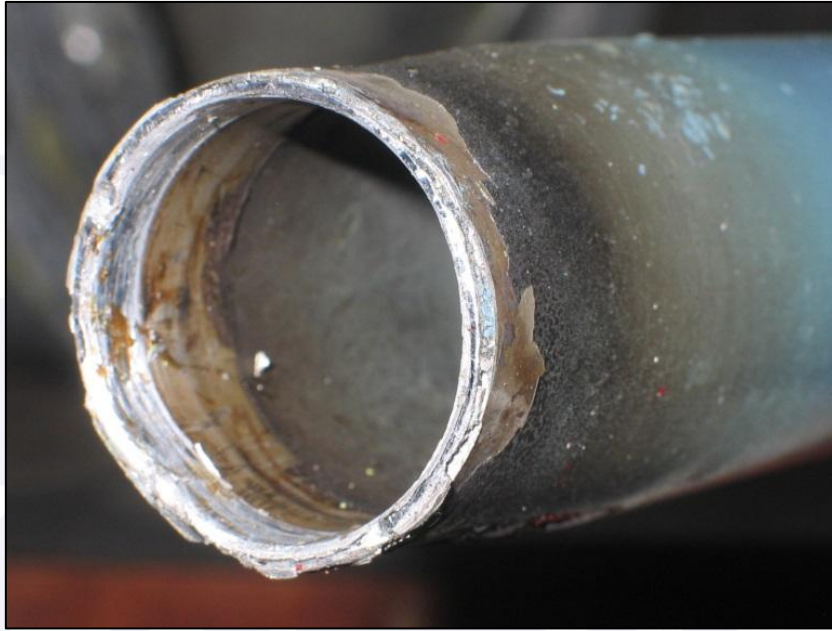
After the breakage, the shaft continued turning forcefully on the connection. Signs of friction and high temperatures were observed between the long shaft (external) and the

short shaft (internal), resulting in fusion of the shaft material (Figure 16). This evidence suggests that the shafts remained concentric, and that there was transmission of rotation for some time.

Figure 15 – End of long shaft broken at the point of connection with the short shaft.

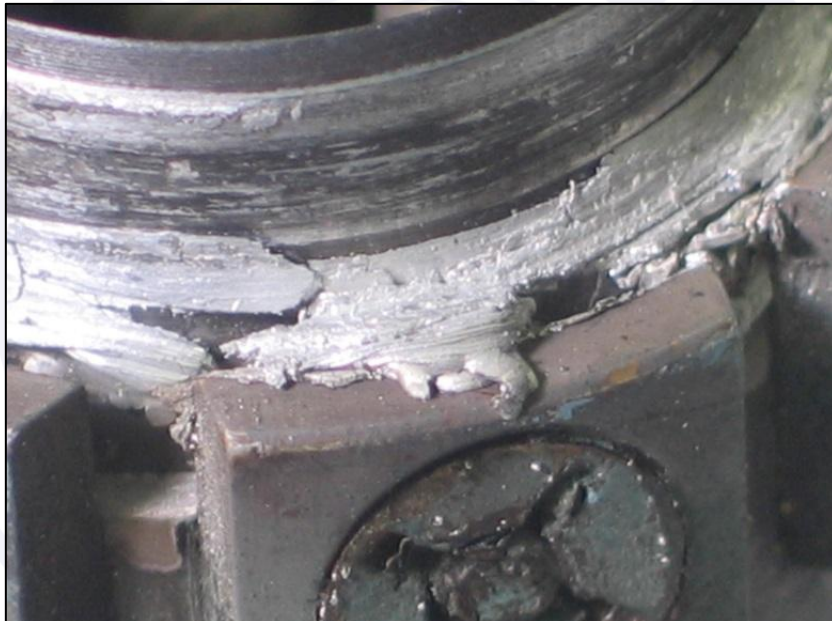
Figure 16 – Molten metal (fusion) deposited in the connection between the shafts.

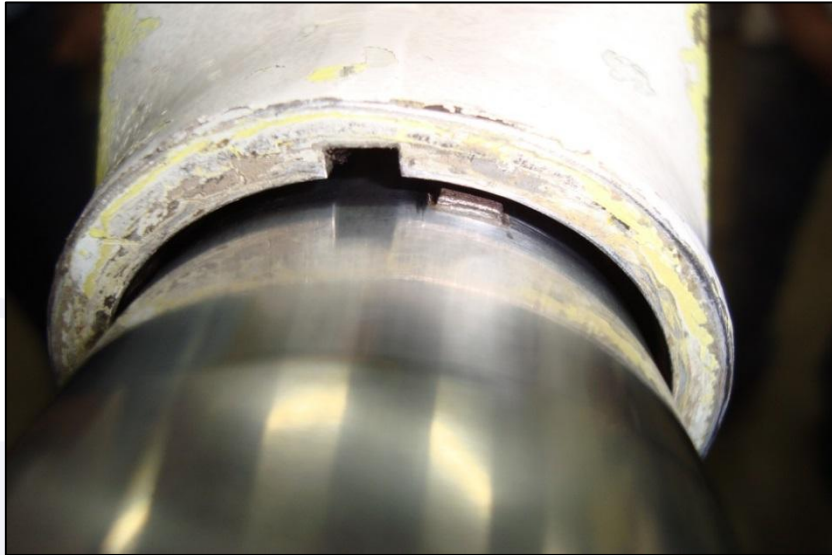
Figure 23 – Incorrect installation of the fork in the conical shaft.

It was observed that, despite the gross appearance, it is possible to follow all the steps for assembling the system, and the prescribed torque (26 kgf.m) is accepted.

In figure 23, it is possible to see that the system remains “superimposed”, and that the applied torque is absorbed by the ‘tongue’. It was observed that the fork does not perfectly match the conical shaft, with a space of .8 mm between the two parts.

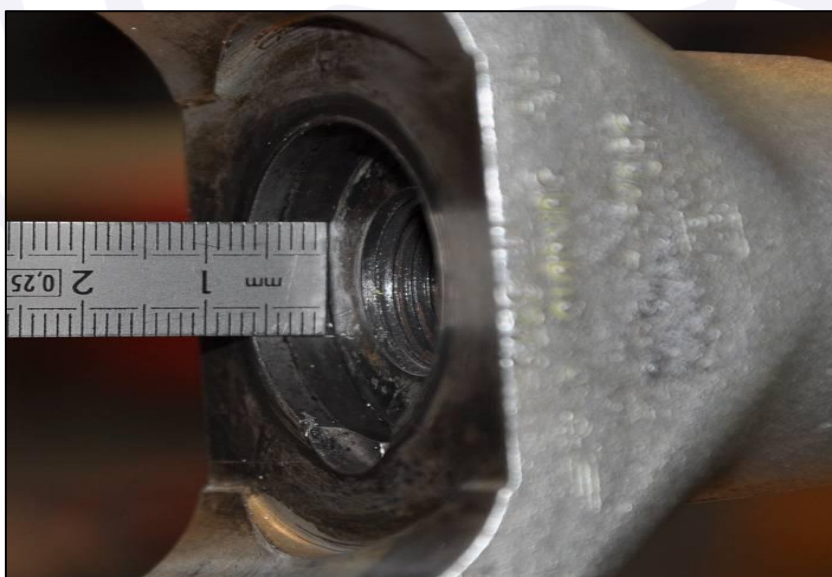
In the incorrect assembly, it was observed that the section of the conical shaft inserted in the fork was approximately 27 mm (without application of torque), and 33 mm when the torque was applied in accordance with the prescriptions of the helicopter maintenance manual. The distance between the ends of the parts on the frontal surface was also different, corresponding to 7 mm. It is worth highlighting that the values found were significantly different from those obtained when the system is assembled in the correct manner (37 to 38 mm; and 3 mm).

Figure 26 – Space of 7 mm between the ends of the fork and conical shaft when the system is assembled incorrectly.

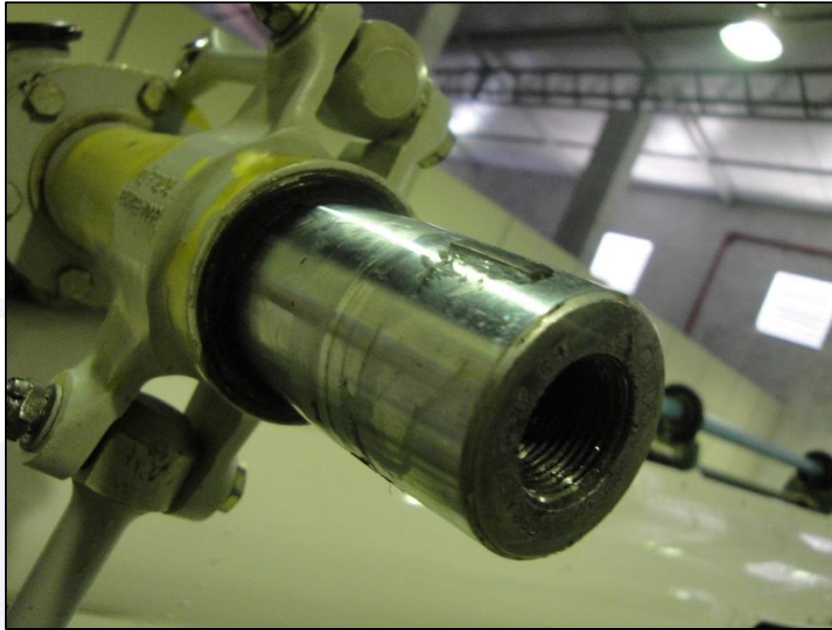
During the simulation, a considerable loss of material was observed as a result of friction between the parts. The figures below illustrate the result of the grinding.

Figure 29 – ‘Tongue’ showing loss of material, after application of torque simulating turn.

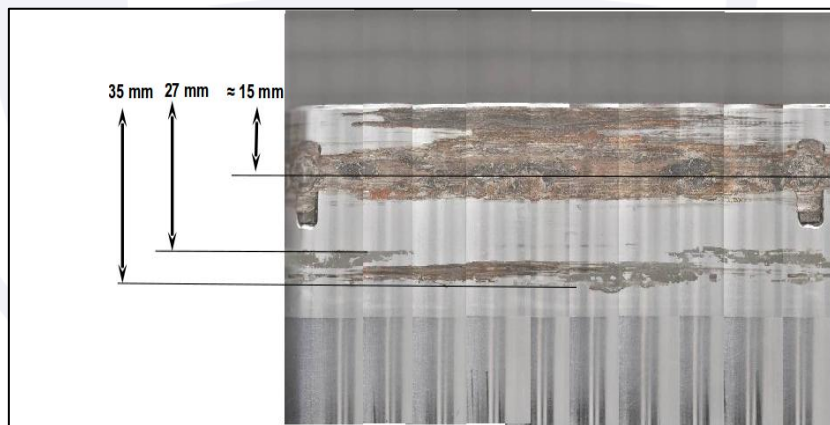
There were some marks on the conical shaft coincidental with the values obtained in an incorrect assembly. Figure 30 shows that the polymer was distributed in a non-homogeneous manner on the conical shaft and gathered close to the ‘tongue’, precisely at the point where a space would exist in the ‘superimposed’ assembly. It is also possible to observe that opposite the ‘tongue’ there is practically no polymer, and there are marks of metal-metal rubbing.

Figure 30 – Conical shaft made plane.

These pieces of evidence suggest that the fork was fastened incorrectly, with the ‘tongue’ outside of the groove, with penetration of polymer in the space existing between the fork and the conical shaft.

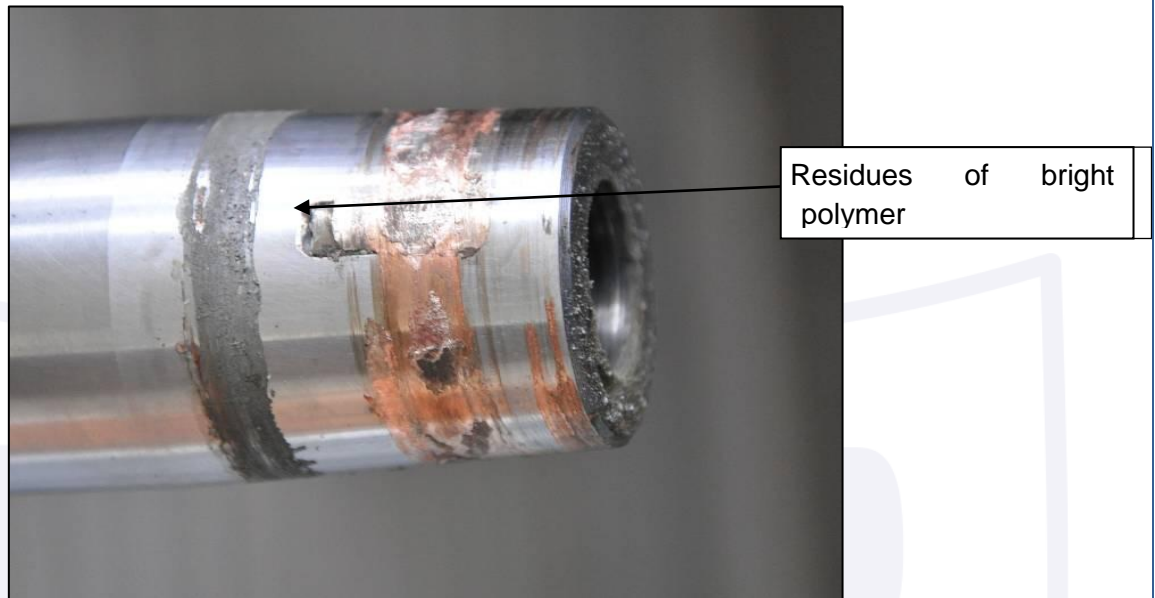
Figure 31 - Residues of bright polymer on the conical shaft.

The pulverized aspect of this polymer suggests that it was not dry when the failure occurred.

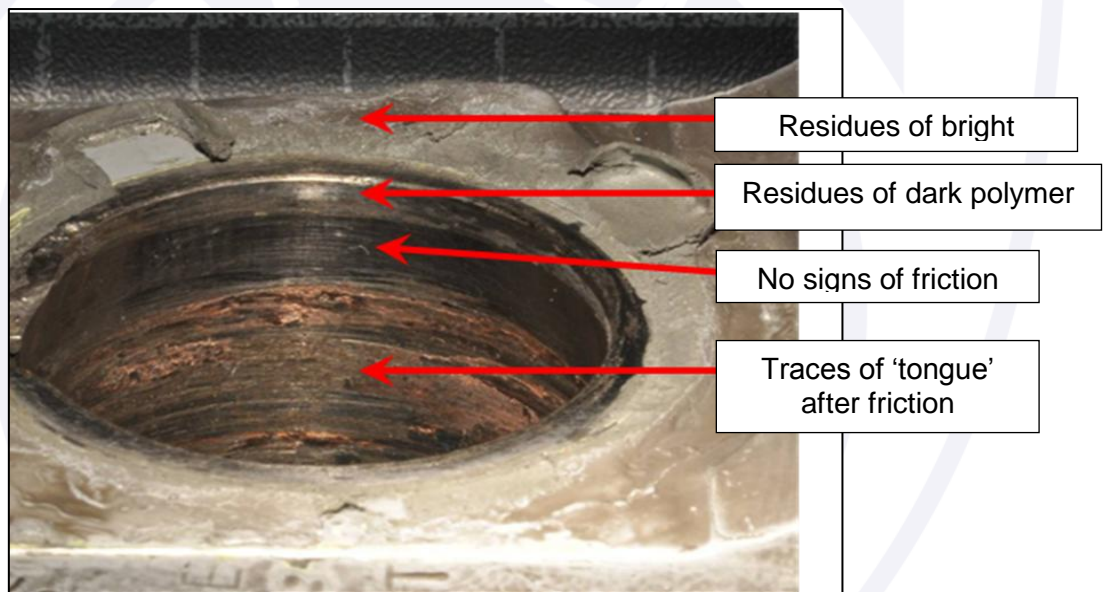
Figure 32 – Evidence of two different polymers.

The presence of residues from different polymers indicates that the polymers had been placed on different dates. The work at the laboratory with a spectrometer also suggests that there were two polymers on the conical shaft and fork, placed on different dates.

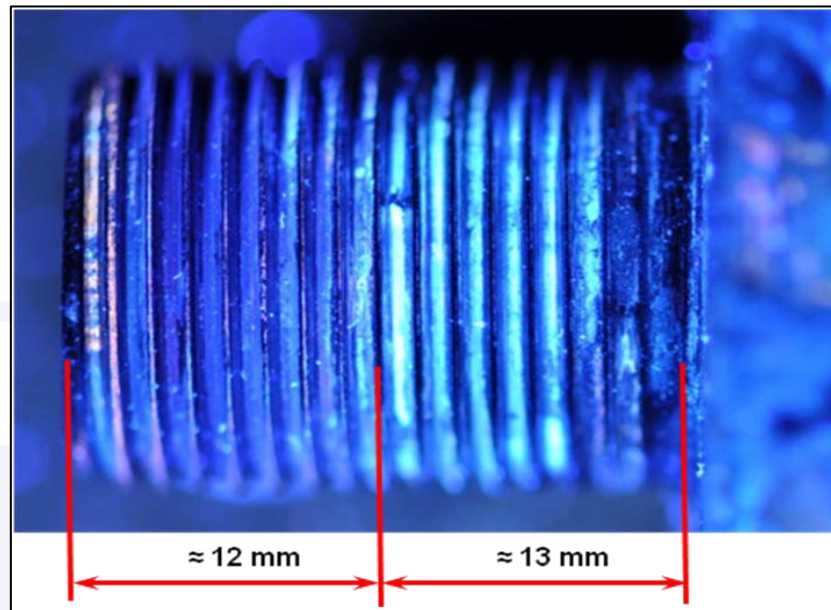
Figure 34 – Fork fastening-bolt.

The Loctite value found was approximately 12 mm, indicating that this was the final position of the bolt at the (incorrect) assembly of the system.
