**COMANDO DA AERONÁUTICA**  
**CENTRO DE INVESTIGAÇÃO E PREVENÇÃO DE**  
**ACIDENTES AERONÁUTICOS**

**FINAL REPORT**  
**A-013/CENIPA/2013**

<b>OCCURRENCE:</b>	<b>ACCIDENT</b>
<b>AIRCRAFT:</b>	<b>PR-IPO</b>
<b>MODEL:</b>	<b>A-109S</b>
<b>DATE:</b>	<b>30 APRIL 2008</b>

This is the final report of the 30 April 2008 accident involving the model A-109S aircraft, registration PR-IPO. The accident was classified as spatial disorientation.

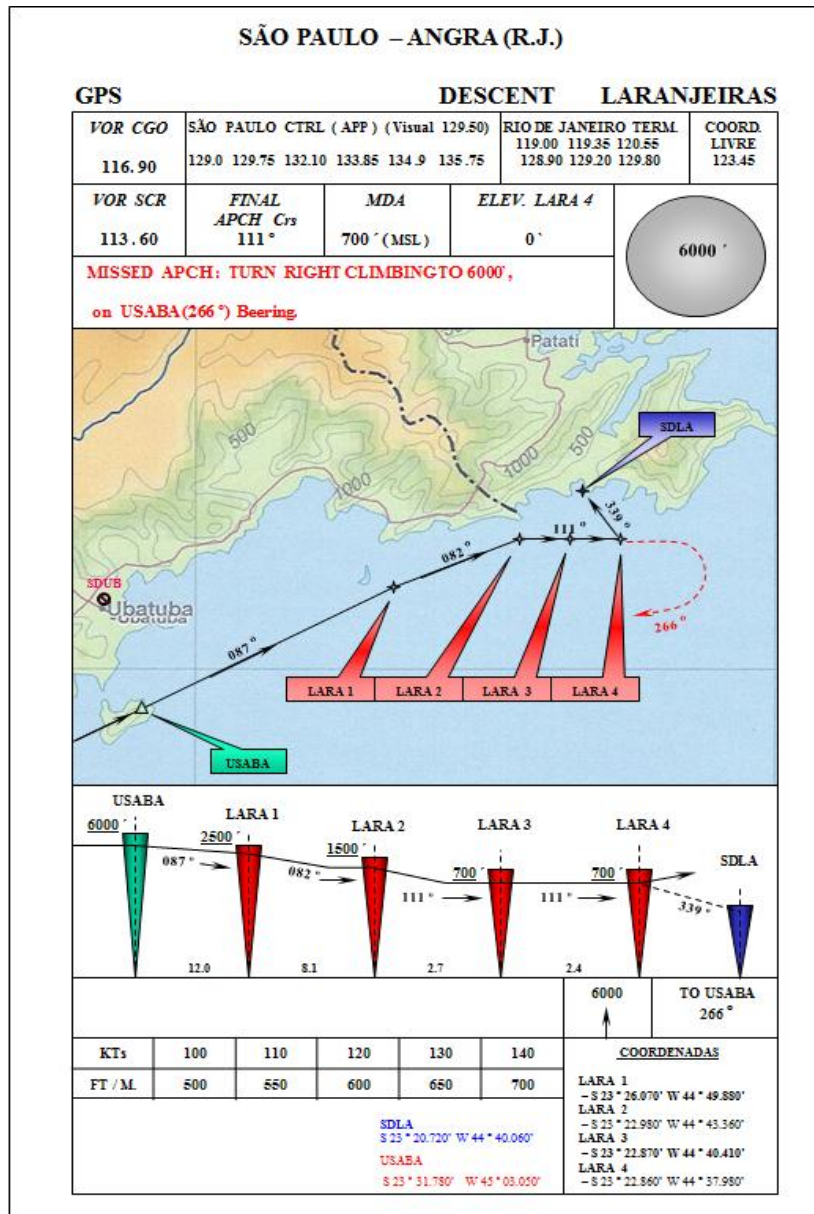
It is possible that the crew utilized a chart with a GPS instrument approach profile for landing in SDLA. This chart is neither homologated nor recognized by the DECEA (Airspace Control Department) in its official publications.

Figure 1 - GPS (Global Position System) "Approach Procedure" chart for Laranjeiras. There is striking similarity between the procedure layout in this chart and the official procedures issued by the DECEA.

If one considers that the VVI rate of climb/descent setting bug was found with a selected rate of descent value of 700ft/min, and that such rate of descent was one of the options established in the chart, it is reasonable considering that the PR-IPO crew was making use of this procedure.

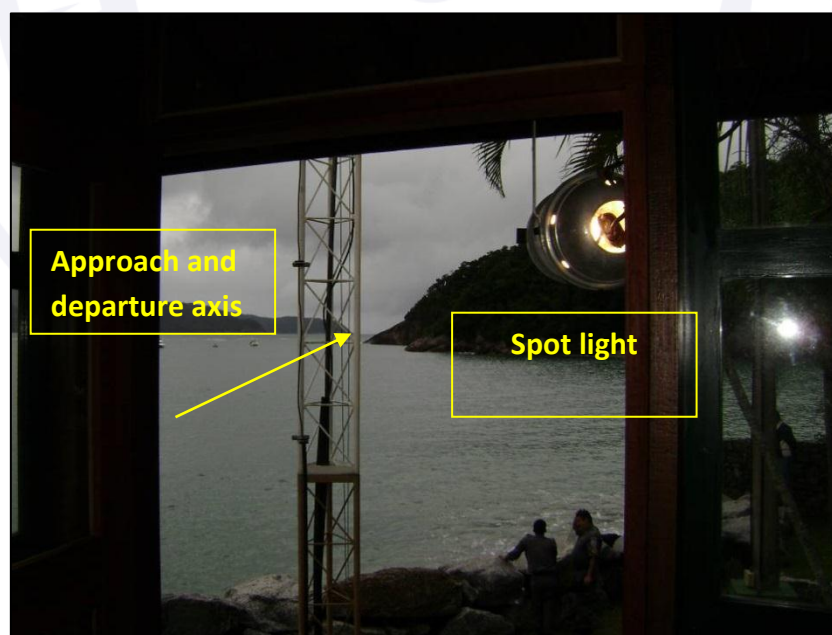
Installed by the Condomínio Management, there was also a stage spotlight, which was utilized in the attempt to illuminate the topographical features capable of interfering with a night-time approach or departure (Figure 2).

Figure 2 - Stage spotlight installed by the *Condomínio* Management in a construction close to the helipad.

The artificial lights (stage spot-light) utilized as palliative rather than mitigating actions by the Condomínio Laranjeiras Management to illuminate the relief features surrounding the helipad could hinder the pilot’s vision during the approach, generating a latent spatial disorientation risk condition.

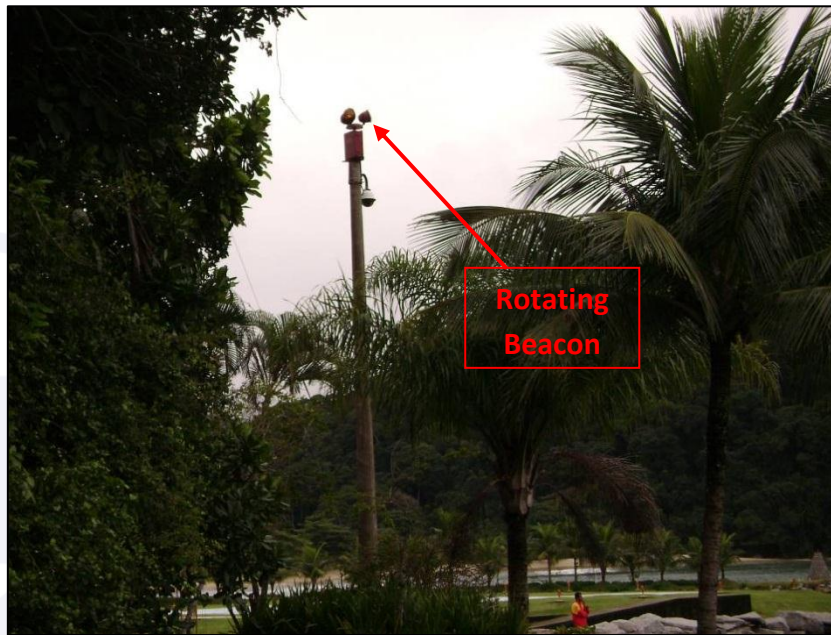
There was a tower installed near the helipad, utilized as a rotating beacon.

Figure 3 - Tower (Rotating Beacon) installed close to the Helipad.

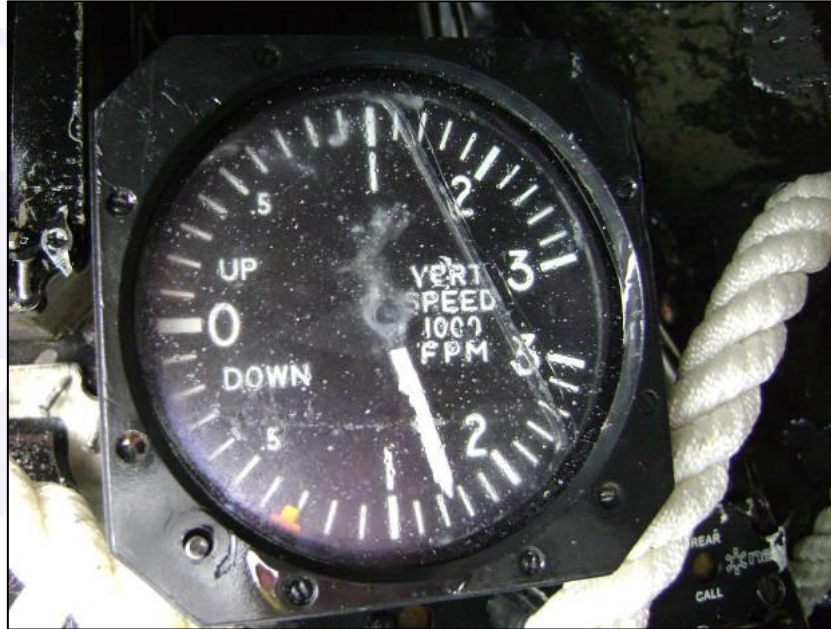
- The “knob” of the “instrument panel” lights was practically in the position “OFF” (light intensity very low);
- The Vertical Velocity Indicator (VVI) of the PD was found with the bug (vertical velocity selector) adjusted for 700 ft/min in the direction of descent, and was in a fixed and frozen position, while the knob, which makes the selection of the vertical velocity, was not found in its original position, probably on account of fracture at the moment of impact;

As for the "VVI" (PN 31230-1127 e SN 361212) installed in the aircraft, it is possible to notice that to movement of the bug (orange color) is associated with the movement of the knob (missing in Figure 4, since it was broken). When the knob is rotated to the right, the bug moves counterclockwise, assuming a rate of descent condition (down), and the opposite is true.

Figure 4 - The VVI as found amid the wreckage.

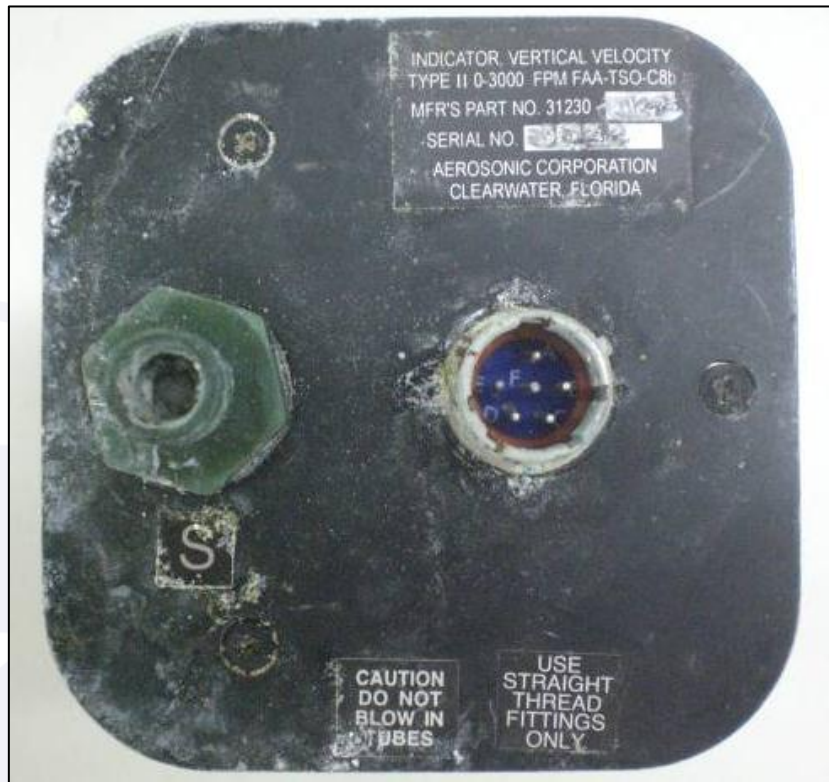
The accident aircraft was equipped with an instrument called VVI (PN 31230-1127), with a tag near the electric connections mentioning the TSO-C8B which had been effectuated on April 1, 1959.

Figure 5 - Rear view of the instrument with tag.

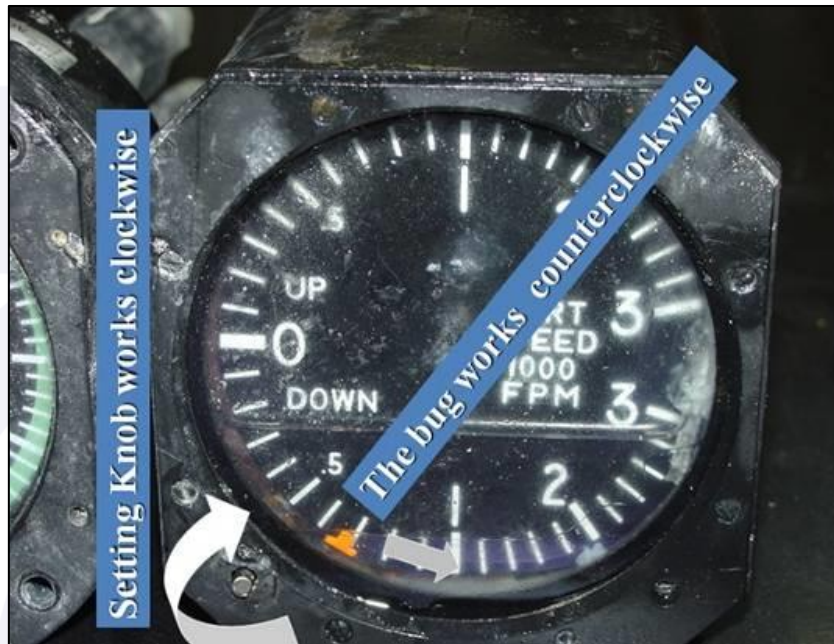
In the VVI, the movement of the bug is associated with the movement of the knob, i.e., when the knob is turned to the right, the bug moves counterclockwise, assuming a rate of descent condition (and the opposite is true).

Figure 6 - The VVI with the bug selected for 700ft/min (down) and fractured knob, showing its direction of rotation and correspondence.

It is possible to see that the knob that moves the bug (in orange color), which is inside the instrument, was severed on the occasion of the impact of the aircraft with the water.

The VVI rate of climb/descent bug was found showing a selection of 700ft/min in the direction of descent, besides being in a locked position. The knob that is used for selecting the vertical velocity was not found in its original position, probably on account of having separated at the moment of impact.
