FINAL REPORT
A - 020/CENIPA/2014

OCCURRENCE:	ACCIDENT
AIRCRAFT:	PP-DFW
MODEL:	C-140
DATE:	29 January 2014

This is the Final Report of the 29 January 2014 aeronautical accident with the C-140 aircraft, registration PP-DFW. The accident was classified as “System/component failure”.

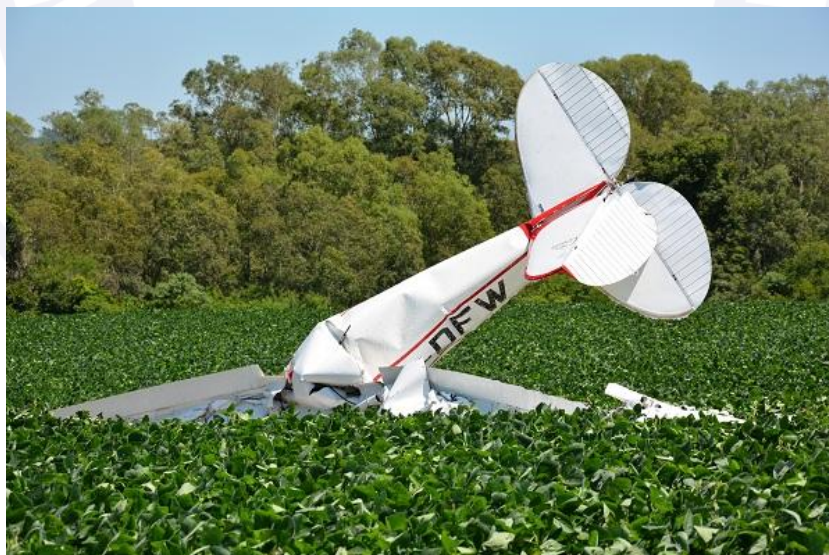
The wreckage had a concentrated pattern. There had been only one frontal impact, at a pitch-down angle of about 90° with the ground. The impact occurred in a soybean plantation area.

The aircraft was equipped with a fixed landing gear. The vertical speed indicator (Climb) showed a rate of descent of 4,500 feet per minute; the speedometer indicated 134 mph, already in the yellow segment (operation with caution); and the oil temperature gauge marked 180°F, in the range of normal operation (green segment).

The damage to the aircraft elevator was not compatible with impact with the ground, since it precluded a pitch-down movement of the aircraft, since the elevator had gotten stuck in the junction with the horizontal stabilizer.

Figure 1 – Position of the aircraft after the impact.

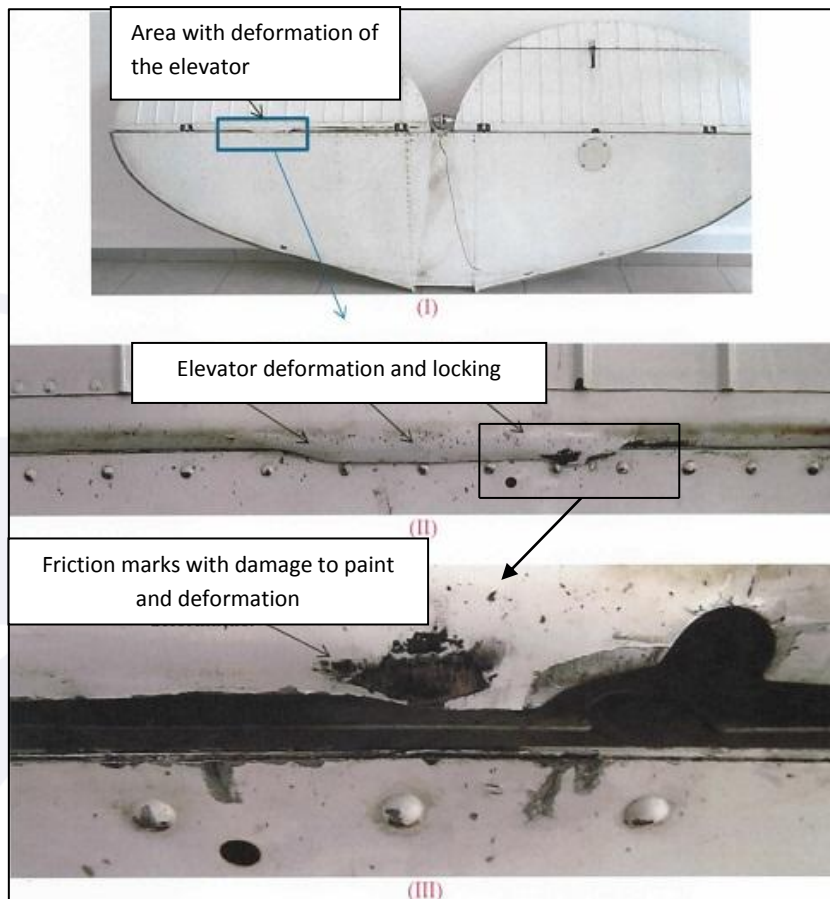
The report issued by the DCTA showed that there was plastic deformation of the elevator structure (Figure 2), making it lock when in contact with the horizontal stabilizer. Moreover, the report made it clear that there were friction marks in the deformed structure, with damage to the paint.

Figure 2 – Aspect of the plastic deformation of the elevator structure.

According to the DCTA report, there was plastic deformation of the elevator structure, causing the elevator to get locked when contacting the horizontal stabilizer. In addition, the rupture of the elevator trim cable was found to be on account of overload. Such deformation is compatible with the type of damage expected as a result of incompliance with recommendations and prescriptions contained in the aircraft manual relative to overspeed and sustainment of high G forces.

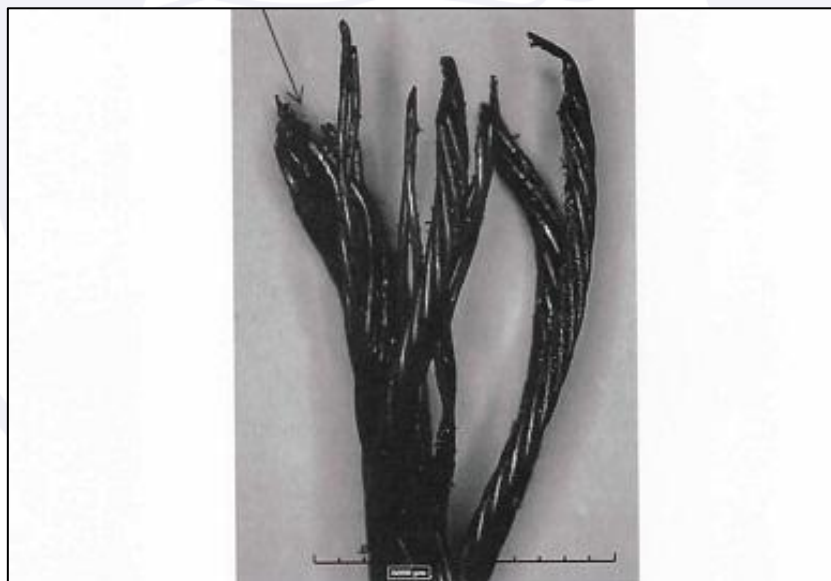
The report also detailed that there had been a rupture of the elevator trim cable due to overload (Figure 3). Another rupture (shearing) of the cable was made by the SERIPA V in order to remove it from the aircraft.

Figure 3 – Aspect of the elevator trim cable rupture due to overload.

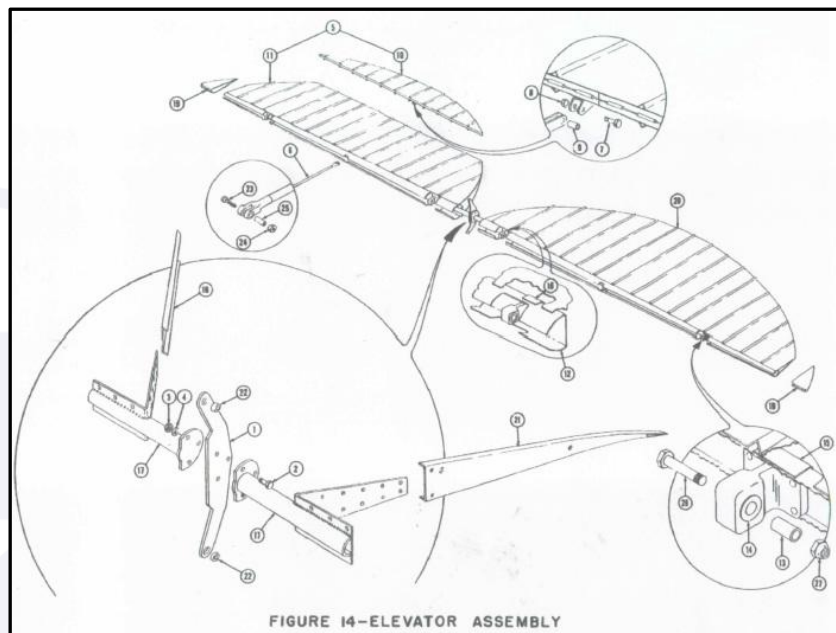
The elevator leading edge consisted of two curved upper and lower metal sheets. Should the structure be subjected to a high G load, it would have its normal curvature reduced, getting closer and closer to the horizontal stabilizer. In such situation, a higher load or an input with a large amplitude on the elevator could cause a displacement of the

metal sheets going beyond the limits of the horizontal stabilizer, resulting in a jammed elevator due to contact with the horizontal stabilizer.

Figure 4 – Drawing of the aircraft elevator assembly.

The design of the aircraft elevator allows its leading edge to be deformed when the aircraft is operated above the prescribed limits. Such deformation may cause the elevator leading edge to rub the horizontal stabilizer, and in a more critical situation, may cause it to get stuck to the horizontal stabilizer.
