COMANDO DA AERONÁUTICA
CENTRO DE INVESTIGAÇÃO E PREVENÇÃO DE
ACIDENTES AERONÁUTICOS

FINAL REPORT
A - 025/CENIPA/2013

OCCURRENCE:	ACCIDENT
AIRCRAFT:	PP-AJV
MODEL:	C90A
DATE:	03 FEB 2013

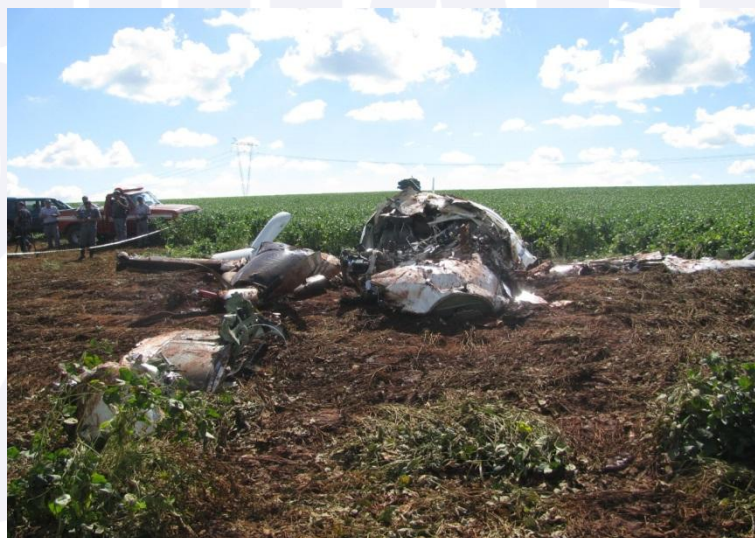
The aircraft wreckage was found in a soybean plantation in the municipality of Cândido Mota, State of São Paulo. There was no indication of impacts prior to the crash. There were electric lines in the area in back of the aircraft without any signs of damage.

Figure 4 – Crash site.

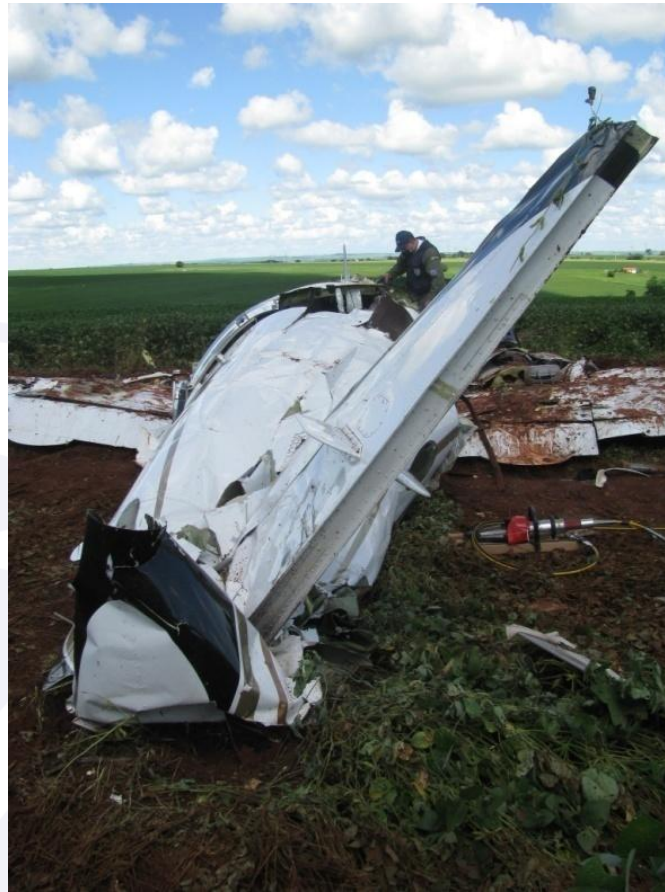
Figure 5 – Aspect of the torsion of the fuselage to the right.

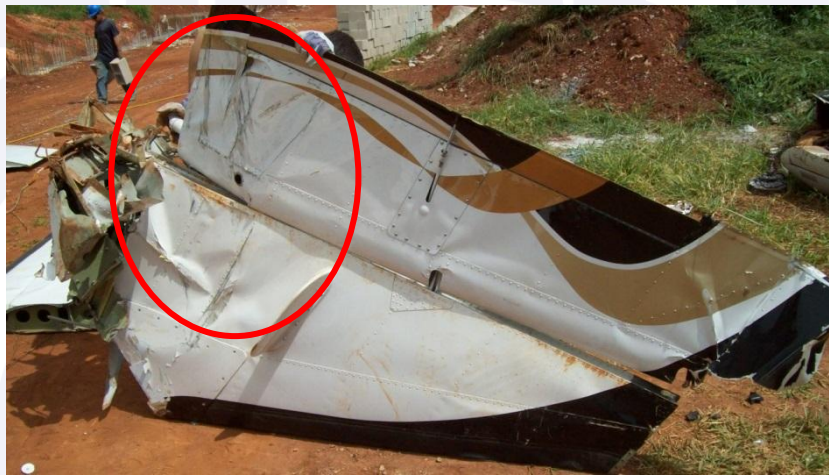
portion of the horizontal stabilizer and directional rudder, small fractures in the coating and significant marks from a material of dark pigmentation.

The inboard ends of the aircraft horizontal stabilizer were covered by surfaces of black rubber seal. The marks found on the base of the vertical stabilizer led to the belief that they were a result of the impact sustained by the sections of the horizontal stabilizer at the moment of detachment.

Figure 6 – Right side of the assembly formed by the horizontal stabilizer and directional rudder.

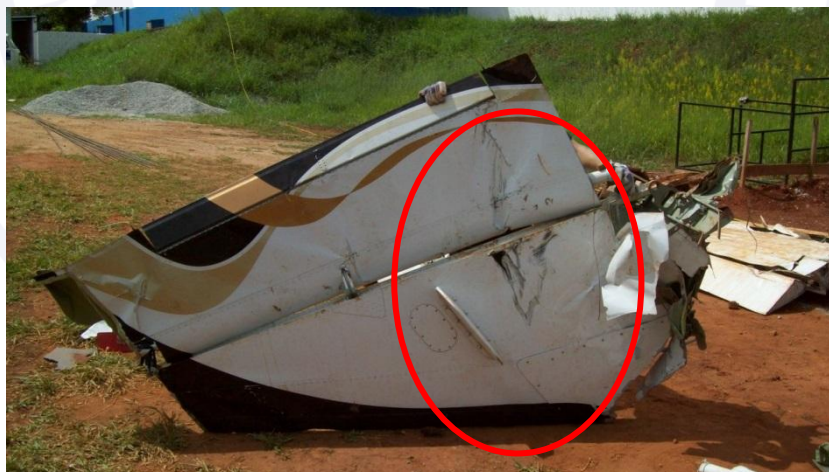
Figure 7 - Left side of the assembly formed by the vertical stabilizer and directional rudder.

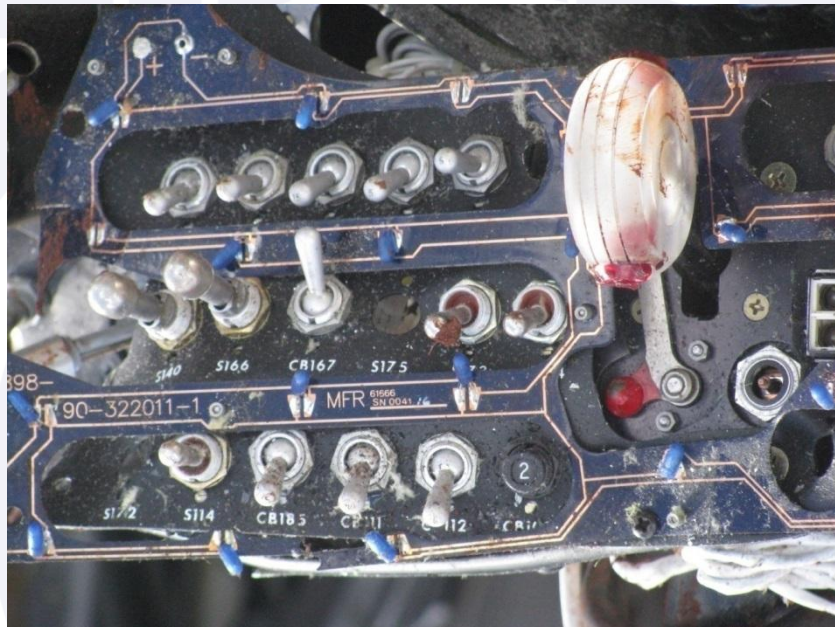
Figure 9 - Pilot's lower right panel, as found amid the wreckage.

The pilot's lower right panel concentrated practically all the Ice Protection System controls. It was found rather damaged, with a few switches dirty with earth, switch-identification plastic covers broken, as well as other deformations resulting from impact.

It was found that, except for the heating switch propellers, all others were found off, including two heating switches of windshields. However, except for windshield switches that had locks, the positions of the other switches can't be assumed as pre-impact positions.

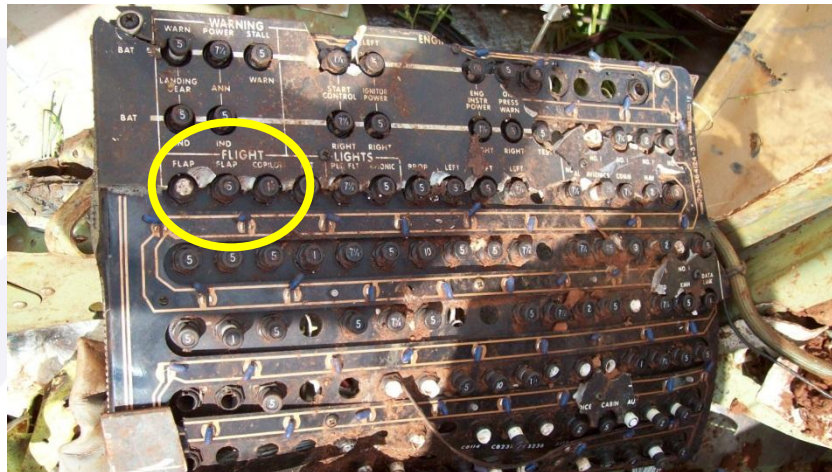
It was found that, due to a characteristic of the aircraft electric design, the hour-meter would become inoperative, while the starter stayed protruded. The hour-meter is a device for recording the engine hours of operation, so that future inspections can be scheduled. At a certain moment, the female passenger in the cockpit showed her concern with the action, questioning why the captain did not make timely provisions regarding the aircraft overhaul, since the safety of all on board would result compromised.

Figure 10 – Starter panel of the copilot. In the highlight, one of the flap starters is seen broken.
