FINAL REPORT
A-028/CENIPA/2014

OCCURRENCE:	ACCIDENT
AIRCRAFT:	PT-OMX
MODEL:	210N
DATE:	09FEB2014

This is the final report of the 09 February 2014 accident with the 210N aircraft, registration PT-OMX. The accident was classified as “loss of control in flight”.

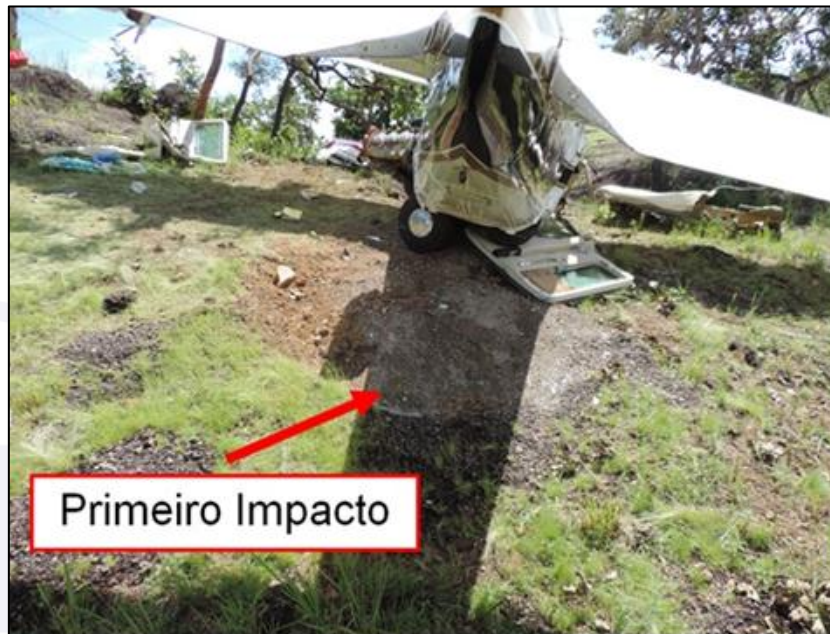
The aircraft resting position was about two meters beyond the point of first impact (Figure 1).

Figure 1 – Point of first impact with the ground.

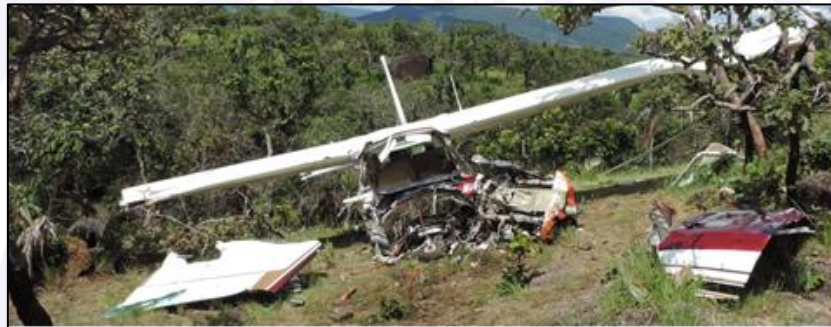
Figure 2 – Front view of the aircraft after impact with the ground.

The analysis of the wreckage showed significant damage to the nose of the aircraft, which was not consistent with an attempted forced landing, but, on the contrary, resulting from a non-controlled flight trajectory.

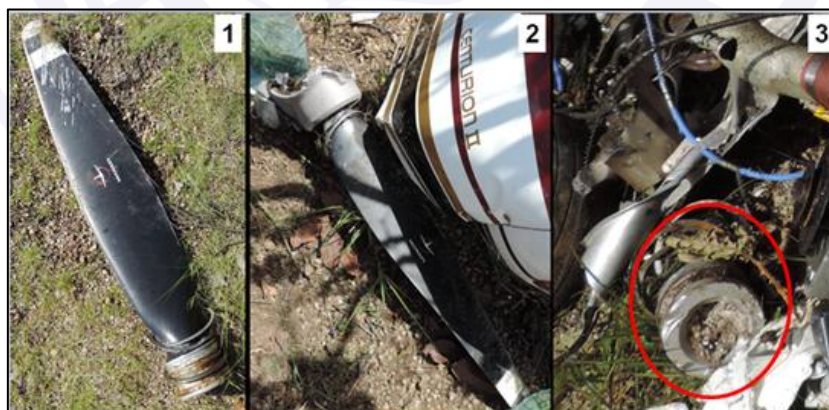
In the field investigation, the investigators verified that the coupling shaft between the propeller assembly and the engine had fractured on account of flexion. The three blades (Figure 3), one of them found under the engine, had kneading consistent with impact with little or even no power at the moment of collision with the ground.

Figure 3 – Aspect of the propeller blades.

The damage sustained by the propeller blades (see item 1.12 of this report) indicated that at the moment of impact the engine was delivering little or no power at all.
