**COMMAND OF AERONAUTICS**  
**AERONAUTICAL ACCIDENT INVESTIGATION AND**  
**PREVENTION CENTER**

**FINAL REPORT**  
**A - 046/CENIPA/2013**

<b>OCCURRENCE:</b>	<b>ACCIDENT</b>
<b>AIRCRAFT:</b>	<b>PR-RCH</b>
<b><u>MODEL:</u></b>	<b>AS-350-B2</b>
<b><u>DATE:</u></b>	<b>09 OCT 2011</b>

This is the Final Report of the 9 October 2011 accident with the AS350B2 aircraft, registration PR-RCH. The accident was classified as “inflight collision with obstacle”.

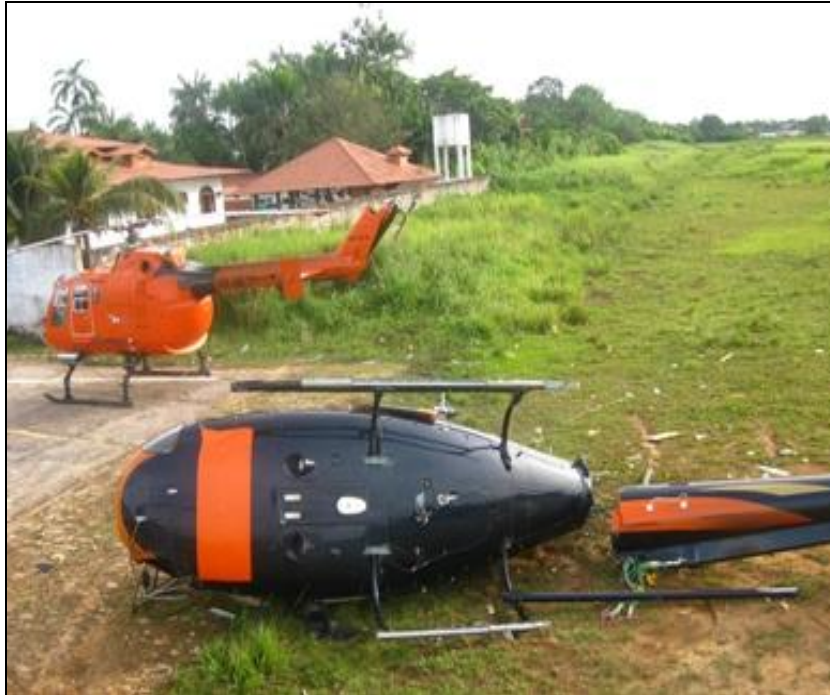
Figure 1 - Approaching view of PR-RCH (behind, there is the other aircraft hit in the tail rotor).

While the aircraft was taxiing at a height of approximately 2 meters above the ground, its main rotor collided with the tail rotor of another helicopter (PR-MET) at the three-o'clock position. The taxiing aircraft tumbled to the right after the collision.

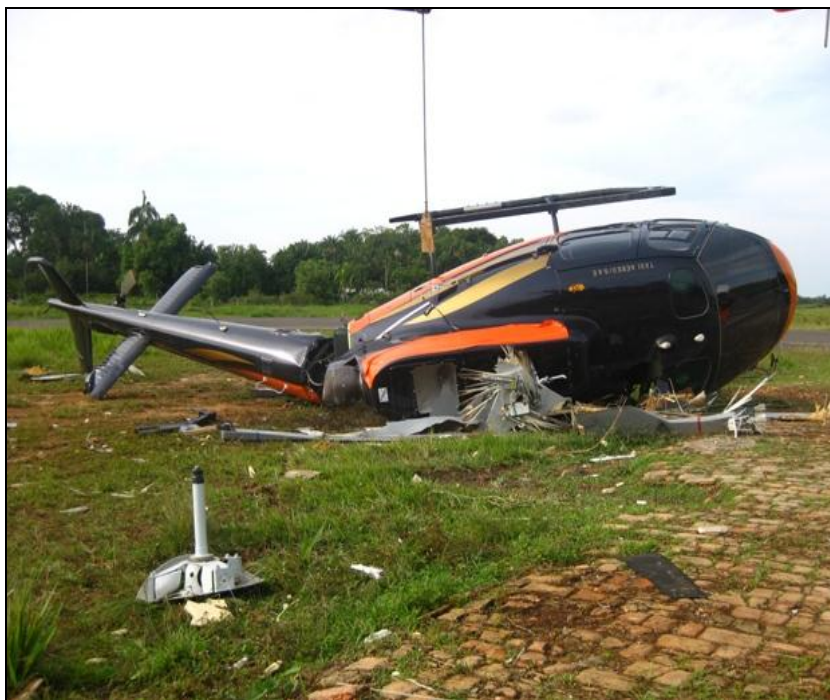
The aircraft sustained substantial damage to the structure, engine, and rotors.

Figure 2 - Damage to aircraft.

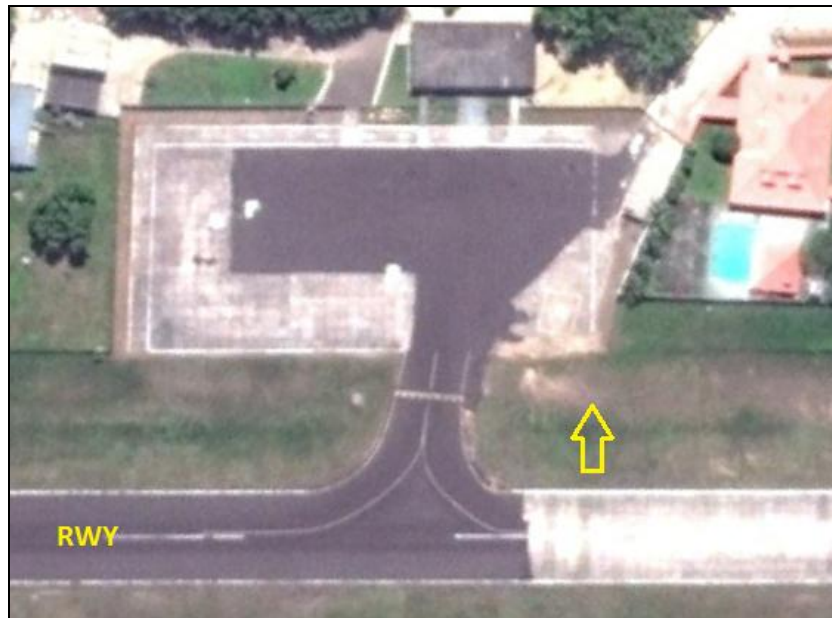
The apron was paved with concrete, measuring 100m x 50m, and did not have horizontal signage to mark the parking positions.

Figure 3 - Apron in relation to the runway (the arrow indicates the aircraft stop position)

The apron, although paved with concrete, measured only 100m x 50m, and did not have signage to mark the parking stands of fixed-wing aircraft and helicopters. The arrangement of the aircraft on the apron was under the responsibility and coordination of the ground support teams of the operating companies.

– On 25 October 2011, the SERIPA 7 forwarded the Official Document 016/SI/204 to the Municipal Government of Carauari, recommending the adoption of measures in relation to the horizontal signage of the apron parking area, in view of the infrastructure deficiencies observed during the post-accident field investigation.
