COMANDO DA AERONÁUTICA
CENTRO DE INVESTIGAÇÃO E PREVENÇÃO DE
ACIDENTES AERONÁUTICOS

FINAL REPORT
A - 061/CENIPA/2013

OCCURRENCE:	ACCIDENT
AIRCRAFT:	PP-CGO
MODEL:	AW119 MKII
DATE:	8 MAY 2012

This is the Final Report of the 8 May 2012 accident involving the AW119 MKII aircraft, registration PP-CGO. The accident was classified as inflight engine failure.

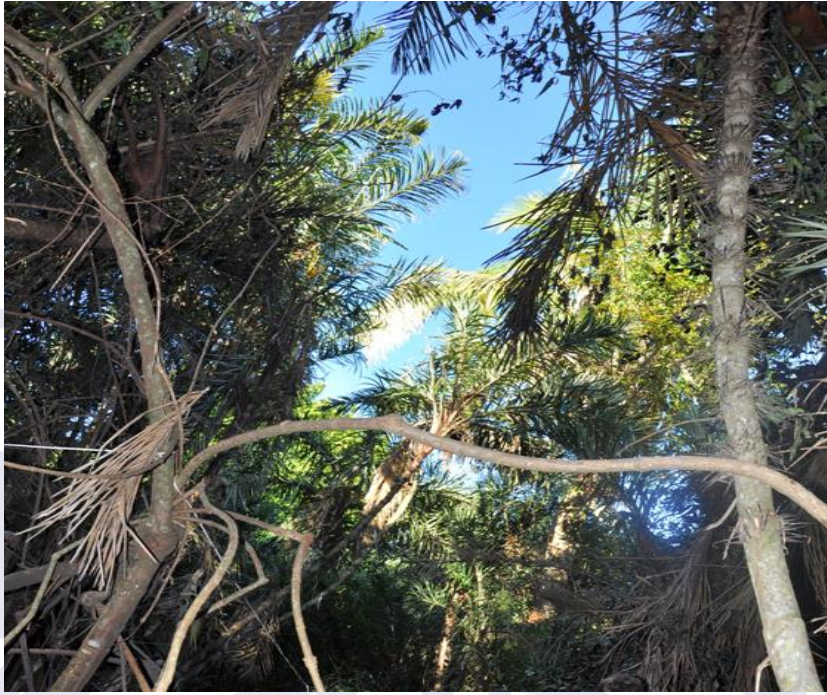
Figure 3 - Clearing formed by the falling aircraft in a native forest area near the *Fazenda Rancho Alegre* farmhouse.

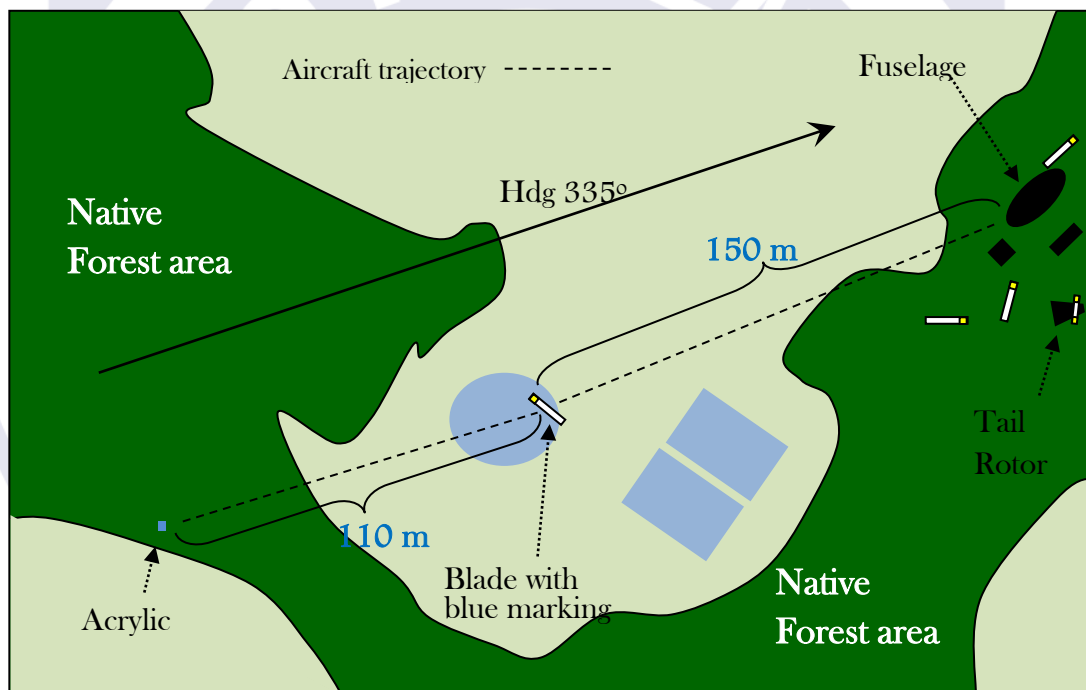
Figure 4. PP-CGO wreckage distribution pattern.

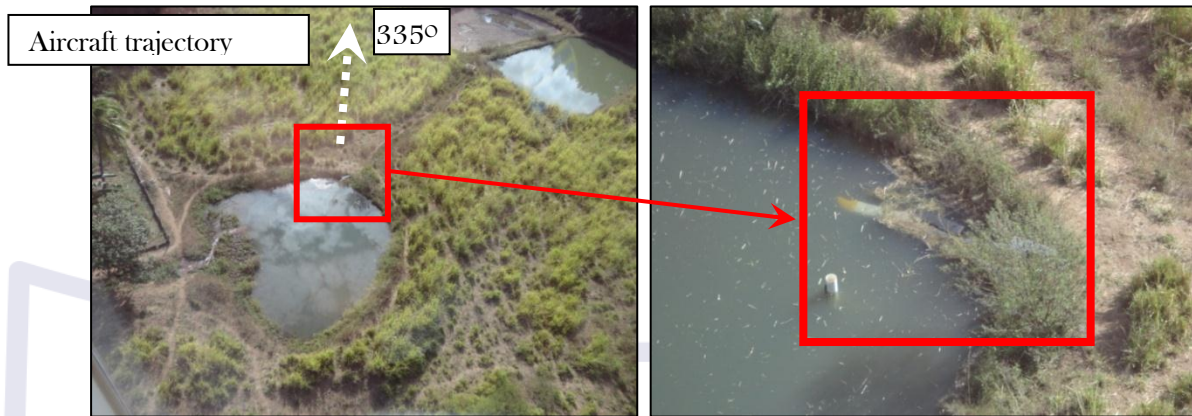
During the Initial Action, the investigation team found out that the aircraft part that was seen detaching in flight was one of the main rotor blades (the one with a blue marking), which came to rest at a distance of 150 meters from the crash-spot (Figures 5 and 6).

Figures 5 and 6 – spot where the blue-marking blade was found, at a distance of approximately 150 meters from the main point of impact.

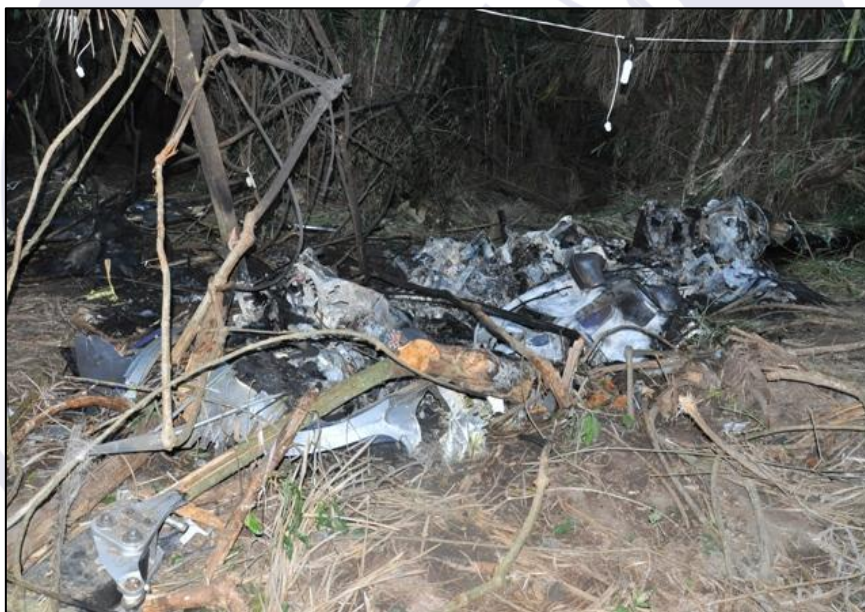
The collision of the PP-CGO with the terrain made a big hole, which contained most of the fuselage, as well as seven of the eight bodies (Figure 7). The eighth body was found a few meters away from the wreckage concentration.

Figure 7 – Aircraft fuselage after the crash.

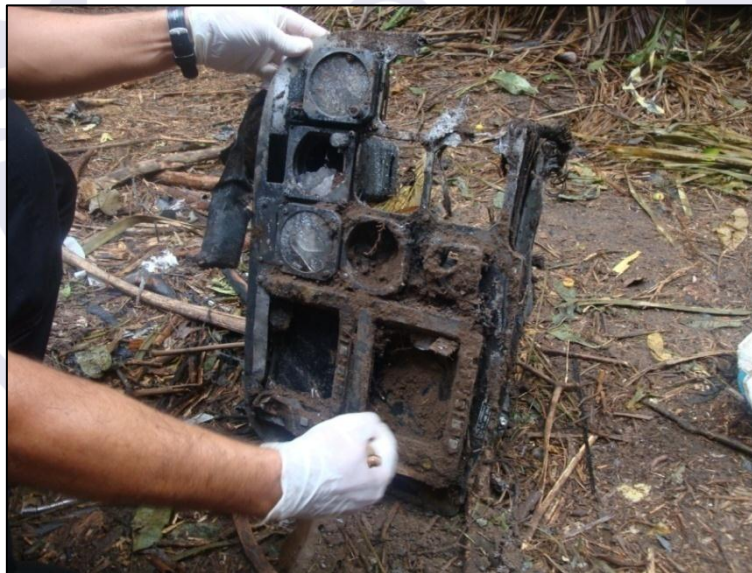
In the instrument panel (Figure 9), which had been buried into the ground (at a depth of more than one meter), it was possible to identify the EDUs 1 and 2 (primary and secondary), the ASI, the dual tachometer, the clock and the altimeter.

Figure 9 – Panel of the PP-CGO.

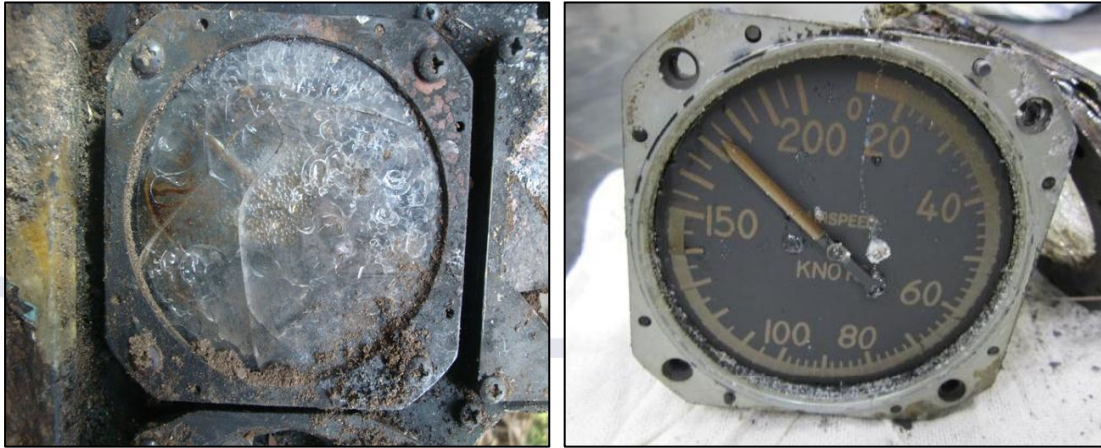
Figures 10 and 11 – ASI of the PP-CGO indicating 174kt. The figure on the right shows the same instrument, after removal of the glass broken in the impact.

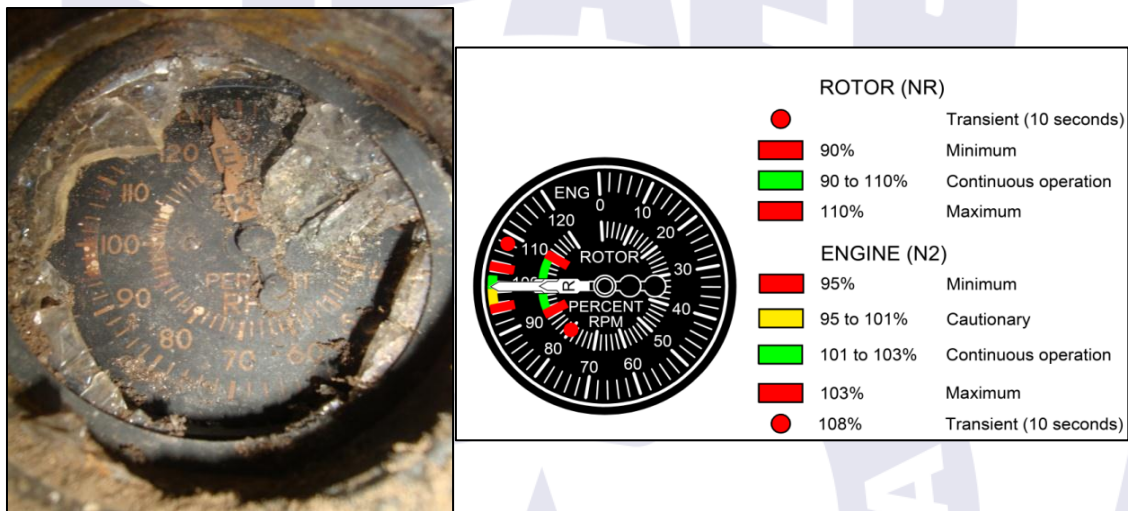
The clock and the altimeter had de-configured on account of the impact of the aircraft with the ground, and so their indications were not dependable. The speed indicator pointer was stuck at the speed of 174kt (figures 10 and 11), while the tachometer indicated NR and N2 equal to zero (Figures 12 and 13).

Figures 12 and 13 – On the left, the pointers E (indicator of N2) and R (indicator of NR) appear at an intermediate position between 120 and 0 (indication not to scale). On the right, one can see the marks of the instrument, according to the aircraft manual.

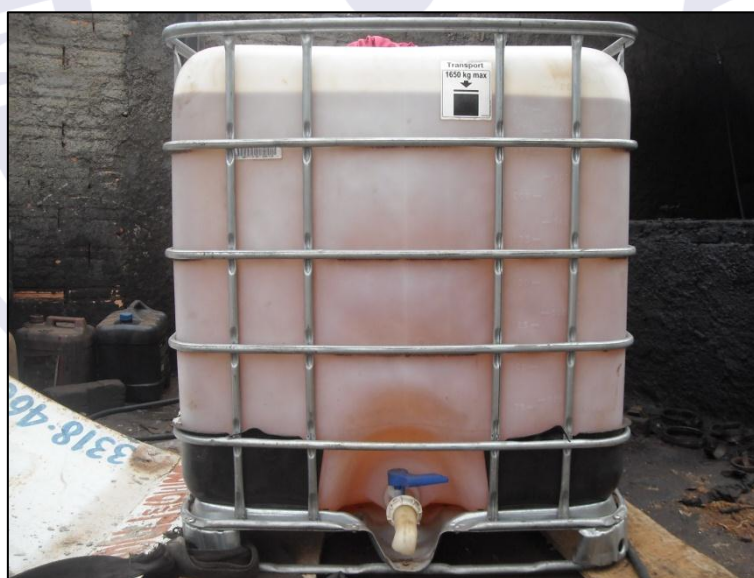
On these occasions, some requirements and procedures for quality control in the storage, transportation and refueling were not conducted in accordance with the rules established in the ABNT NBR 15216 and 13310. According to reports obtained in the investigation, the last time this container had been used was approximately three weeks before the accident.

Figure 14 – Fuel container utilized by the Air Unit in off-base missions.

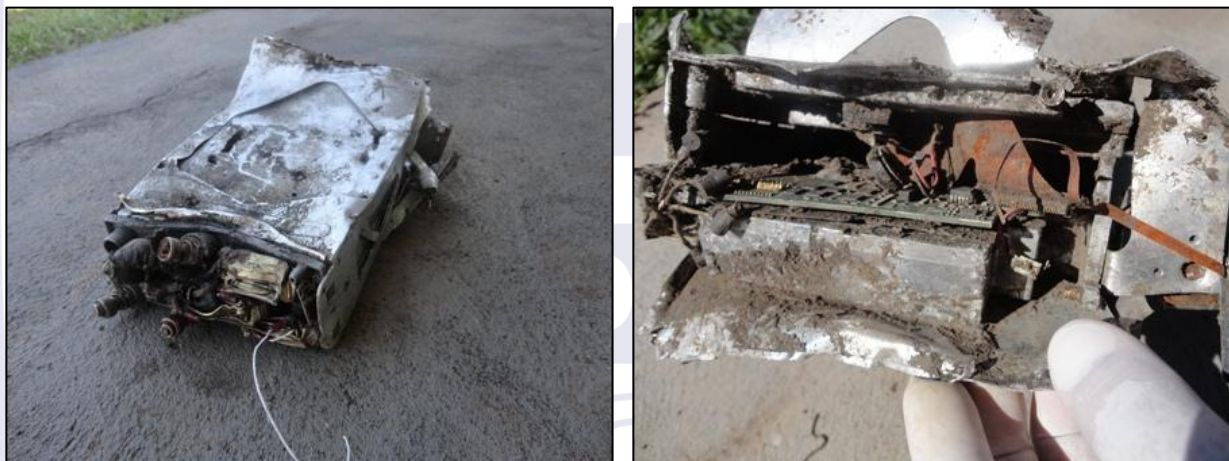
The GPS (model GNS430W), PN 011-01060-00, manufactured by Garmin, and equipping the PP-CGO at the time of the accident (Figures 15 and 16), was analyzed by the Garmin representative in Brazil, GPS Center company, in São Paulo, and by the AERO Avionics company, Sorocaba, SP, specialized in the installation and maintenance of electronic equipment in aircraft. The technical opinions pointed out the impossibility of recovering data from the Non-Volatile Memory (NVM) of the equipment, on account of the damage sustained in the crash.

Figures 15 and 16 – *Garmin* GNS430W GPS equipment retrieved from the PP-CGO wreckage.

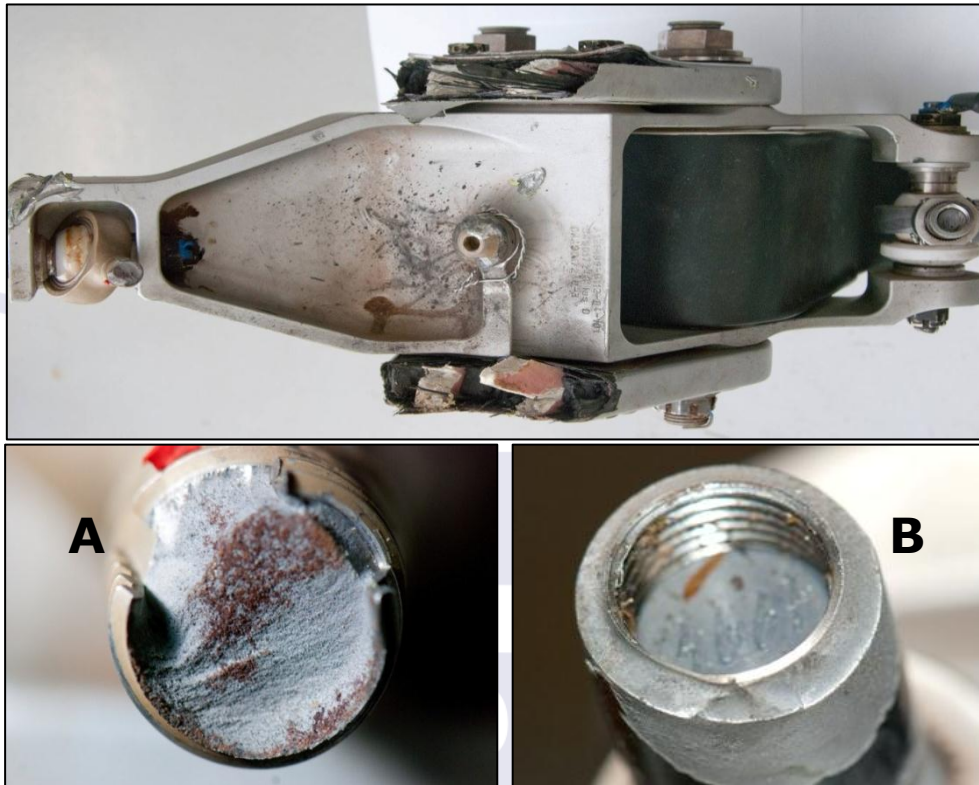
The visual tests with respect to the blue marking blade - which detached during the flight - showed that the lugs have suffered overload-related fractures, as can be seen in Figure 17, and, in detail, in Figures 18 and 19.

Figures 17, 18 and 19 – Main Rotor propeller blade (blue). The fractures in A and B are characteristic of overload.

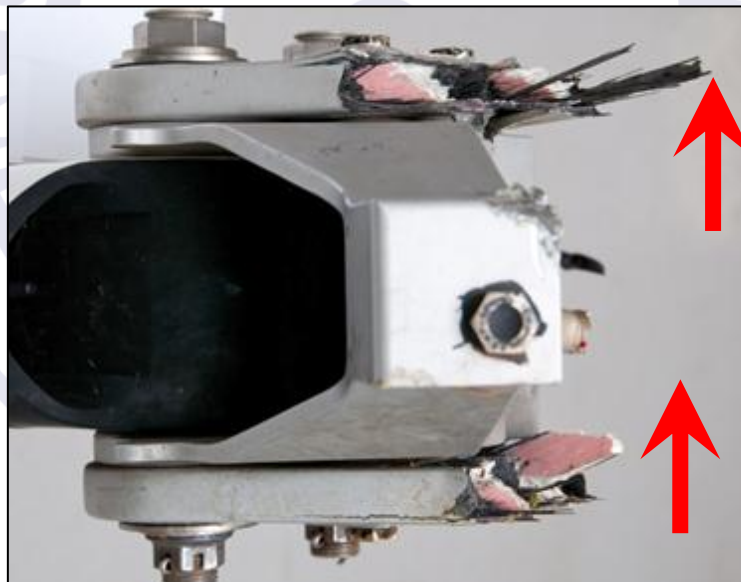
Still with respect to the blue marking blade, it was observed that the inclination of the fracture in the composite material ran from the lower to the upper side, indicating that the propeller blade sustained a vertical movement during the breakage process, as shown by the arrows (Figure 20).

Figure 20 - Lateral view with detail of the fractures. It is possible to see a bottom-up inclination, indicating that the propeller blade moved vertically during the structural disruption process.

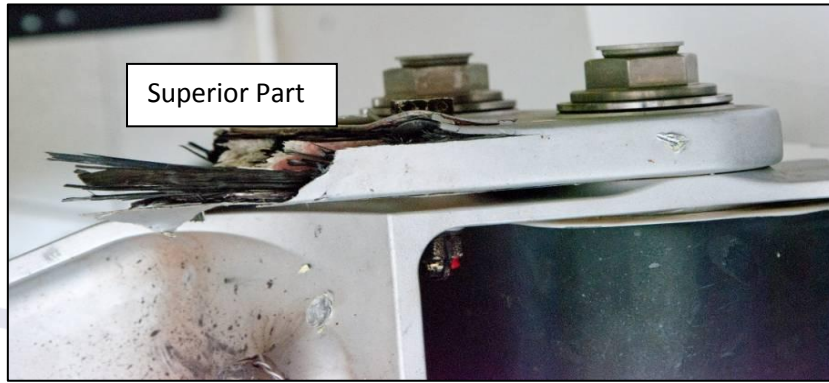
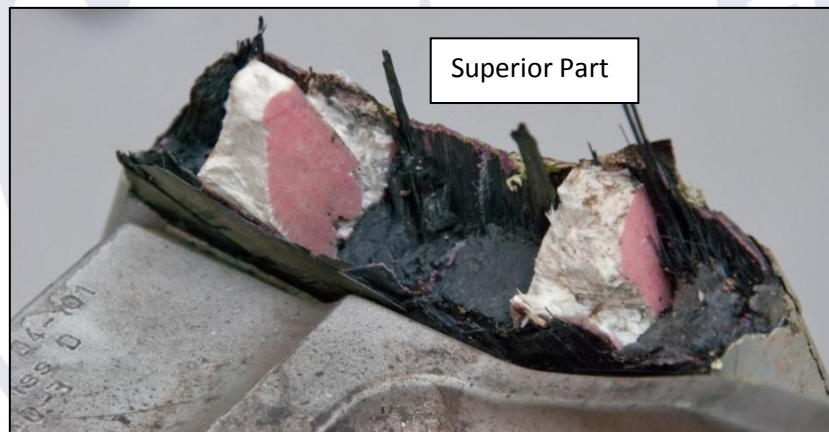
Additionally, it was found that the fracture surfaces showed regions characteristic of traction and compression, as can be seen in Figures 21, 22, 23 and 24.

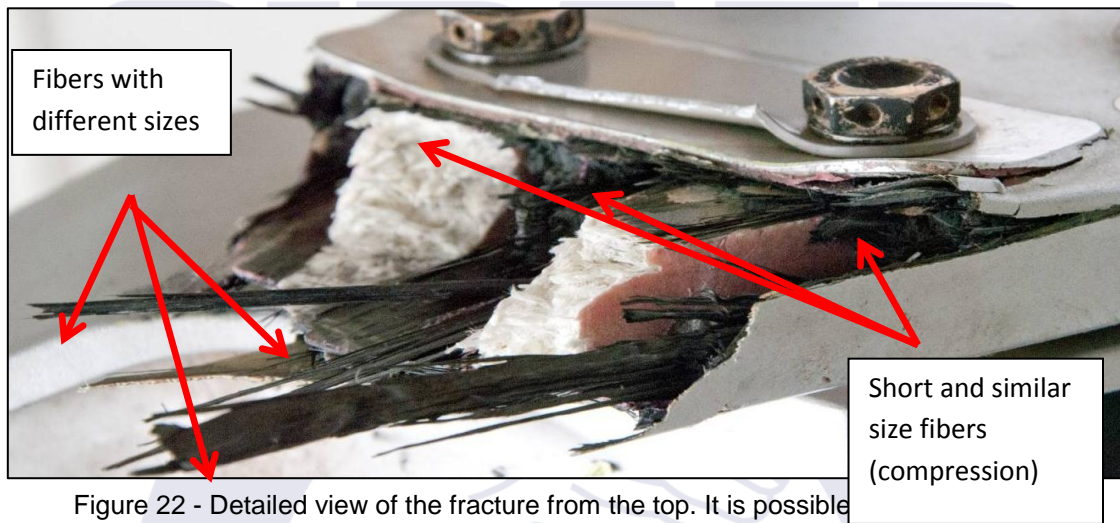
Figure 22 - Detailed view of the fracture from the top. It is possible to see regions of compression and traction on the surface of the fracture.

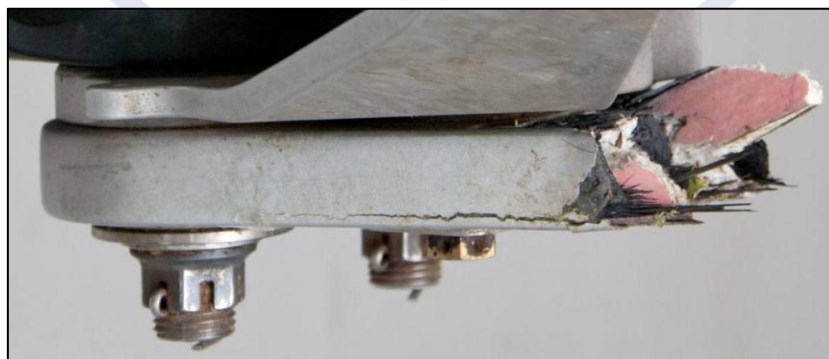
Figure 24 - Detail of the fracture as viewed from the bottom. It is possible to see regions of compression and traction on the surface of the fracture.

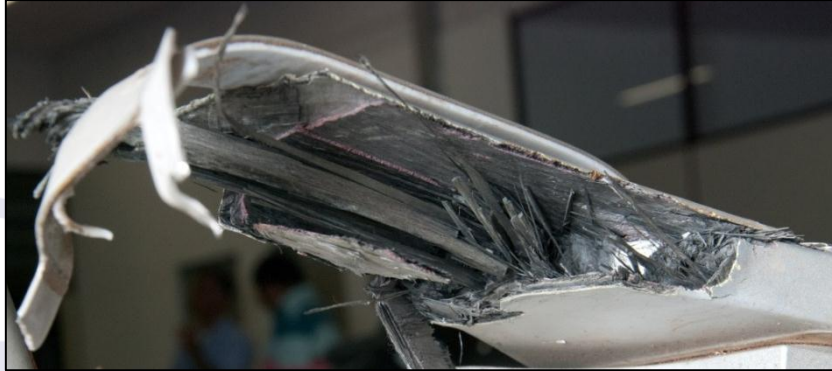
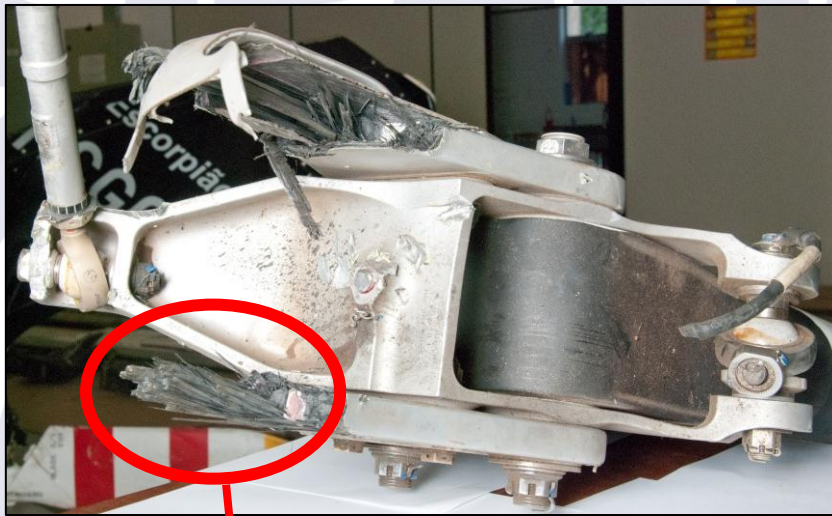
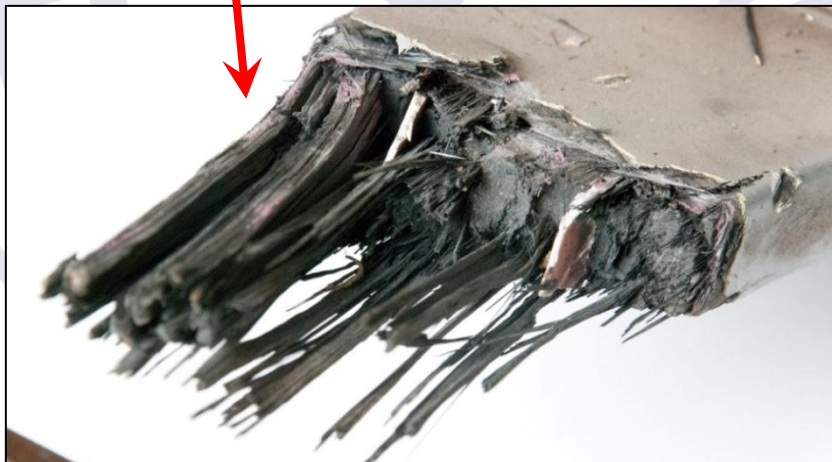
As for the red-marking blade, it showed overload-related fracture characteristics on the horizontal axis (Figures 25, 26 and 27).

Figures 27 - Fracture details of the red-marking propeller blade. It is possible to see that the direction of the blade breakage was along the horizontal axis.

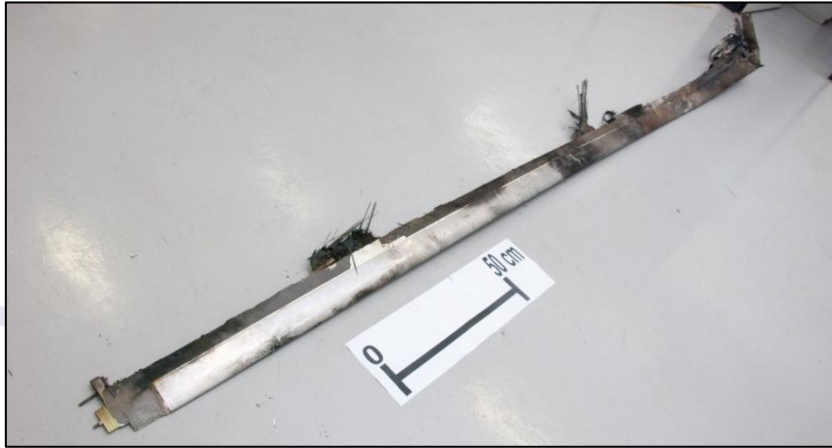
One of the main rotor blades suffered a burning process during the event (Figure 28). The other blade, without the fist region, presented an aspect of rupture due to overload (Figure 29).

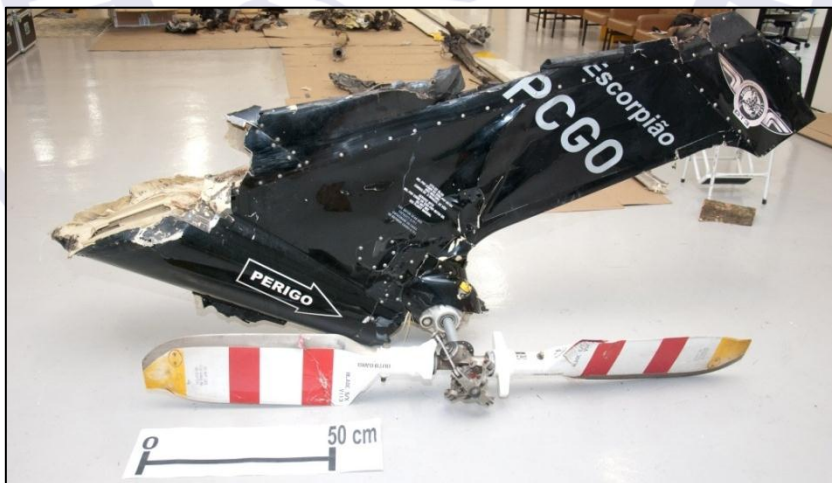
The tail rotor blades revealed overload-related fracture characteristics, due to the impact with the ground, with delamination of the composite material, as can be seen in Figures 30, 31 and 32.

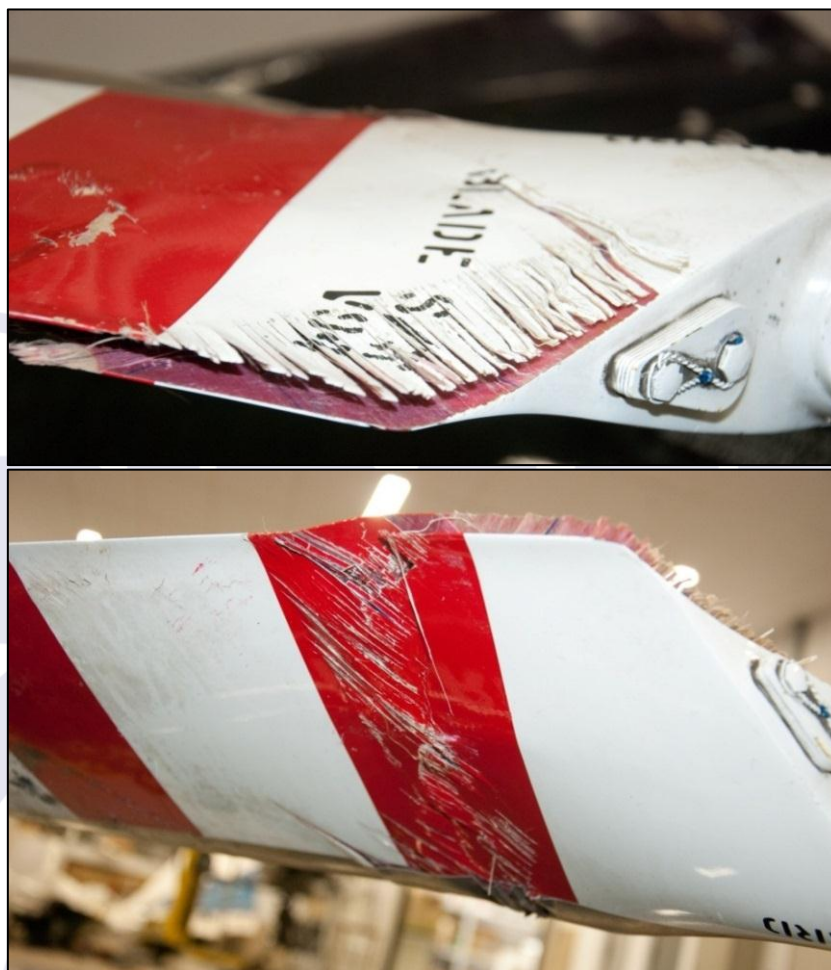
Figures 31 and 32 – Details of the tail rotor blade. The fractures and delamination resulted from the impact with the ground.

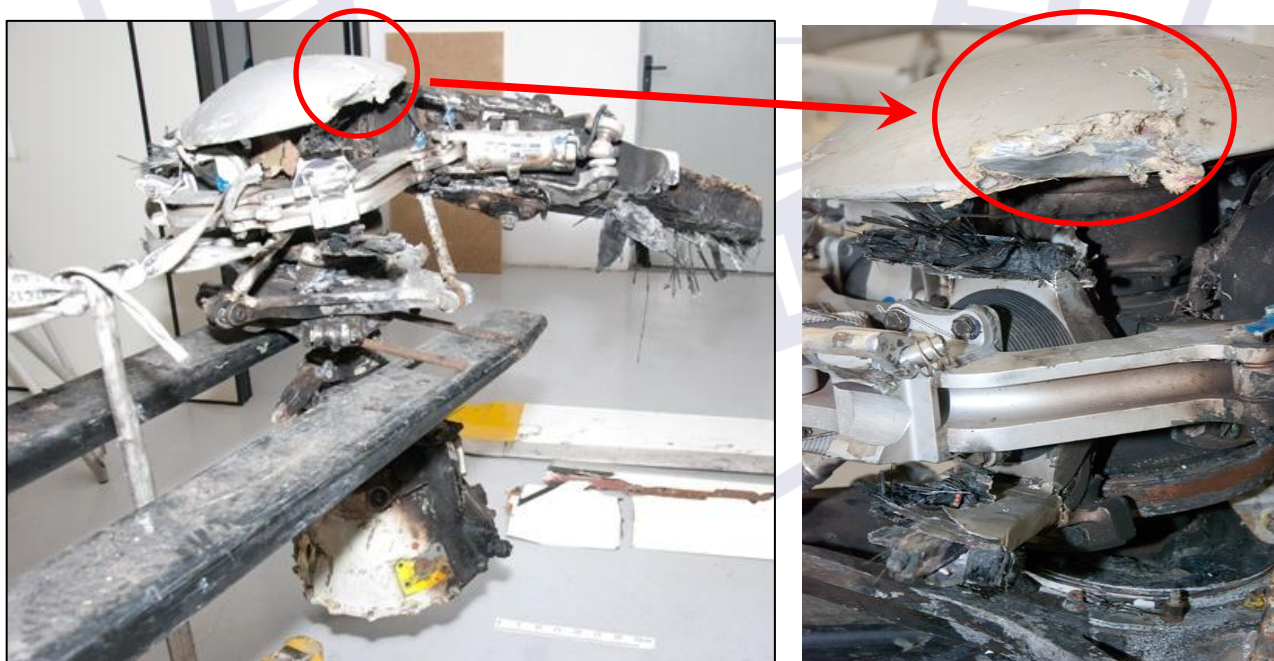
In the main transmission, the "Chinese Hat" showed a notch probably produced by the vertical movement made by the blue-marking main rotor blade.

Figures 33 and 34 – Main transmission on the left. On the right, detail of the "Chinese Hat", with a notch probably made by the blue-marking blade's upward vertical movement.

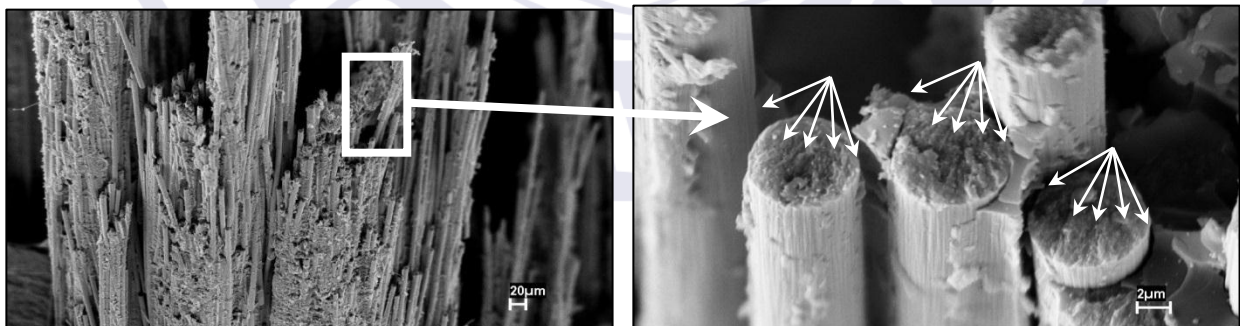
Figure 37 shows fibers with disruption due to traction overload. Figure 38 shows details of the fracture surface of the fibers, with indication of the direction of the rupture.

Figures 37 and 38 – Details of the fractured fibers marked in Figure 36. On the left, it is possible to observe that the fibers had different sizes – characteristic of traction-related fracture. On the right, the arrows indicate the direction of the fracture.

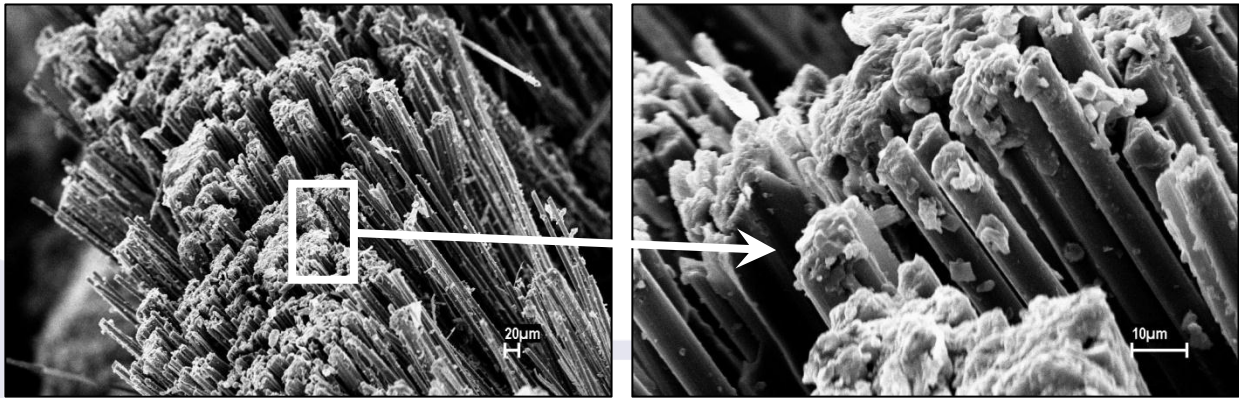
Figure 39 shows fibers with disruption due to compression overload. Figure 40 shows details of the fracture surface.

Figures 39 and 40 – Details of fractured fibers. On the left, one can see that the fibers had similar sizes; they sustained fracture due to compression. On the right, details of compression-related fractured surfaces.

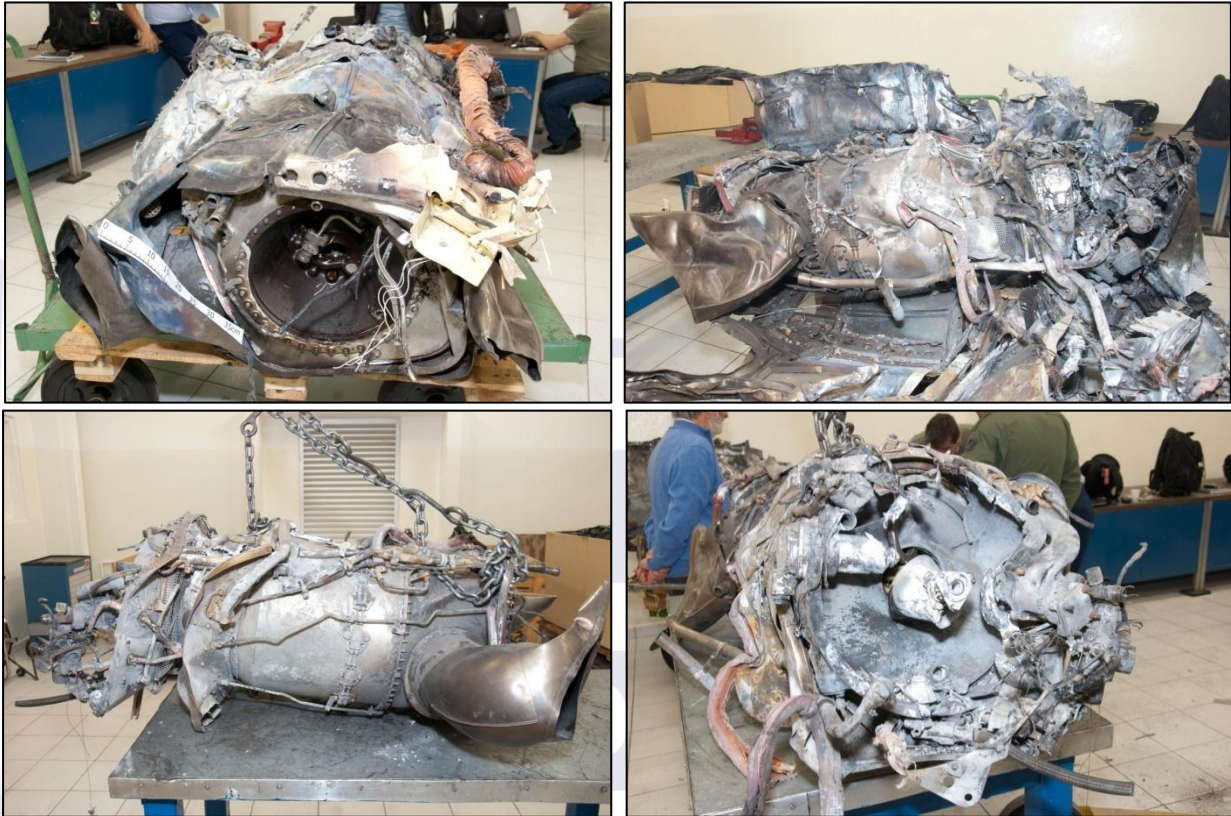
In the beginning of the work, the engine was embroiled in the structure of the nacelle, which exhibited significant damage from impact and severe fire (Figures 41, 42, 43 and 44). The reduction gearbox was fractured at the junction with the power section of the engine (at flange "B") and had no damage caused by heat (Figure 45).

Figures 41, 42, 43 and 44 – Engine of the PP-CGO in the laboratory of the Engine Division of the Aeronautics and Aerospace Institute (IAE). Front, left side, right side and rear views.

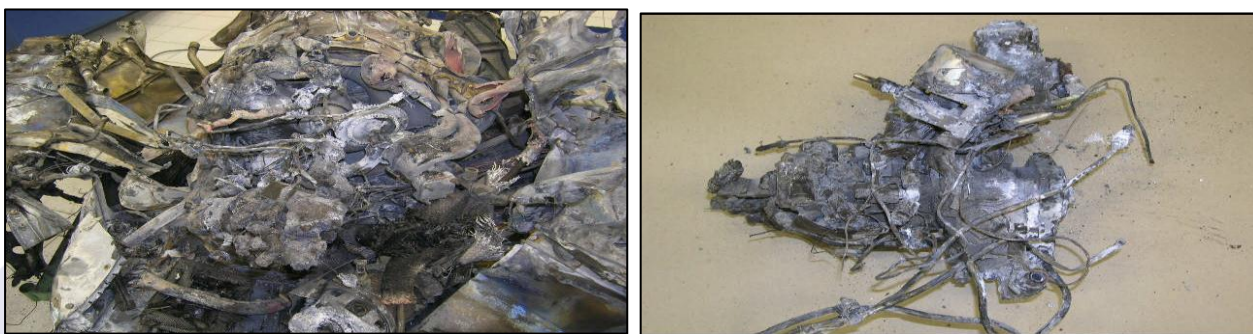
After removal of the nacelle surrounding the engine, it was found that all external components had been damaged due to impact and fire. The accessories box had been extensively consumed by intense heat, exposing its inner features (Figure 46). The high pressure pump fuel, the fuel control unit (FCU), the fuel heating and the electronic governor were in their correct positions, showing serious damage from fire and impact, which precluded any functional verification (Figure 47).

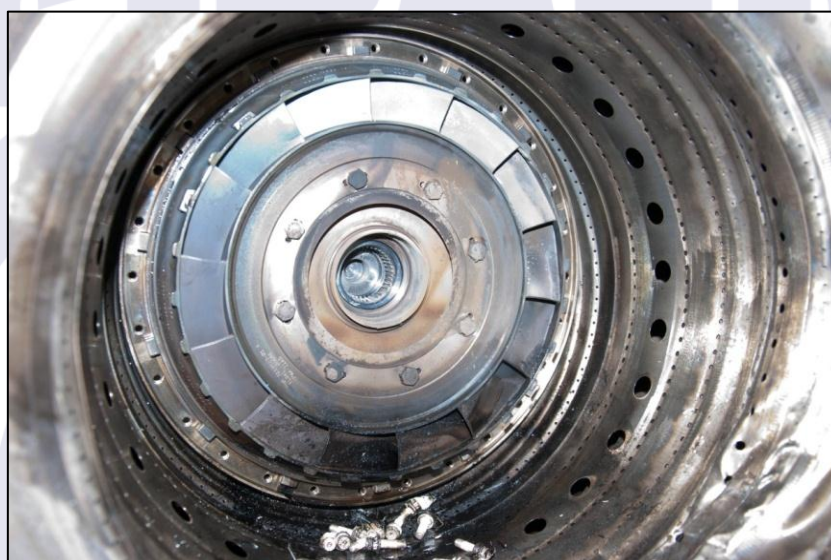
The stator of the compressor turbine (Figure 48) showed no evidence of wear or damage that could impair the operation of the engine.

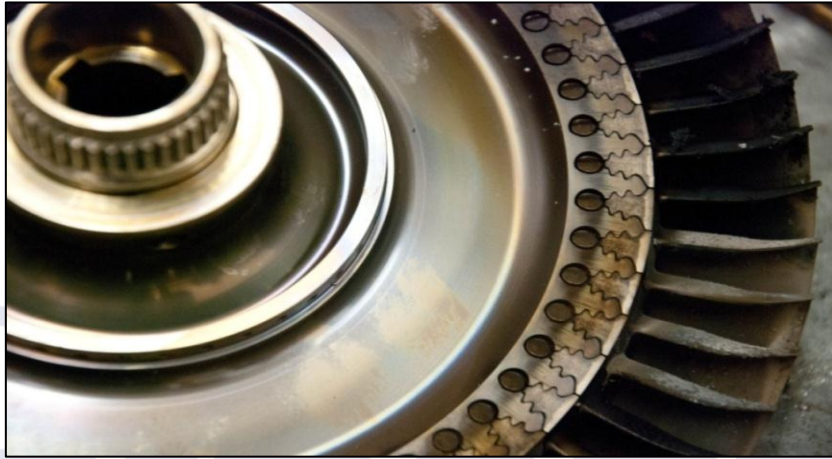
Figure 50 – Marks of mild rubbing at the root of the blades.

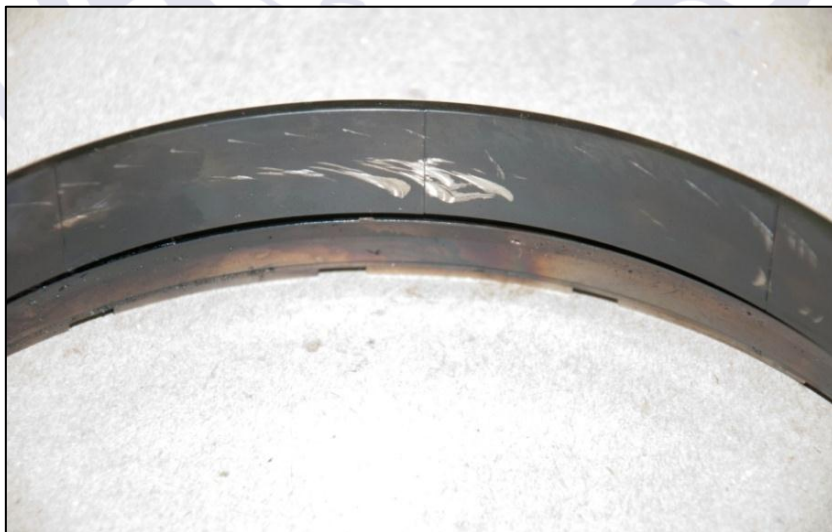
Figure 51 – Marks of impact left by the compressor turbine rotor blades.

On account of the results obtained, the Report no. RI APA 03/2013 (item 3 - Discussion of the Results), concluded that the impact marks left by the blades of the compressor turbine rotor on the segmented ring were produced when the rotor had already stopped, indicating that, at the time of the collision with the ground, the aircraft engine was inoperative after an inflight flame-out. The report also reads that, during the work of disassembling, no mechanical problems, damage to bearings, lack of lubrication, fractures or other discrepancies capable of causing malfunction or a complete stop of the engine were identified.

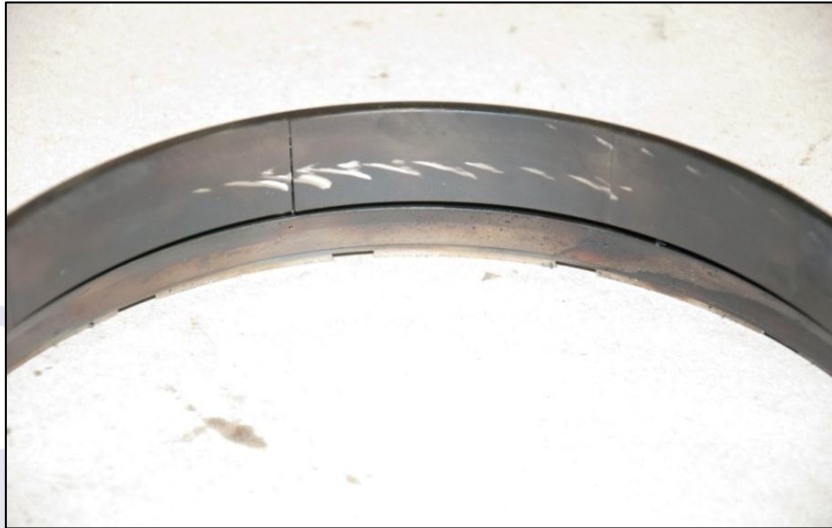
Figure 52 – Marks of impact left by the compressor turbine rotor blades.

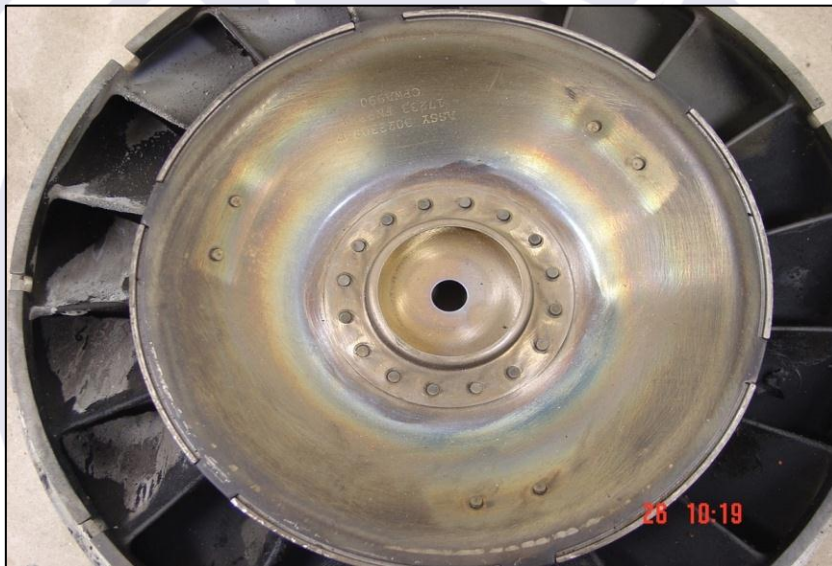
The diaphragm showed signs of mild rubbing. The power turbine stator of the engine was in good condition, showing no damage from high rotation or impact. The rear side of the diaphragm (Figures 53 and 54) also had signs of mild rubbing left by the roots of the power turbine rotor blades.

Figure 53 – Diaphragm with marks of light rubbing left by the roots of the compressor turbine rotor blades.

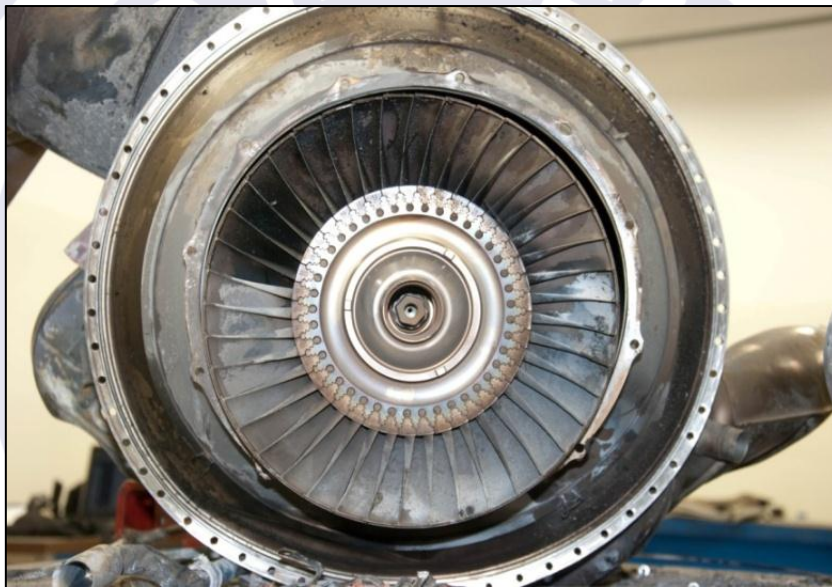
The power turbine rotor blades showed no damage or evidence of having suffered sudden stop due to impact (Figure 55).

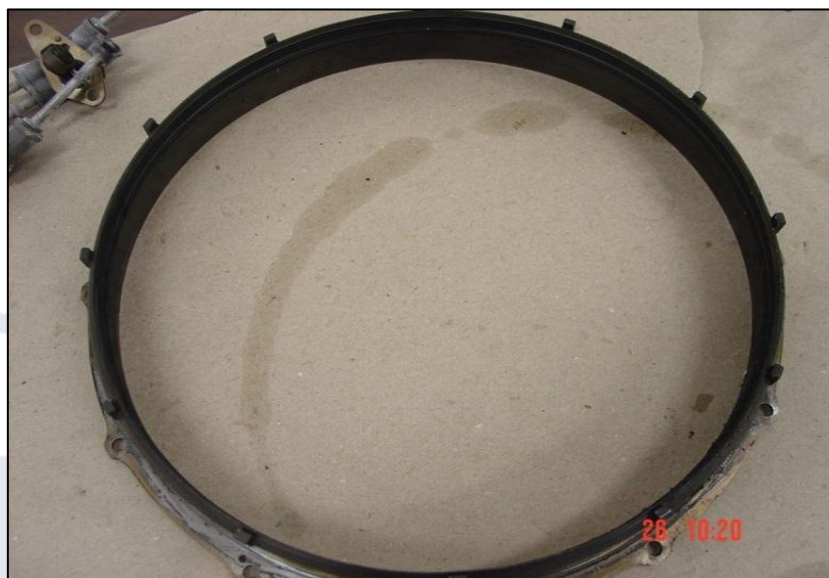
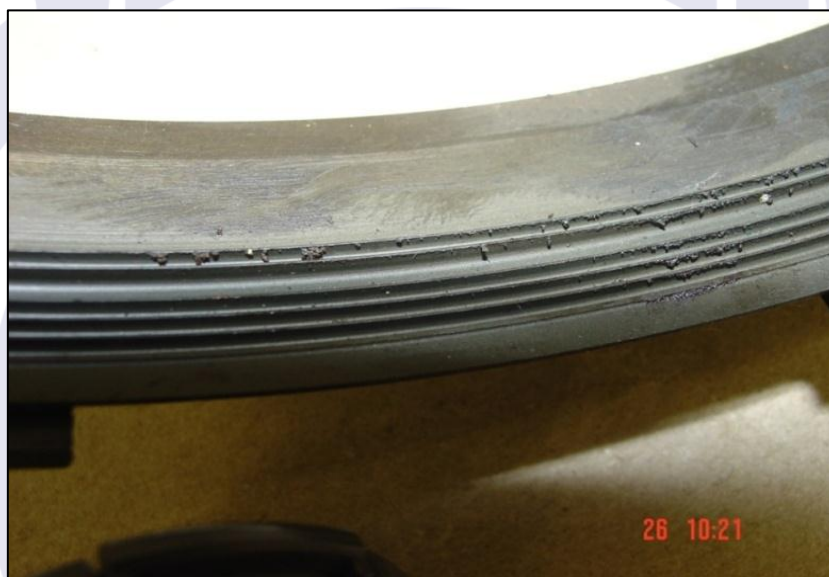
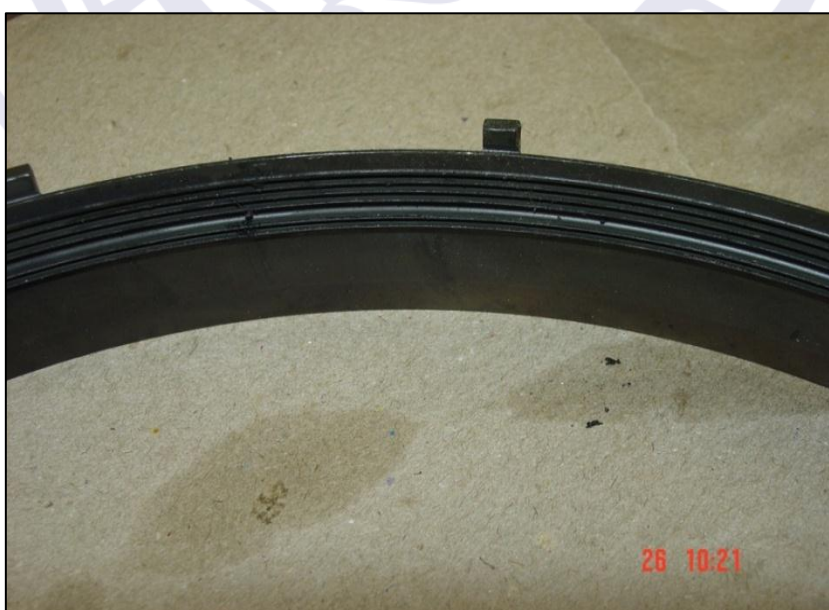
The small canals of the power turbine rotor sealing ring had no marks or damage resulting from rubbing with the ends of the blades of the power turbine rotor (Figures 56, 57 and 58).

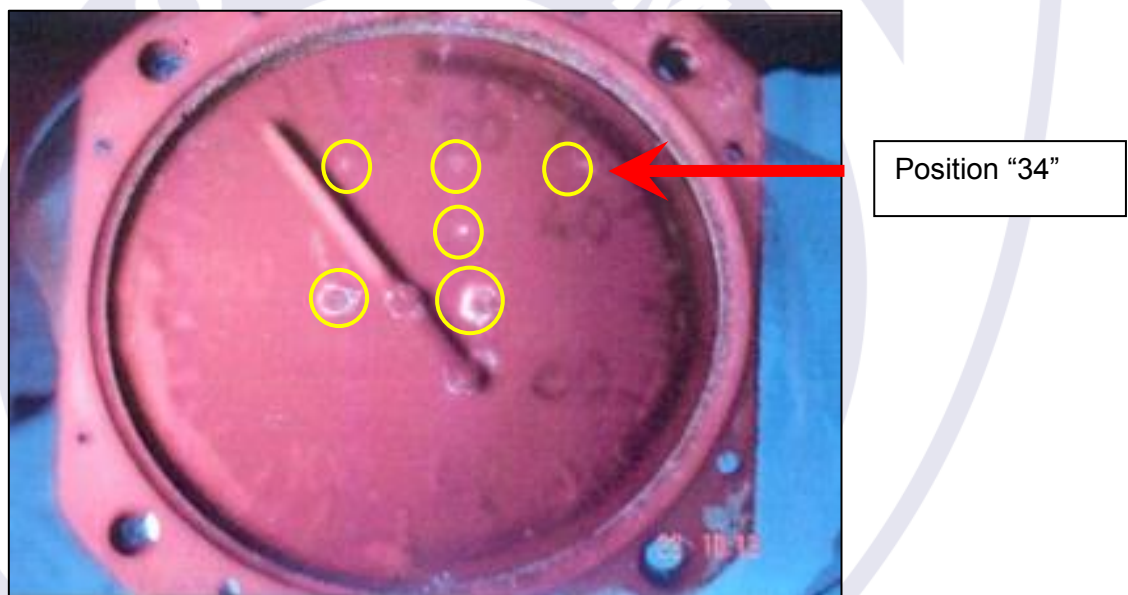
In the research that was done, it was possible to observe points with light color, contrasting with the dark background of the instrument, something that, according to the report, could be interpreted as sign of rust or contamination (Figure 59). Moreover, the point found at position "34" (Figure 60), which coincided with the contact region in a frontal impact, presented a light color aspect without the characteristic presence of fluorescence - similar to many other apparent signs - and therefore should not be taken into consideration.

Figure 59 – ASI under the action of black light with intensity of $1,310 \mu\text{w}/\text{cm}^2$. The yellow circles indicate the points that were not considered.

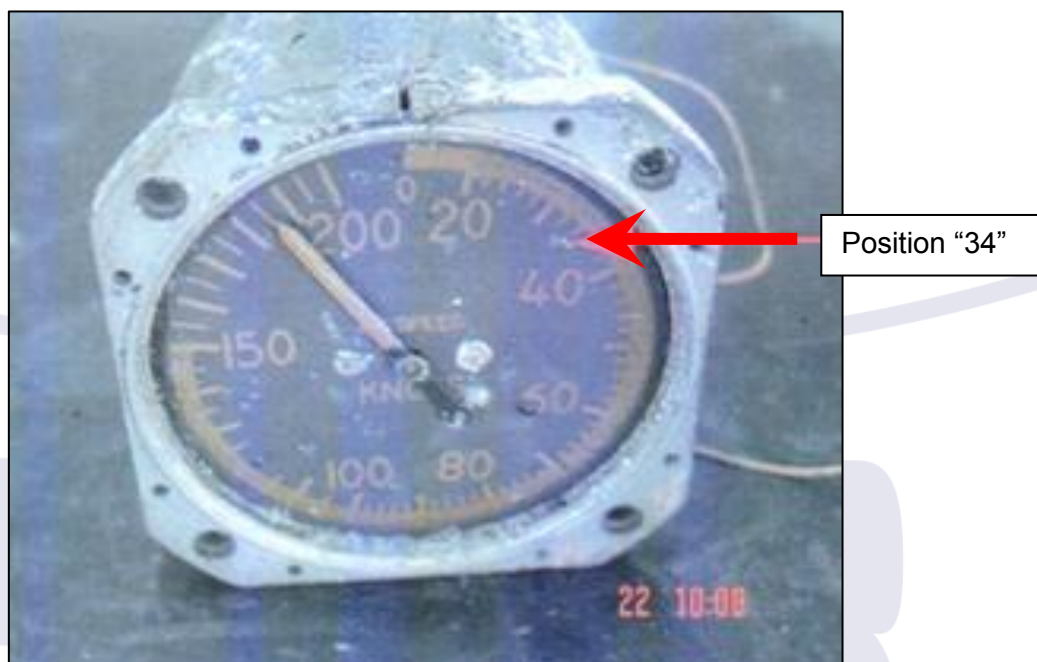
Figure 60 – ASI under the action of white light. In highlight, the only point that could have been caused by the pointer (position "34"), but which was not considered as evidence in the 20-E/2012 Report.

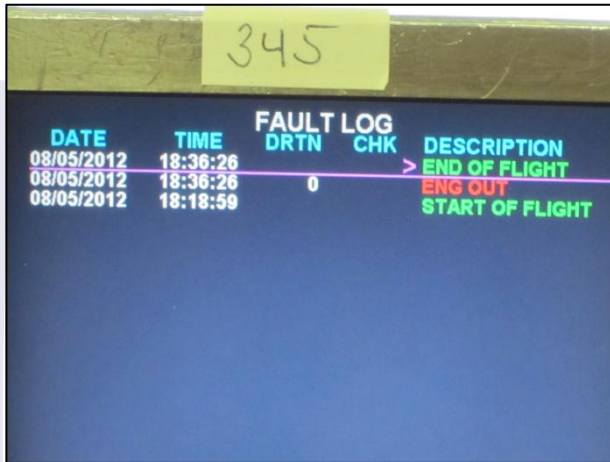
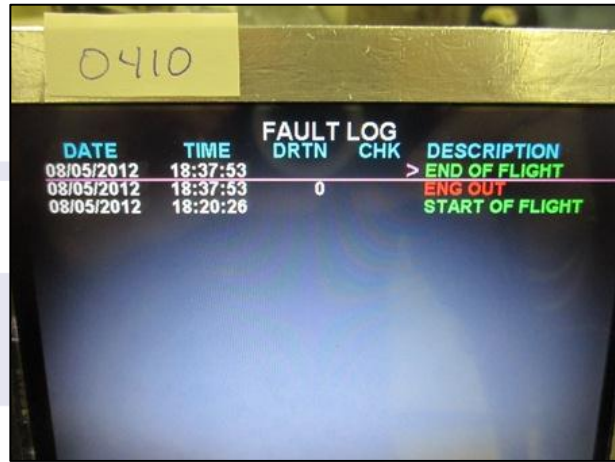
Figures 68 and 69 –Fault Log messages relative to the accident flight stored in the PP-CGO EDUs.

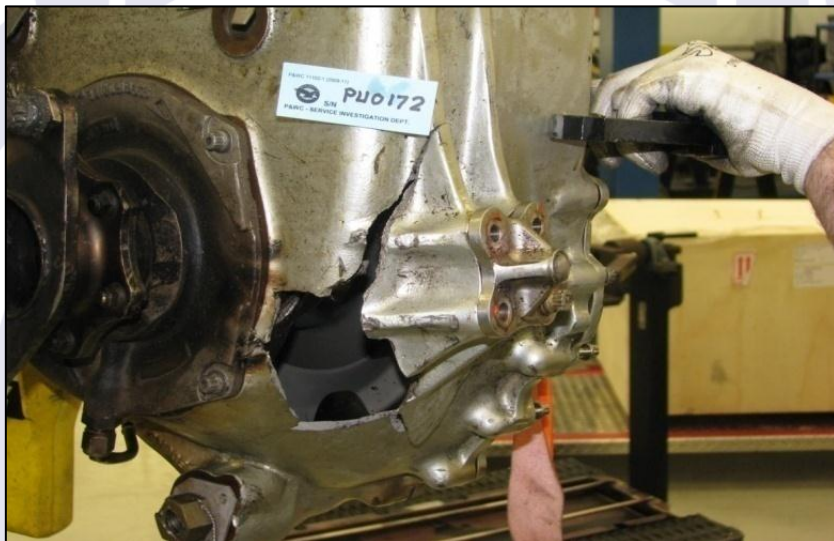
Figure 73 - Fracture resulting from the impact sustained by the RGB in the accident.
