COMANDO DA AERONÁUTICA
CENTRO DE INVESTIGAÇÃO E PREVENÇÃO DE
ACIDENTES AERONÁUTICOS

FINAL REPORT
A - 061/CENIPA/2013

OCCURRENCE:	ACCIDENT
AIRCRAFT:	PP-CGO
MODEL:	AW119 MKII
DATE:	8 MAY 2012

This is the Final Report of the 8 May 2012 accident involving the AW119 MKII aircraft, registration PP-CGO. The accident was classified as inflight engine failure.

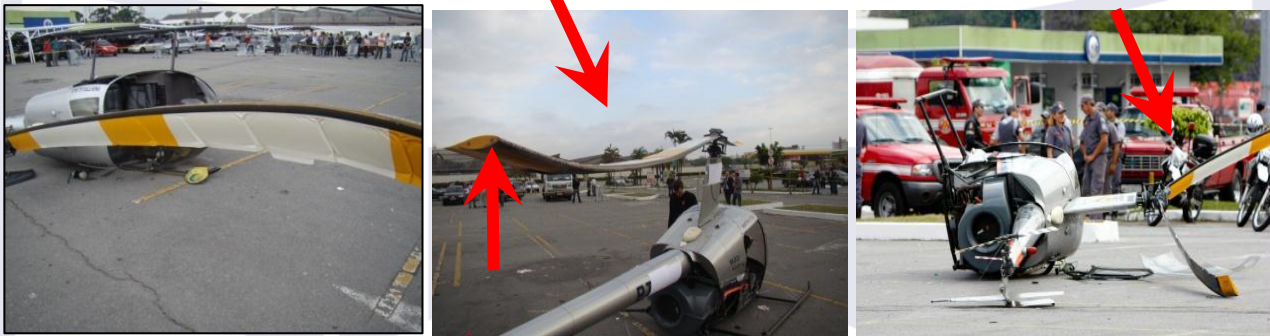
Figures 89, 90 and 91 – Situation of the PT-YZZ main rotor blades after the accident. In highlight, details of the upward bending of the blades. Source: SERIPA IV
