COMMAND OF AERONAUTICS
AERONAUTICAL ACCIDENT INVESTIGATION AND
PREVENTION CENTER

FINAL REPORT
A-103/CENIPA/2014

OCCURRENCE:	ACCIDENT
AIRCRAFT:	PT-YJJ
MODEL:	AS 350 BA
DATE:	07 JUNE 2014

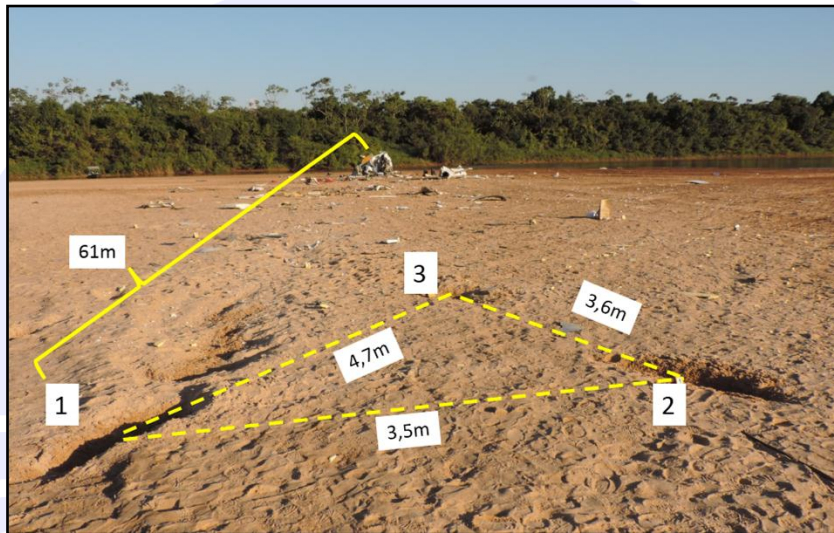
Figure 5 – Initial points of impact: 1 – front part of the right ski; 2 and 3 – cuts in the terrain made by the tips of the main rotor blades.

At point 1, traces of white paint from the end of the right ski were found.

At point 2, the metal component of the tip of one of the main rotor blades was found. At a distance of approximately 0.3 meters from point 3, another similar metal component was found.

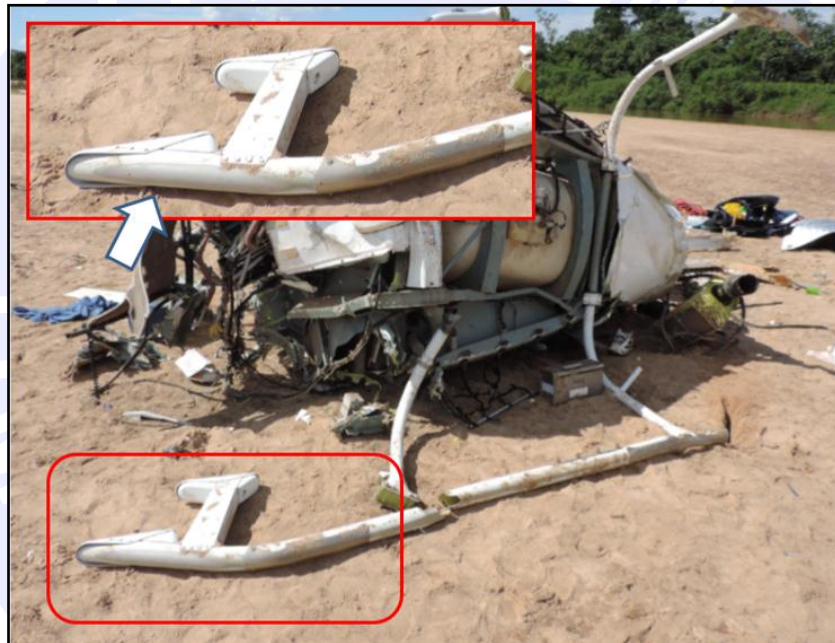
Figure 7 – The end of the right ski, in highlight, was repositioned for evaluation.

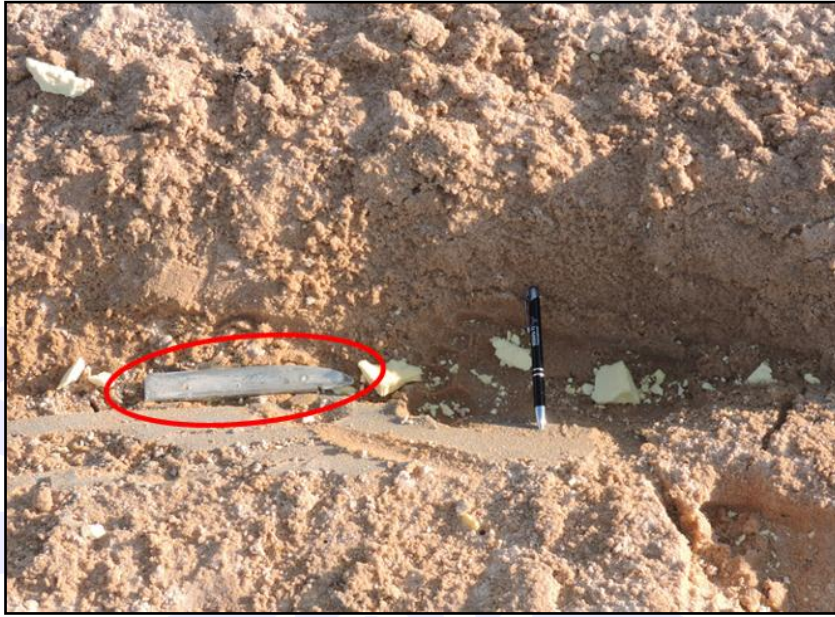
Figure 8 – Point 2: in highlight, the metal component of the tip of one of the main rotor blades.

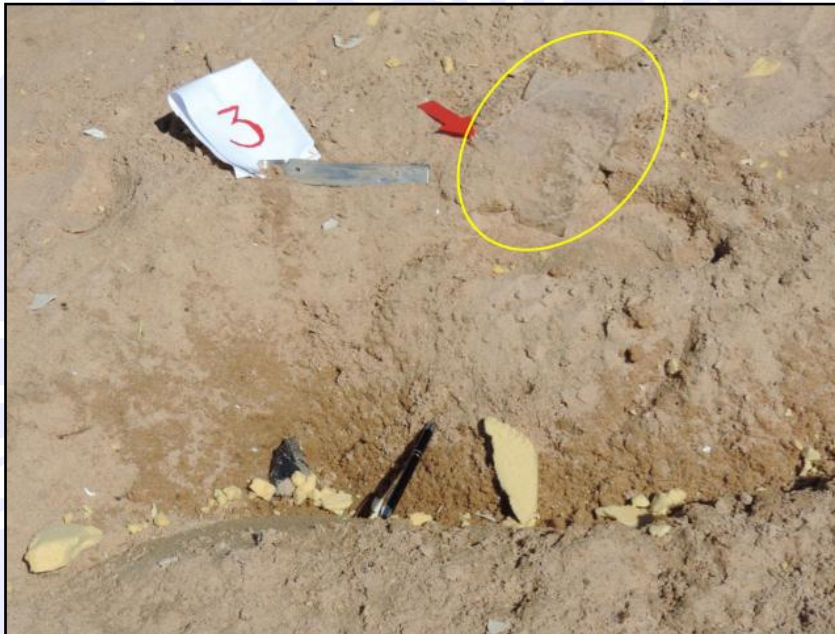
In the direction of movement, to the right and sides of the points 2 and 3, there were fragments of the aircraft lateral windows.

Figure 9 – To the side of point 3, highlighted by a yellow circle, fragments of the lateral windows.

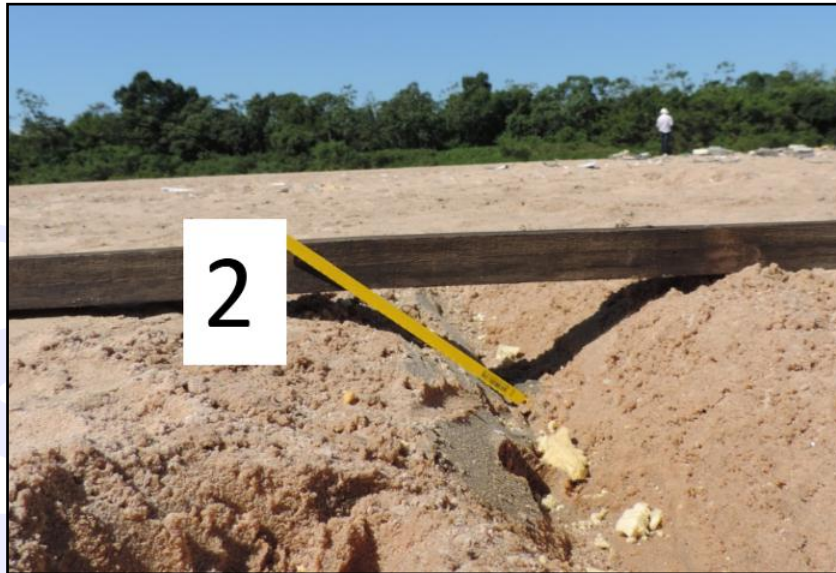
At point 2, the blade made a cut in the terrain at an angle of 32° ; at point 3, the cut was at an angle of 43° .

Figure 10 – Cut in the terrain at point 2, made by the main rotor blade (angle of 32°).

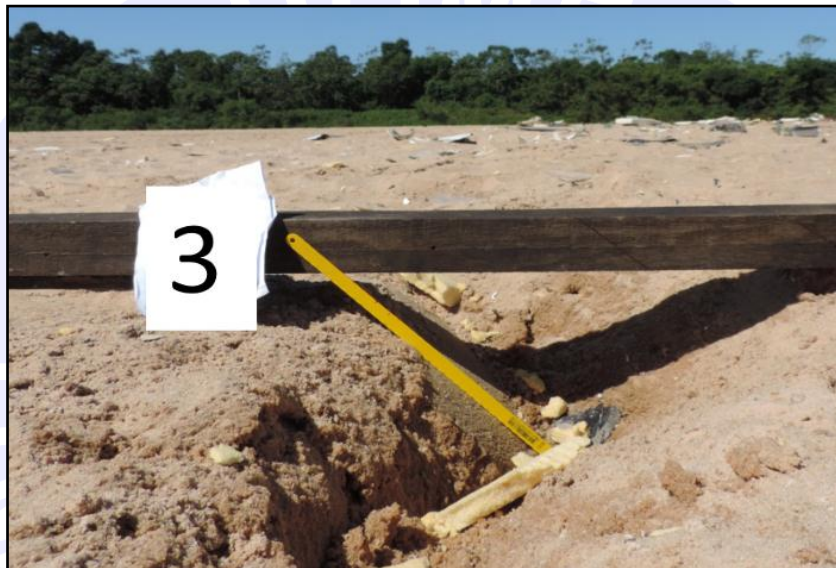
Figure 11 – Cut in the terrain at point 3, made by the main rotor blade (angle of 43°).

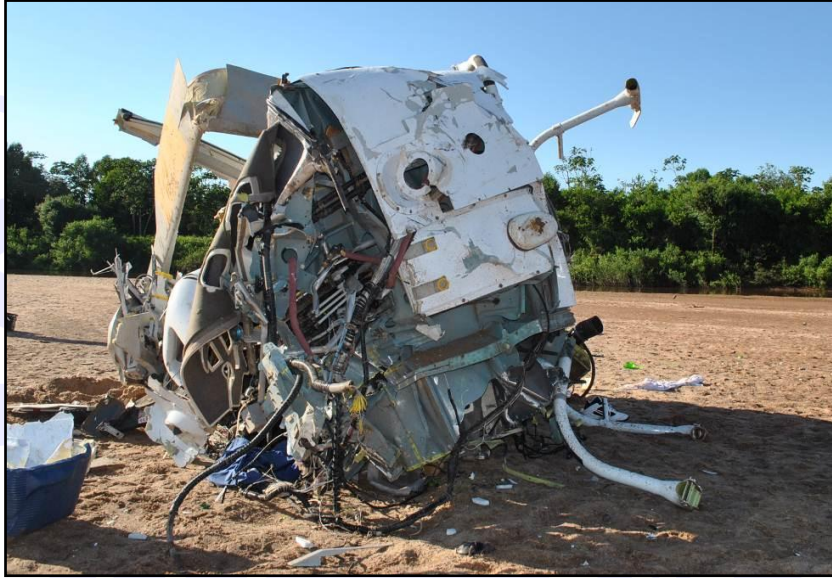
The right side of the front section, on the underside of the aircraft, sustained more damage and a more significant displacement of the floor in a down-up direction when compared with the left side.

Figure 13 – Damage to the underside of the aircraft front section.

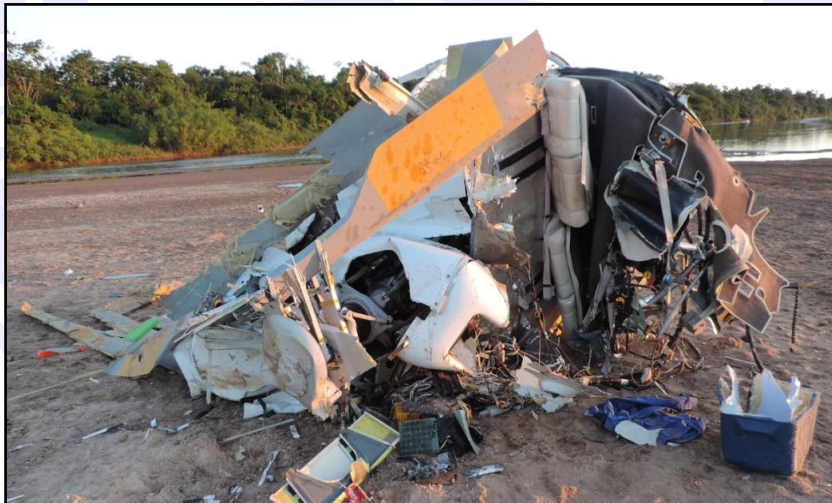
The main rotor blades were substantially damaged, as would be expected in the situation of high rotational energy with which the aircraft impacted the ground. Fragments of the main rotor blades were scattered within a radius of 12 meters around the initial points of impact. (points 2 and 3 of figure 5).

Figure 14 – Main rotor blades after the full stop of the aircraft.

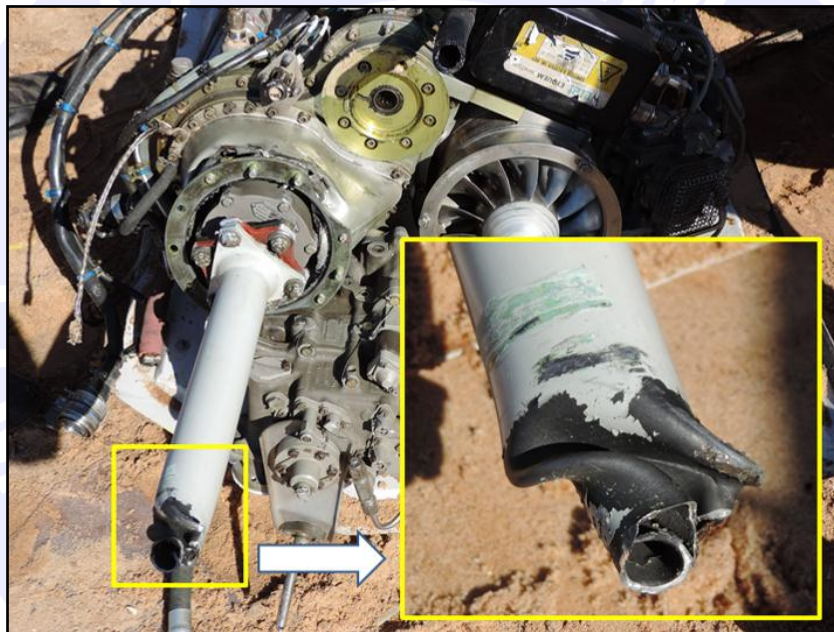
In the figure below, it is possible to observe part of the transmission shaft, connected to the engine of the aircraft. At the point of breakage, in highlight, it is possible to see signs indicative of significant rotational movement at the moment of fracture.

Figure 16 – Main rotor activation shaft connected to the engine. In highlight, the point of fracture.

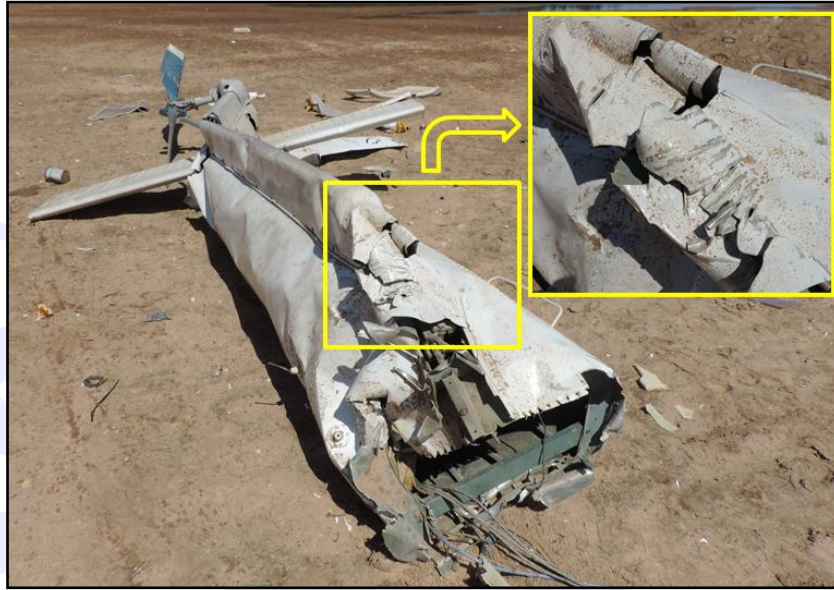
Figure 17 – Damage to the cowling of the tail rotor activation shaft, indicating high rotation movement at the moment of fracture and separation.

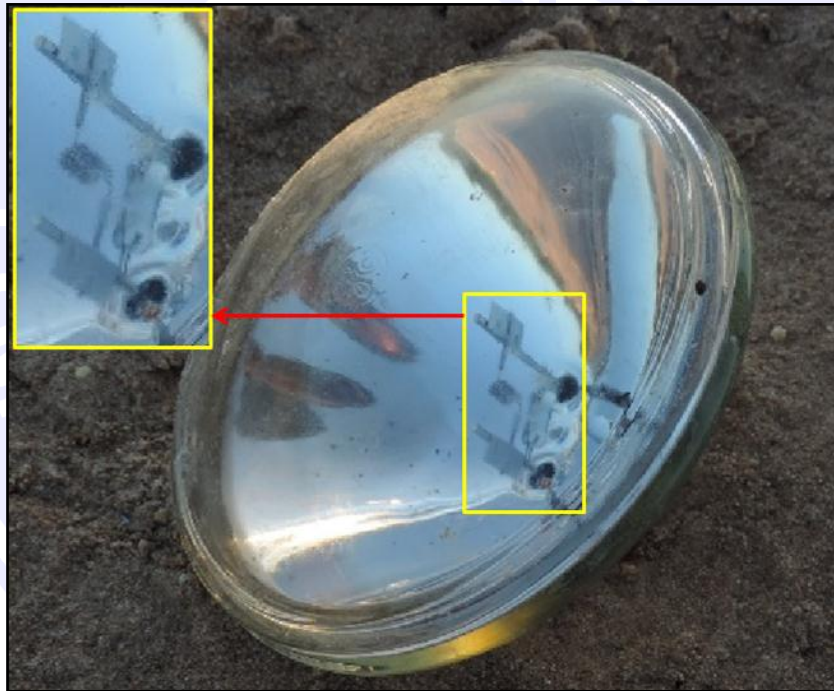
The aircraft landing light was found in the midst of the wreckage. The filament of the lamp was intact.

Figure 18 – Headlight with an intact filament.

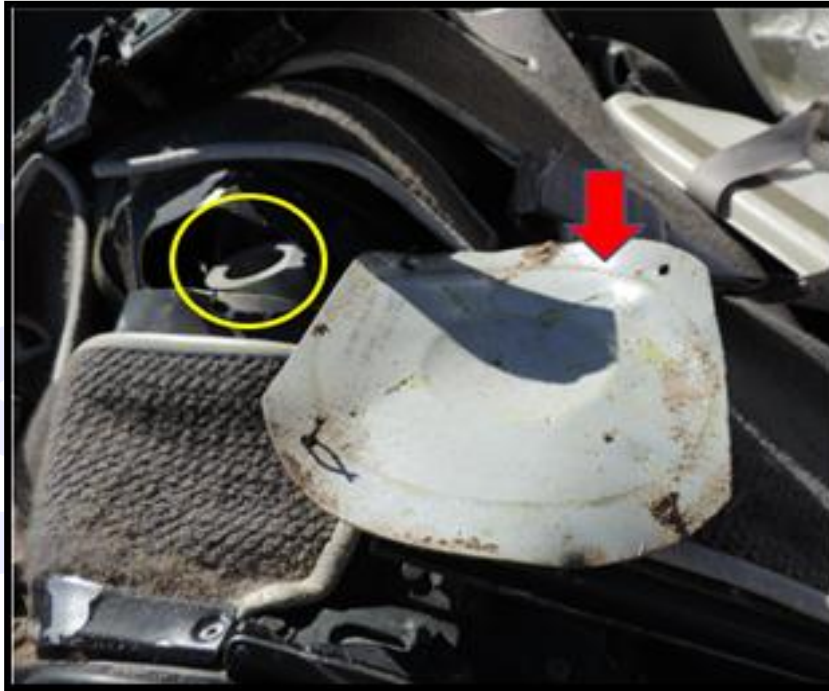
It was observed that there was no cyclic control in the left piloting position. Neither were there in the place designed for lodging the cyclic any signs of damage indicative of a contingent separation due to impact. In addition, the lid used to cover the empty space of the cyclic lodging was found.

Figure 21 – Left-hand side piloting position. The yellow circle shows that the cyclic was not installed. The red arrow shows the lid that was installed to cover to cyclic lodging.

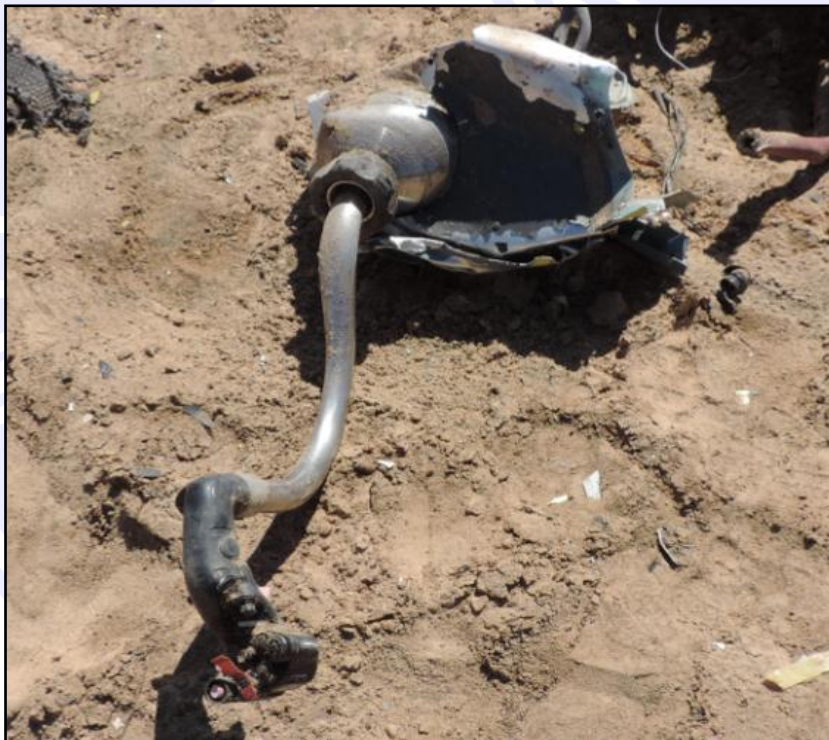
The control of the cyclic of the right-hand side piloting position was found five meters short of the place where the control cabin had stopped.

Figure 22 – Cyclic of the right-hand side piloting position, found at a distance of five meters from the aircraft cabin.

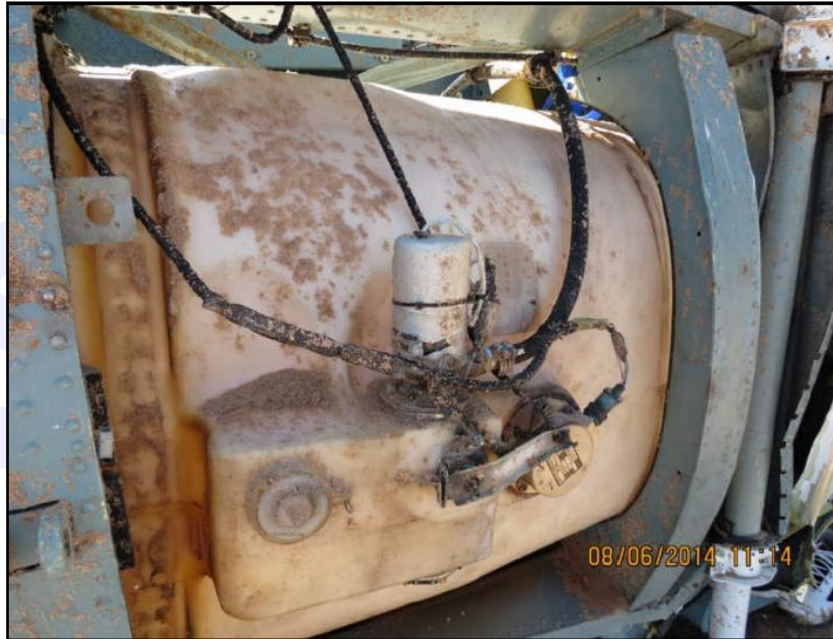
The fuel tank did not sustain any breakage. The fuelling opening separated from the fuselage because of the impacts. Such disconnection allowed sand and humidity to enter

and contaminate the fuel after the accident. More than 120 liters of fuel remained in the tank.

Figure 23 – Fuel tank of the aircraft.

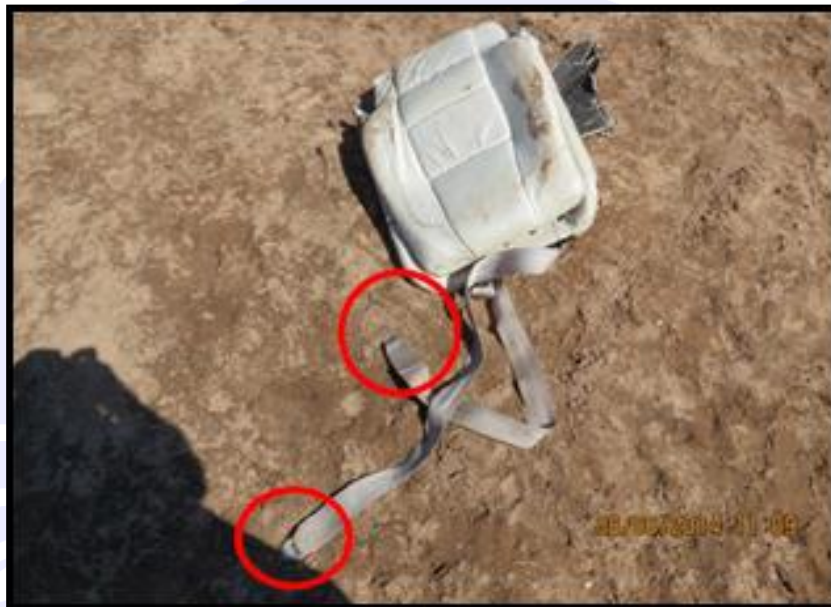
The suspenders of the front seats were intact, without indication of effort in the straps or points of attachment. No evidence was found that the passengers had been wearing them.

Figure 26 – Suspenders of the left front seat, not fastened.

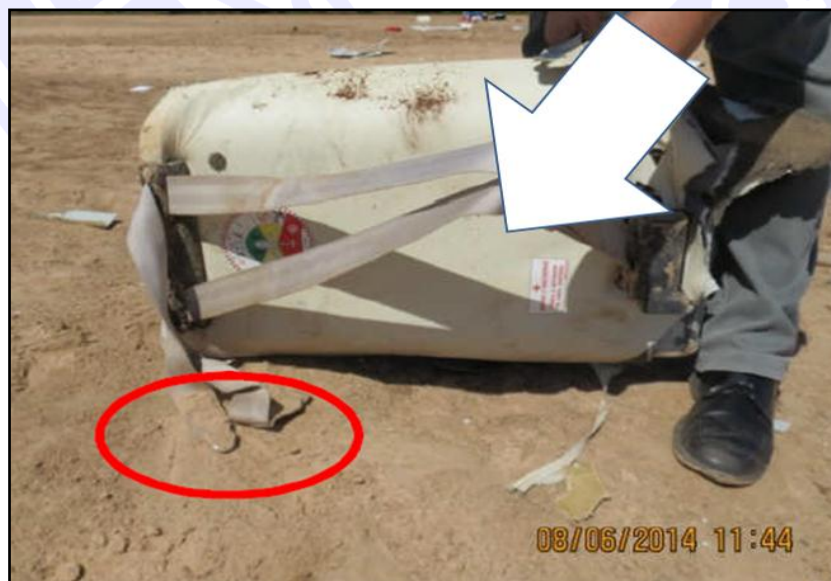
Figure 27 – Suspenders of the right front seat (pilot's) not fastened.

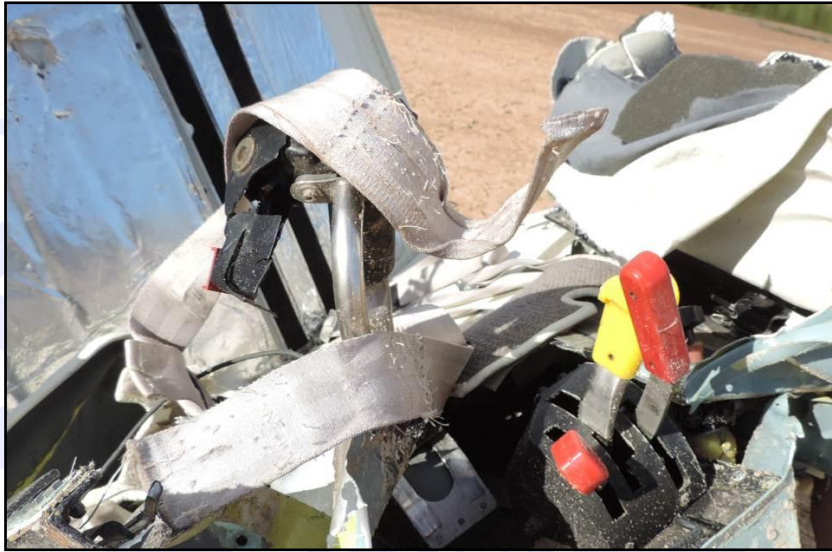
The abdominal belts of the front seats sustained rupture of the stitch sewing (figure 26). These belts remained connected to the points of attachment in the aircraft (figure 27).

Figure 28 – Abdominal belt of the right front seat with its stitch sewing ruptured.

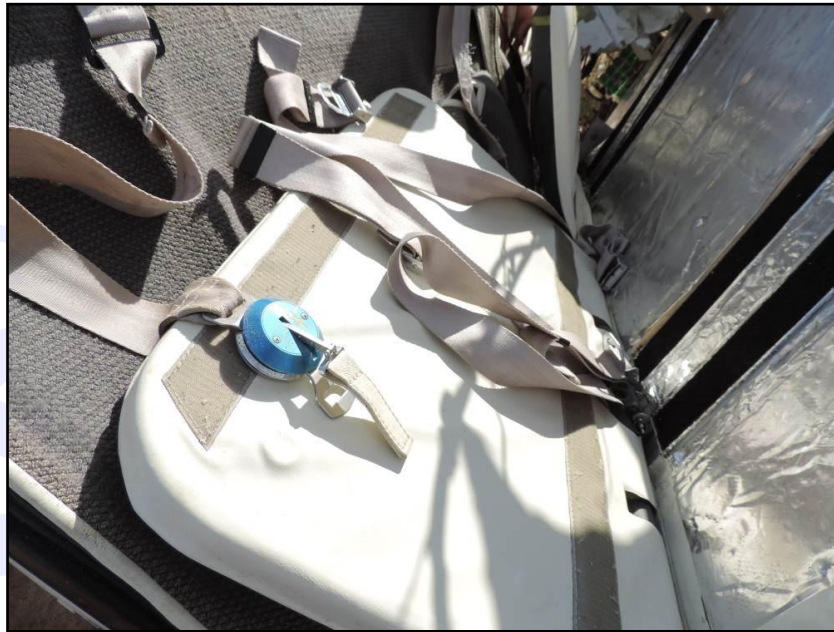
The belts and suspenders of the rear seats were intact, without marks or damage that would be typical if the aircraft occupants had been wearing them.

Figure 30 – Safety belts of the rear seats.

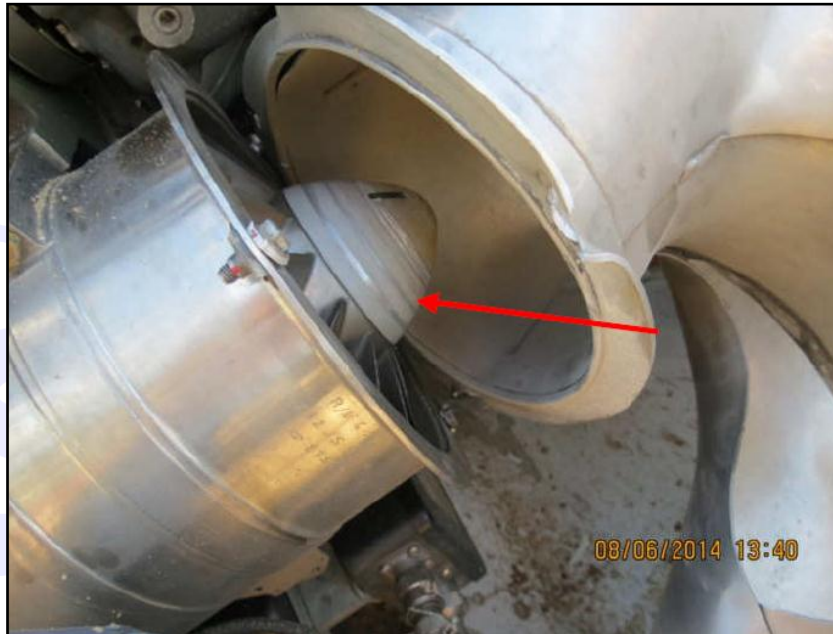
The air inlet cone of the engine axial compressor showed signs of circumferential friction, an indication that the engine was running at the moment of impact.

Figure 32 – Circumferential marks in the air inlet cone of the engine axial compressor.

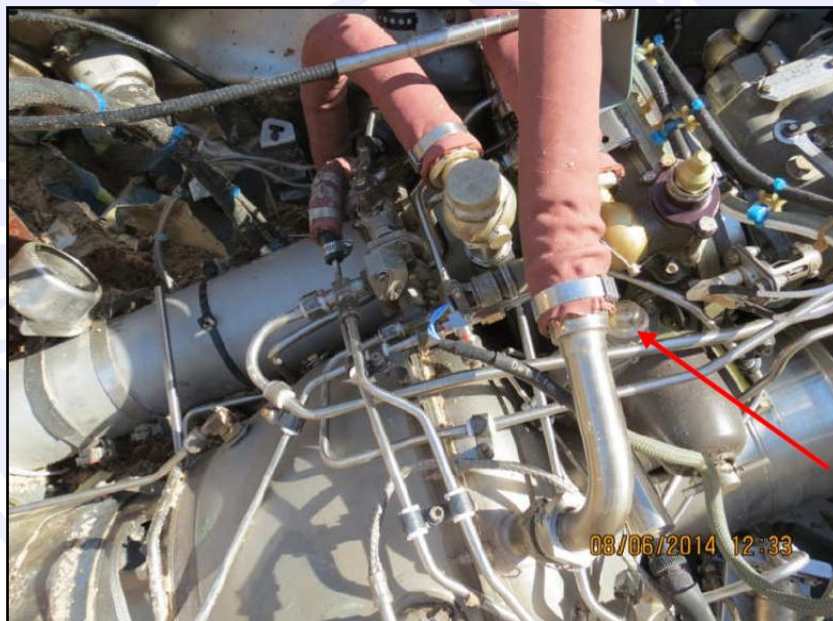
All the lines between the FCU, accessories and engine were well connected and tight. The pre-blockage indicator of the engine oil filter was not popped-out - showed no clogging of the engine oil system.

Figure 33 – Pre-blockage Indicator of the engine oil filter (not popped-out).

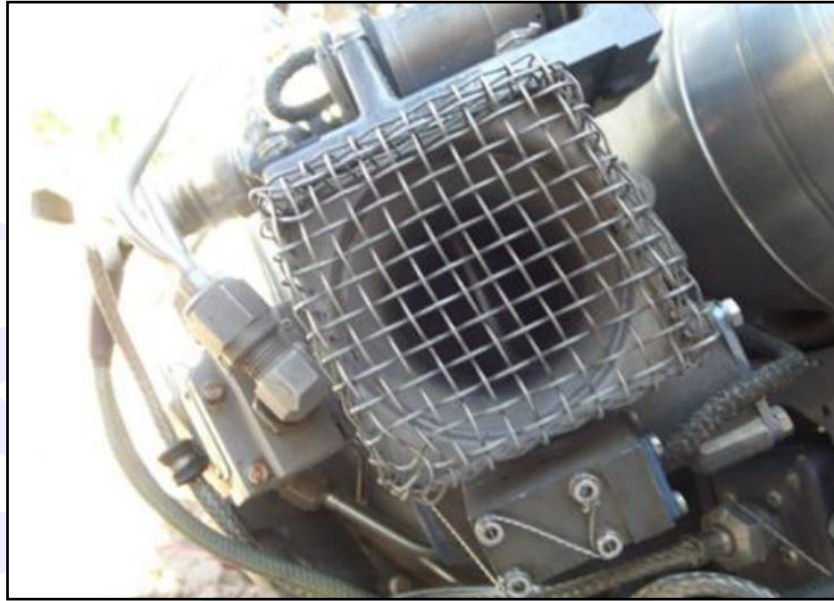
The bleed valve was in the open position, a normal condition for that phase of flight.

Figure 34 – Bleed valve in the open position.

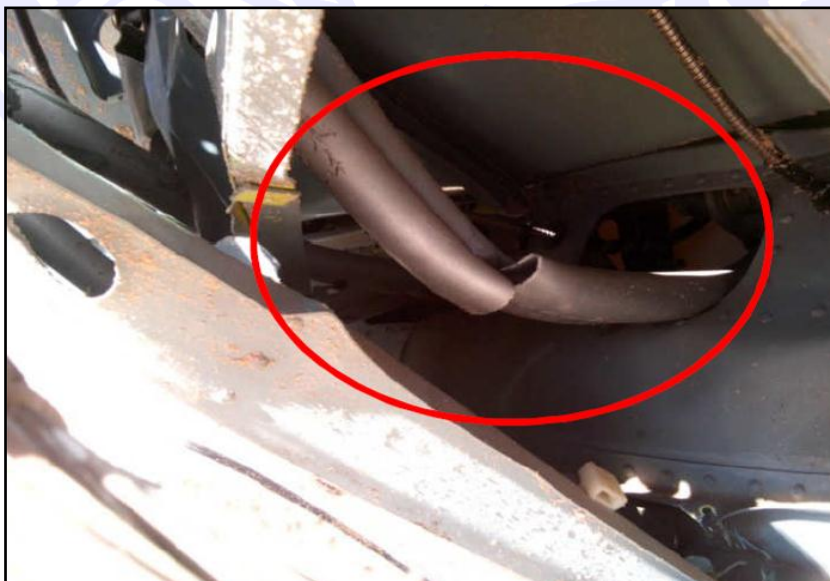
The control rods of the lateral cyclic and collective in the lower part of the left side of the cabin were verified. The connecting rods were fractured on account of the deformation of the aircraft structure.

Figure 37 – Lateral cyclic and collective control levers on the left side of the lower part of the cabin.

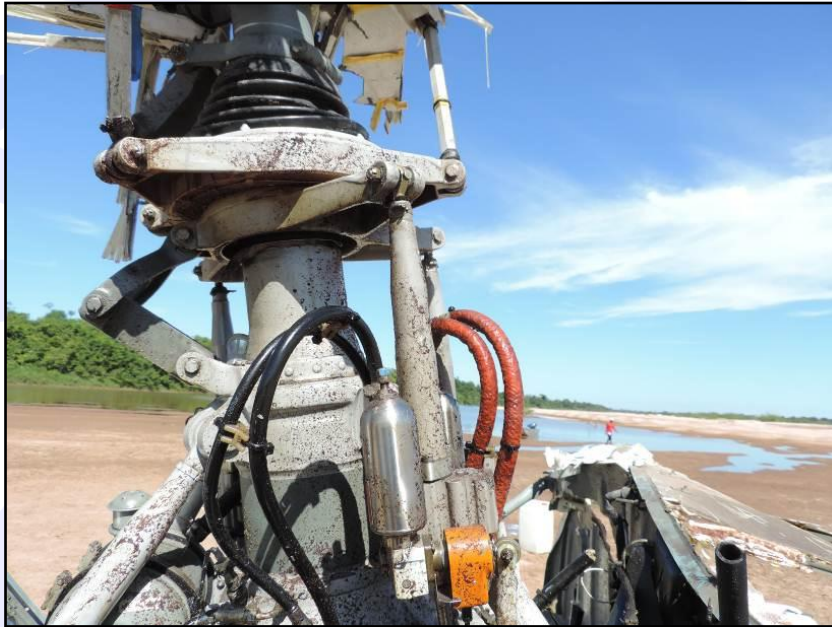
The hydraulic reservoir was empty. The fluid was pumped out of the system through the hydraulic lines at the point of junction of the tail boom with the rear structure. The piping got broken with the impact, which caused the separation of the tail cone from the rear structure. The hydraulic pump continued functioning, activated by the transmission during the sequence of impacts sustained by the aircraft. The hydraulic pump activation belt remained connected in the normal way.

Figure 38 – Dirt adhered to the places where the hydraulic fluid spread on the main rotor mast during the impacts.

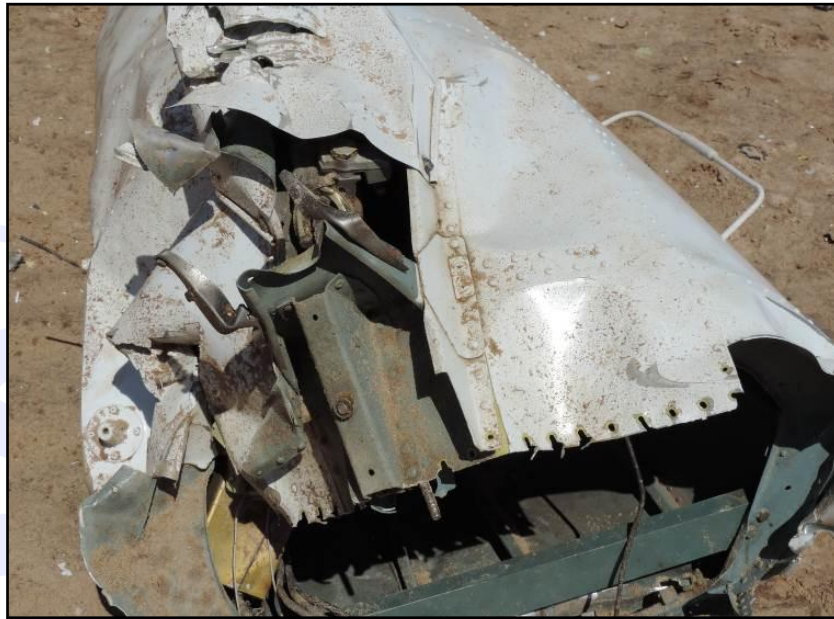
The cone presented deformation by compression on the right and on the lower parts. There were signs of traction (attachment points of the rivets were torn) on the upper left side, next to the point of attachment of the cone to the structure. These characteristics were an indication of a frontal impact, more significant on the right hand side of the aircraft, as it was with the tail pointing upward (figure 39).

Figure 39 – Section where the breakage of the tail rotor occurred. It is possible to observe that the points of attachment of the rivets were “torn”.

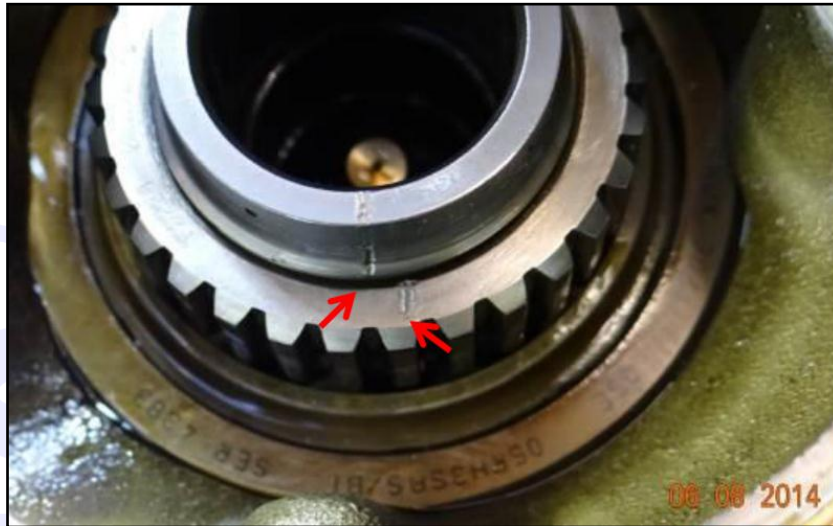
In the module 5 of the engine, a 2mm-misalignment was found in the splined nut of the driving gear (figure 41).

Figure 41 – Misalignment of 2mm in the splined nut of the driving gear.

In the module 5, the misalignment of 2mm of the marks of the splined nut of the driving gear indicates that engine was submitted to an overtorque condition (a sudden increase of an important resistance torque while engine was delivering the required power).

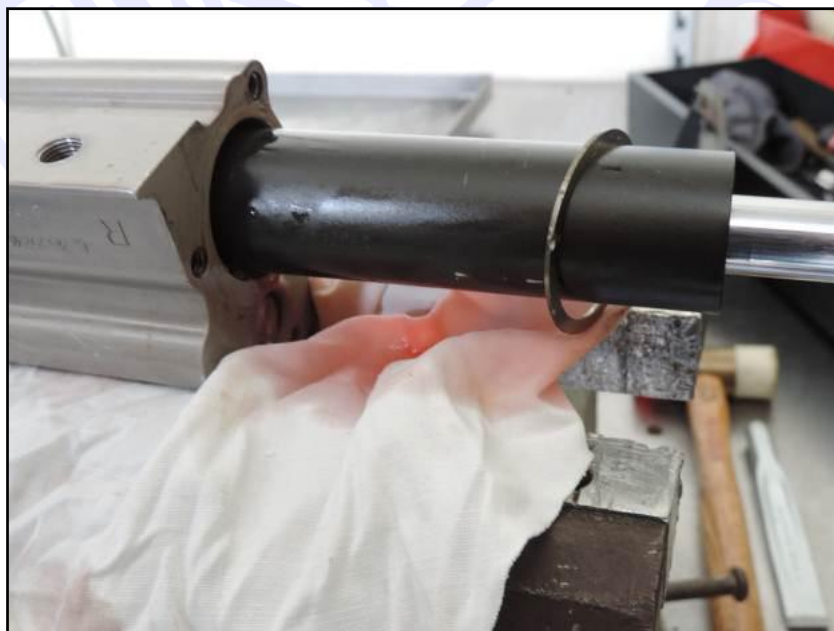
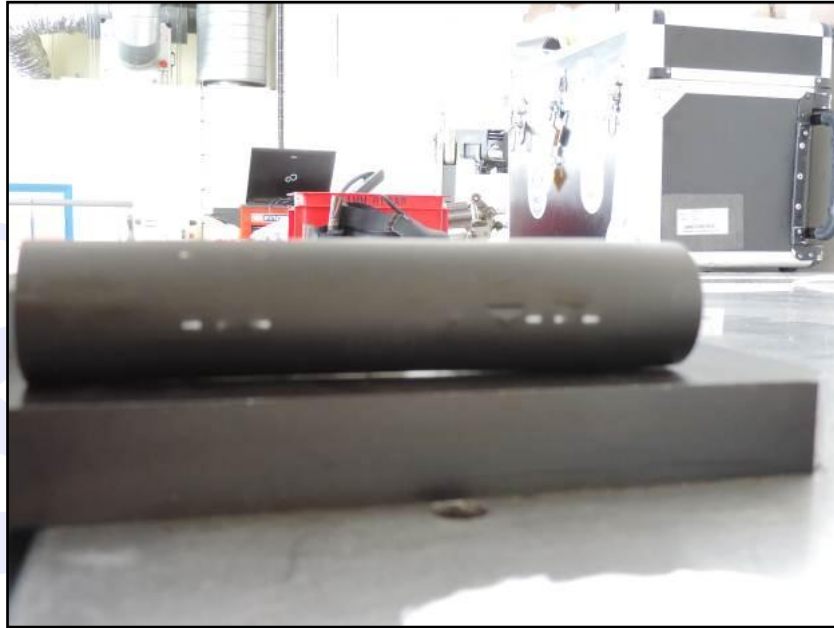
The exams indicated that the deformation in the cylinder was compatible with the information contained in the technical report *UTAS Report Ref. CE3523*. In the case in question, the servo control had the prescribed pressurization. At the high speed impact, there was no way to transmit the pressure, resulting in an overpressure condition (from the inside to the outside) which caused the deformation of the cylinder.

Figure 43 – Disassembly of the left servo control.

Figure 44 – The central part of the cylinder would not touch the floor surface.

No evidence was found that could indicate malfunctioning of the left servo control before the impacts of the aircraft with the ground.

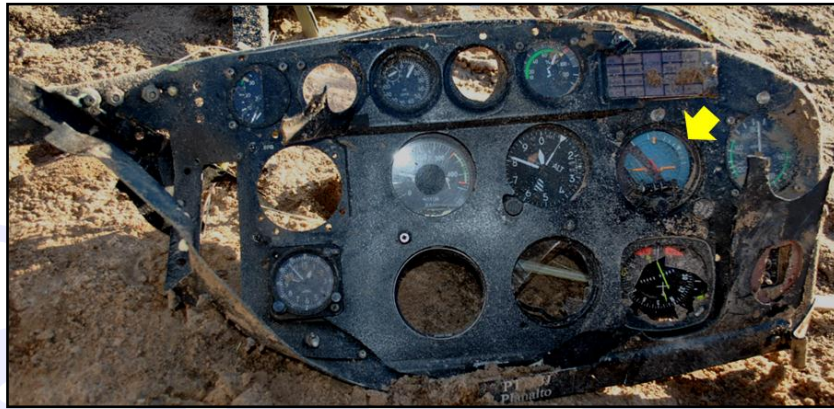
Figure 57 – The aircraft panel detached after the impacts. The artificial horizon is the instrument indicated by the yellow arrow.
