**FINAL REPORT**  
**A - 131/CENIPA/2013**

<b>OCCURRENCE:</b>	<b>ACCIDENT</b>
<b>AIRCRAFT:</b>	<b>PR-OKK</b>
<b>MODEL:</b>	<b>BE58</b>
<b>DATE:</b>	<b>16 JULY 2013</b>

This is the Final Report of the 16 July 2013 accident with the BE-58 aircraft, registration PR-OKK. The aeronautical accident was classified as “loss of control on the ground”.

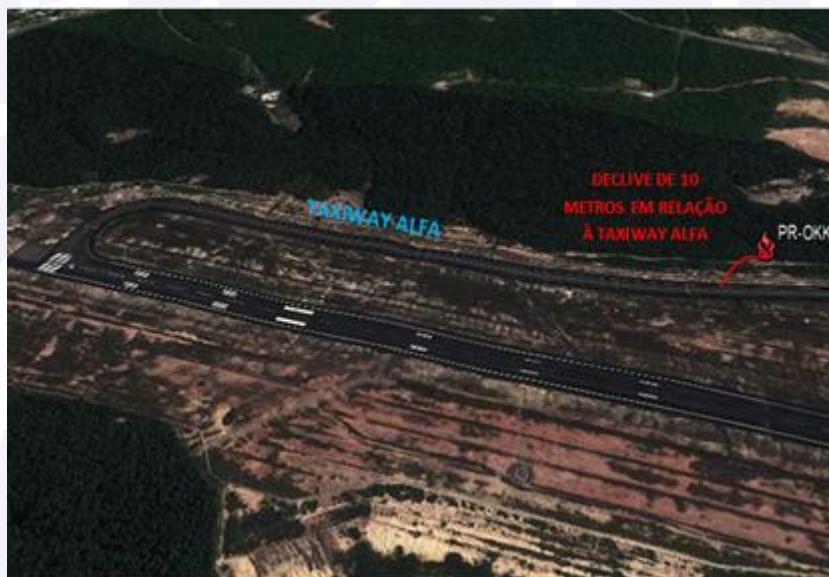
The accident occurred next to Alpha taxiway, in an area with accentuated declivity, 10 meters lower than the taxiway surface. In the area, there was vegetation with small to mid-size trees.

Figure 1 – Aircraft crash site (next to taxiway *Alpha*).

The aircraft first hit the treetops, resulting in breakage of the shaft and detachment of the right engine propeller. Then, the aircraft assumed a pitch-down attitude, and crashed into the ground at a speed of approximately 65kt, according to data transmitted by the transponder equipment to ATC units.

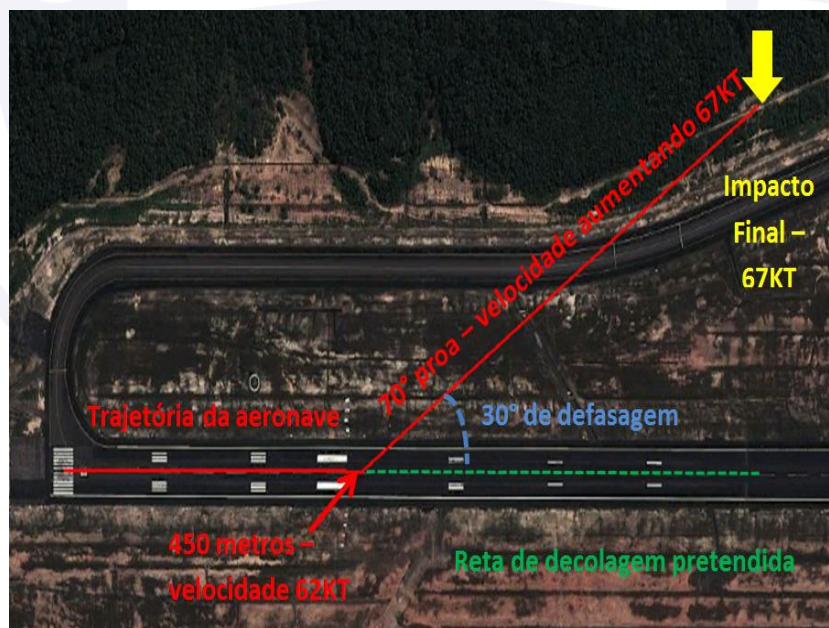
While still on the take-off run, the aircraft inadvertently turned to the left and exited the runway, traveling approximately 690 meters on a trajectory forming an angle of 30° with the runway center line, and collided with a terrain declivity next to taxiway Alfa.

Figure 2 – Trajectory of the aircraft until the final impact.

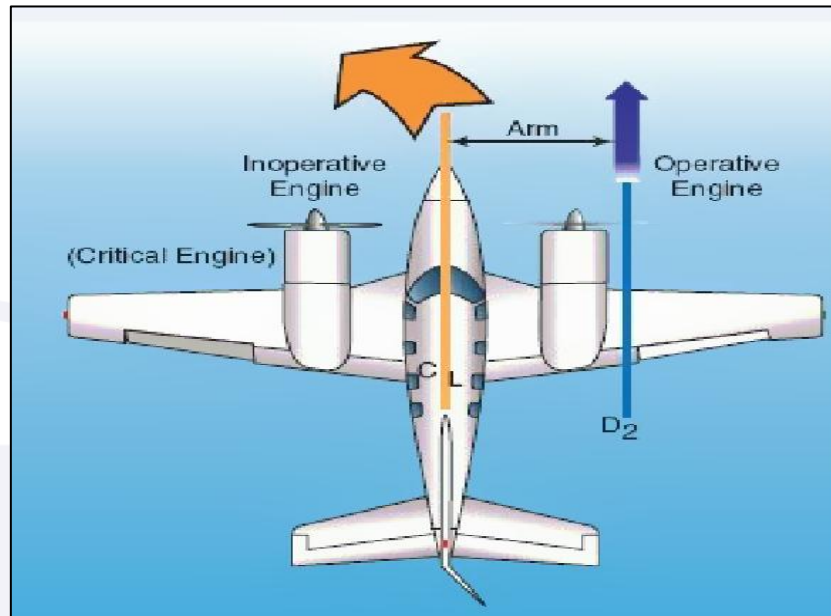
An engine failure, in this type of aircraft, is critical, especially if the affected engine is the left one and is not immediately feathered, increasing drag and creating a tendency of an abrupt yaw.

Figure 10 – Critical engine inoperative – Yaw tendency
