FINAL REPORT
A-149/CENIPA/2014

OCCURRENCE:	ACCIDENT
AIRCRAFT:	PT-DLA
MODEL:	177B
DATE:	30AUG2014

This is the final report of the 30 August 2014 accident with the 177B aircraft registered in Brazil as PT-DLA. The accident was classified as loss of control in flight.

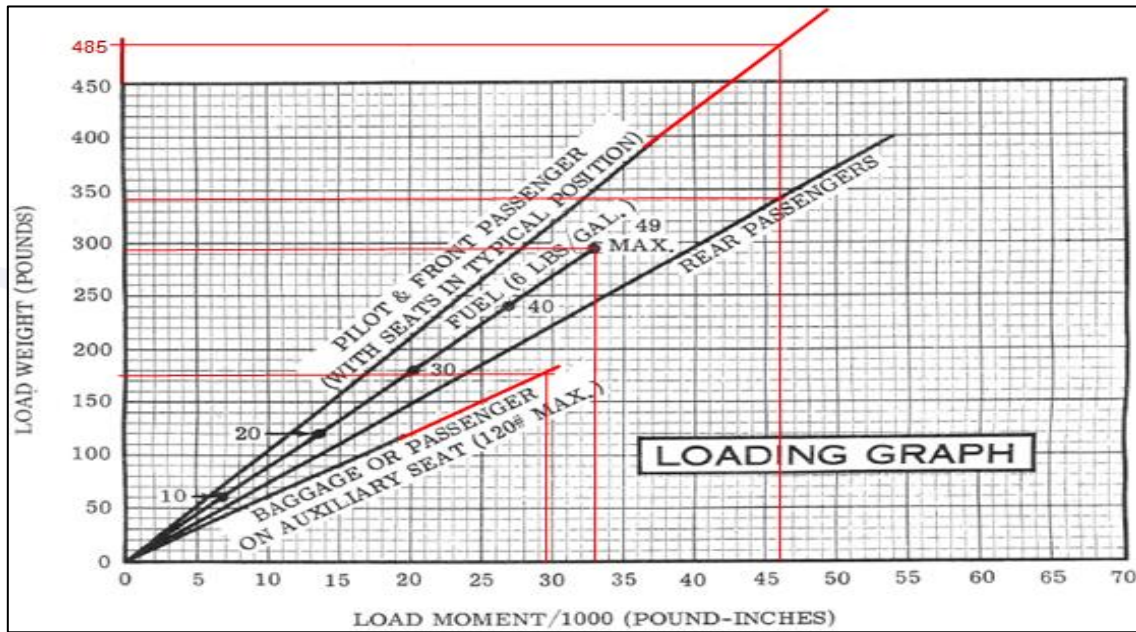
Figure 1 – Diagram for obtainment of the load moment.

The weight limits relative to the front seats and cargo compartment (max. 120 lb.) were exceeded. In the diagram, such values were inserted merely for illustration (in red).

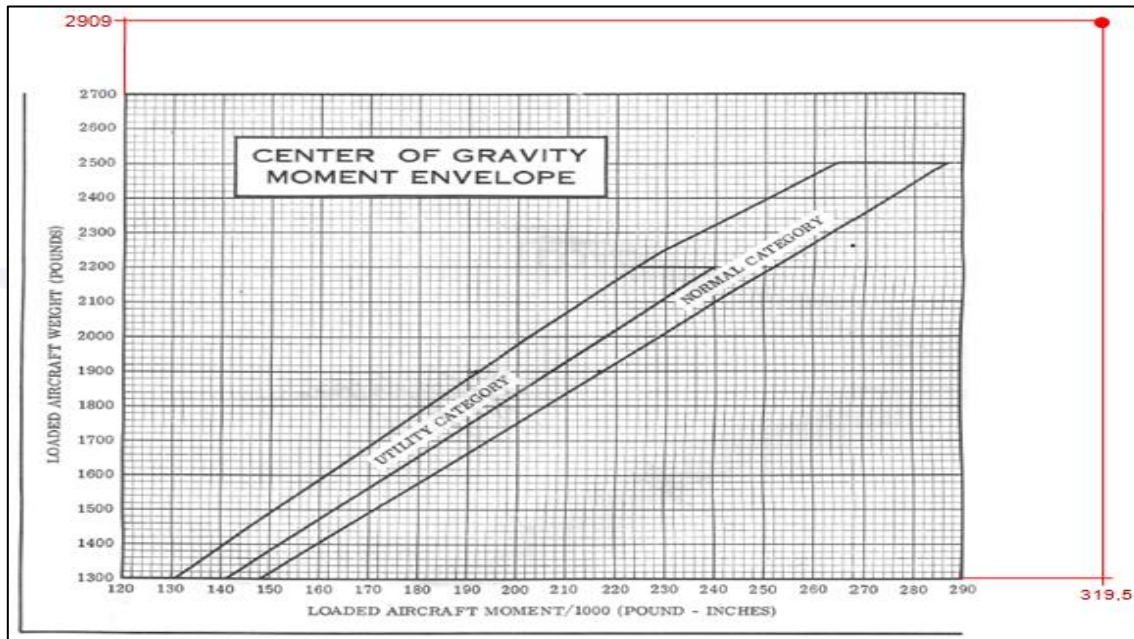
Figure 3 – Diagram of the Aircraft Center of Gravity.

Thus, in a mere illustrative fashion, one verifies that the limits of the aircraft center of gravity and maximum takeoff weight were considerably outside of the envelope certified for the aircraft.

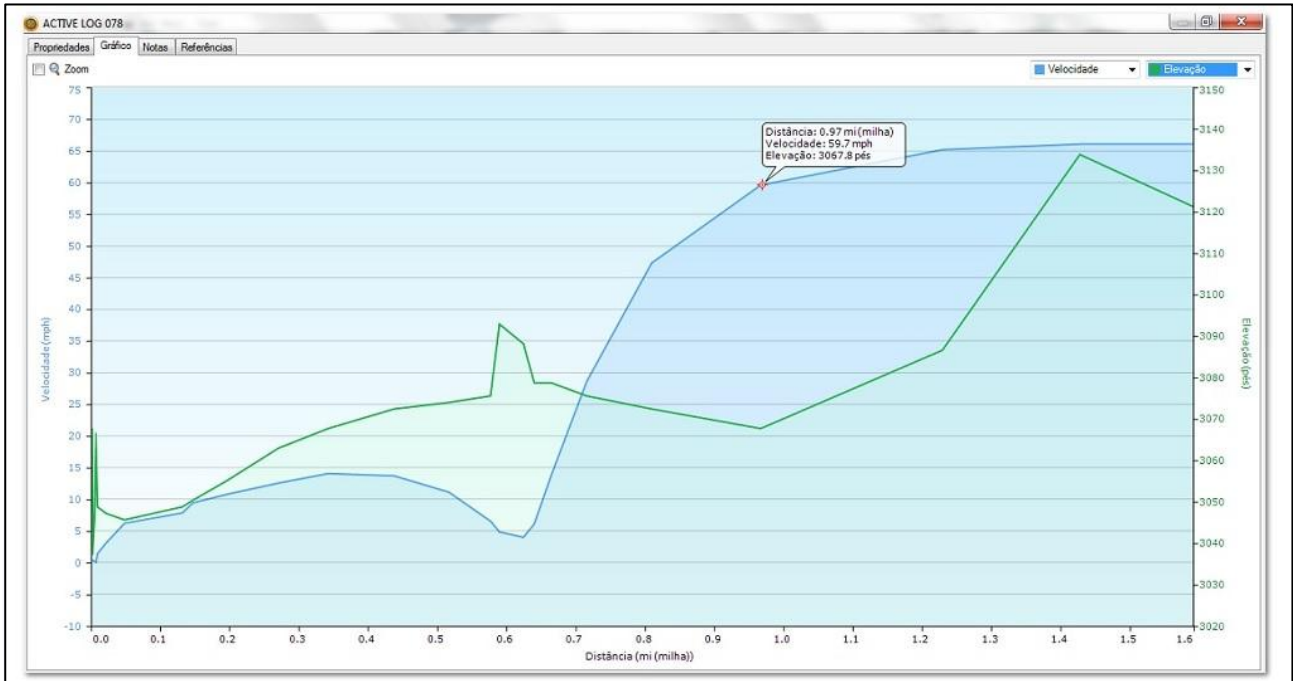
Figure 4 – Speed and elevation diagram.

Data retrieved from the GPS showed that the aircraft started the takeoff at a ground speed of 60 mph. Upon getting airborne, the aircraft climbed 70 ft, reached a maximum speed of 68 mph, and then began a pronounced descent.
