**COMANDO DA AERONÁUTICA**  
**CENTRO DE INVESTIGAÇÃO E PREVENÇÃO DE**  
**ACIDENTES AERONÁUTICOS**

**FINAL REPORT**  
**A - 207/CENIPA/2013**

<b>OCCURRENCE:</b>	<b>ACCIDENT</b>
<b>AIRCRAFT:</b>	<b>PR-MXM</b>
<b>MODEL:</b>	<b>R66</b>
<b>DATE:</b>	<b>20NOV2013</b>

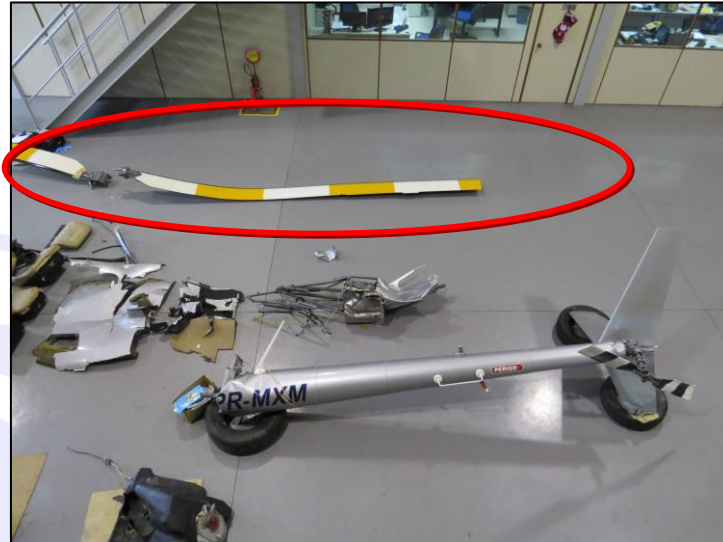
During the reconstruction of the aircraft, the investigation commission observed that one of the main rotor blades was deflected upward on its first one-third measured from the blade-root (Figure 9).

Figure 9 – Main rotor blade deflected upward.

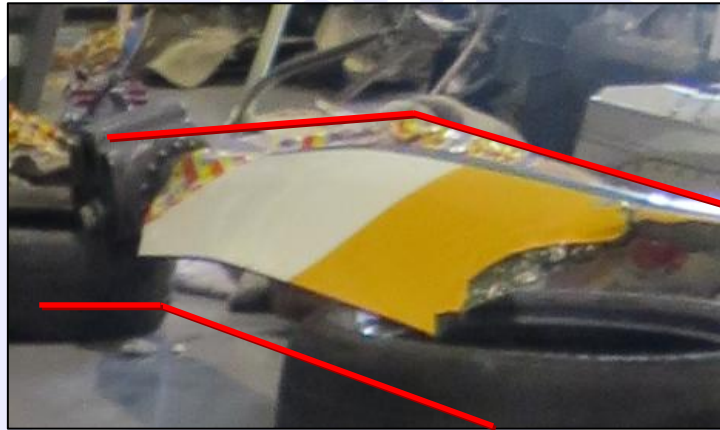
The other main rotor blade had a downward deflection close to its root (Figure 10), and a bend to the left on the leading edge in the direction of rotation, with absence of material of the blade profile, measuring approximately 1 meter. At about 2.10 meters from the blade root, there was a break perpendicular to the blade length (Figure 11).

Figure 10 – Main rotor blade deflected downward.

It was also observed that one of the main rotor blades had a downward deflection close to its root, an indication that the aircraft had experienced a mast bump/extreme teetering event.

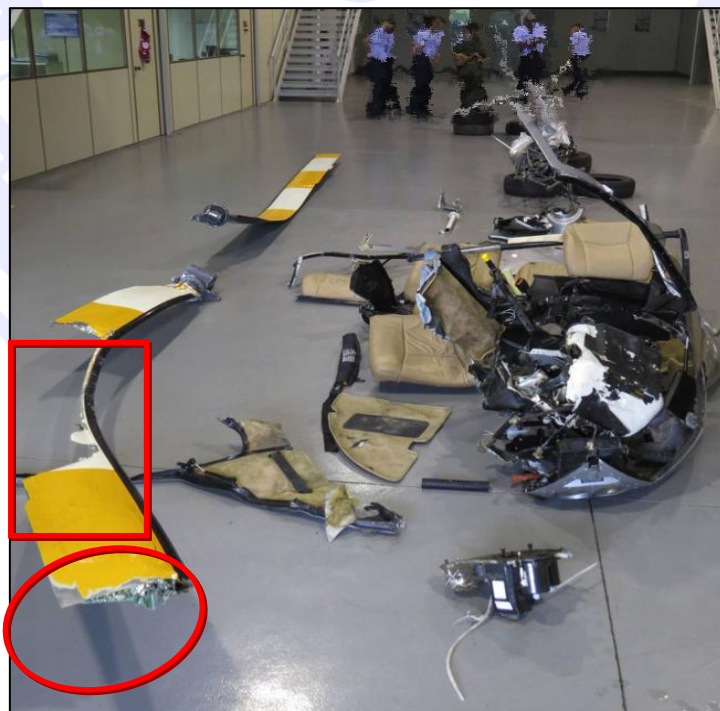
Figure 11 – Leading edge of the blade showing curvature in the direction of rotation, absence of material of the blade profile, and a fracture perpendicular to blade length.

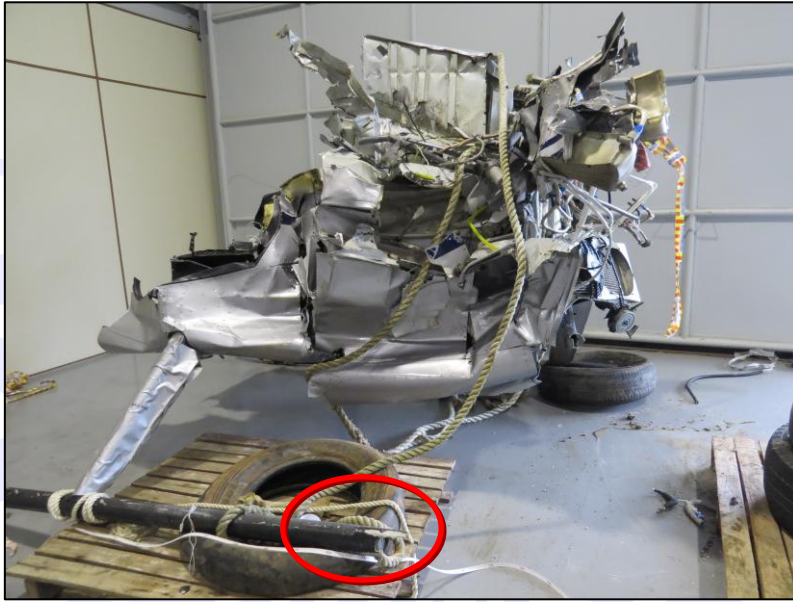
The left skid had a fracture in the back (Figure 12).

Figure 12 – Left ski with a breakage in the back part.

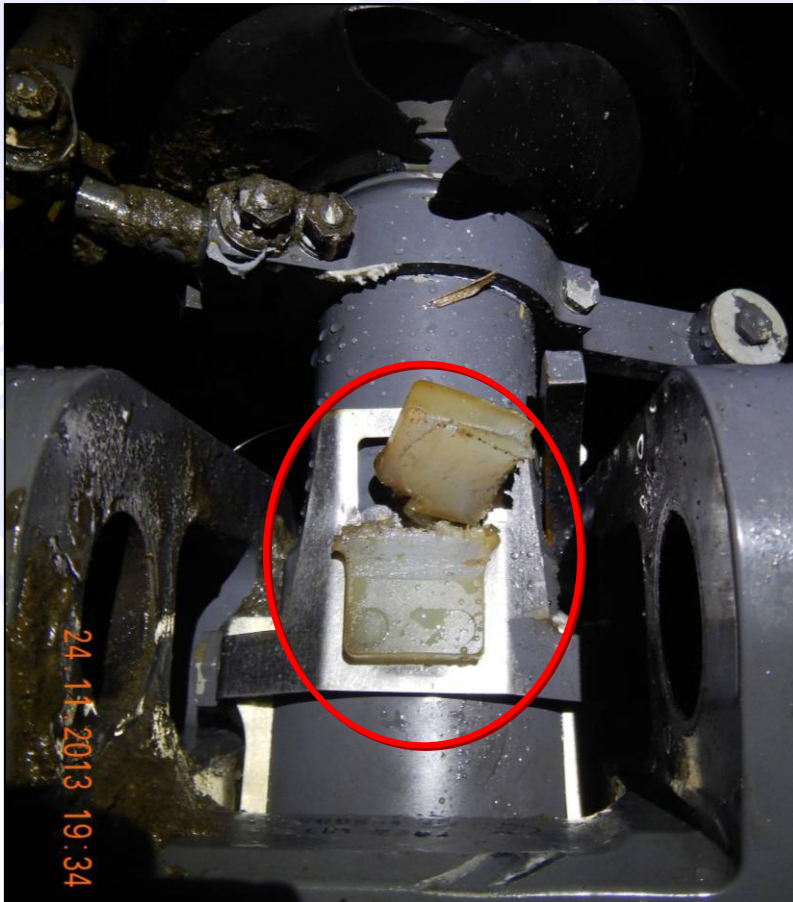
The teeter stops of the main rotor head were broken (Figure 13).

Figure 13 – Broken teeter stop of the main rotor head.

The possibility of a mast bumping event is also strengthened by the analysis of the aircraft wreckage. It was observed that one of the teeter stops had marks compatible with a possible contact between the main rotor head or blade spindle and the aforementioned protection (figure 13).

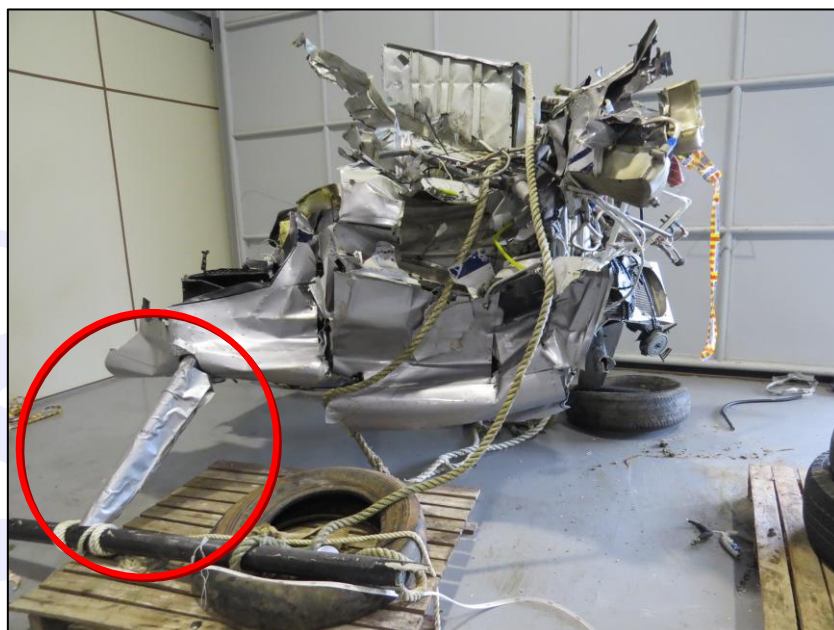
The forward strut fairing of the left skid presented deformation (Figure 14), while the strut fairing of the right skid and part the right side of the fuselage had little damage (Figure 15).

Figure 14 – Forward strut fairing with deformation.

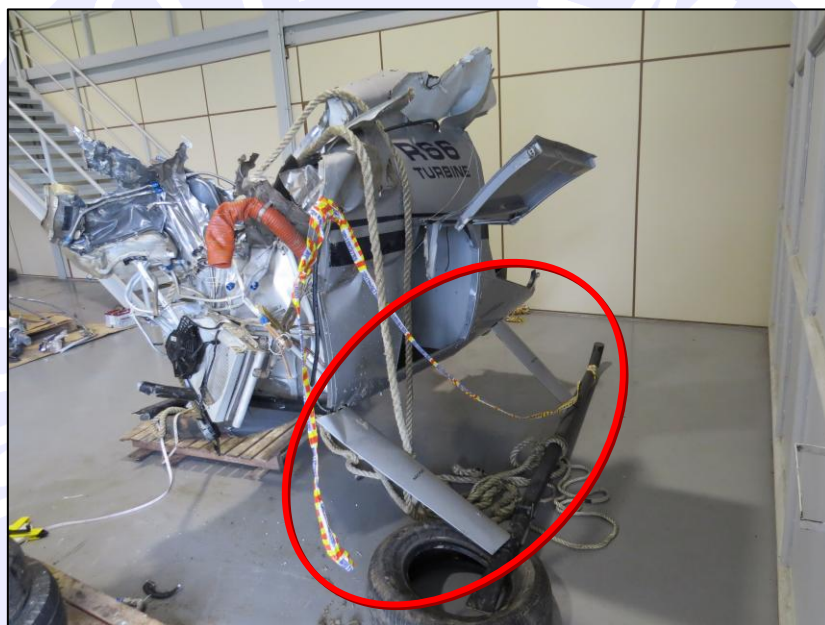
Figure 15 – Strut fairing of the right skid and part of the fuselage with little damage.

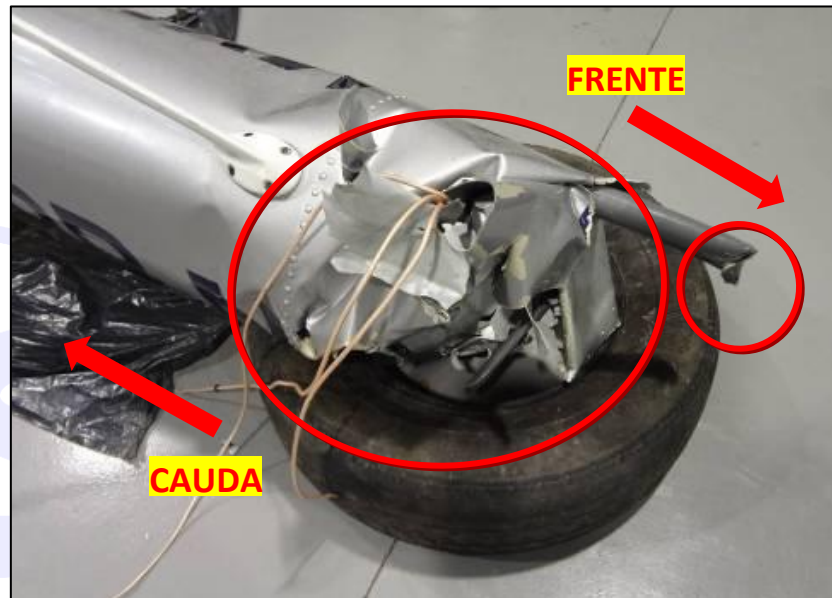
The tail boom had a breakage due to torsion from the left to the right, as seen from above (Figure 16).

Figure 16 – Tail boom with breakage due to torsion from the left to the right, viewed from above.

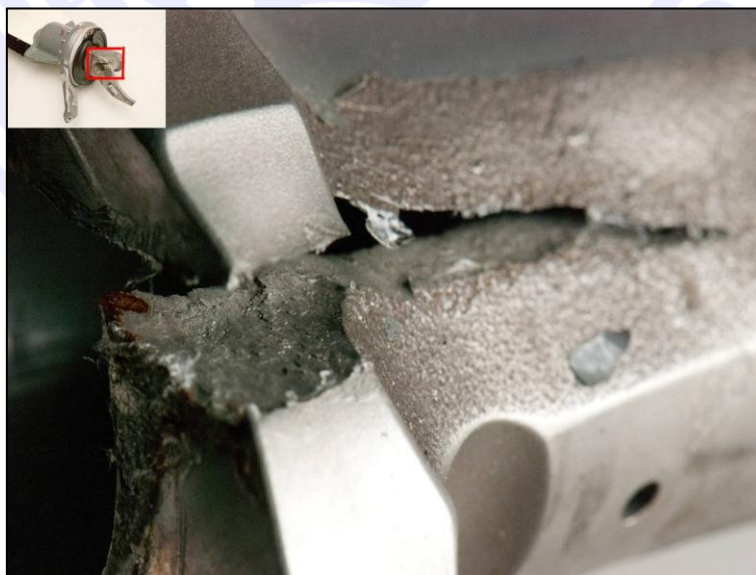
The fracture surfaces of the blade spindles and pitch links had dents and an incline of approximately 45 degrees, indicative of overload (Figures 21 and 22).

Figure 21 – Blade spindle fracture surface.

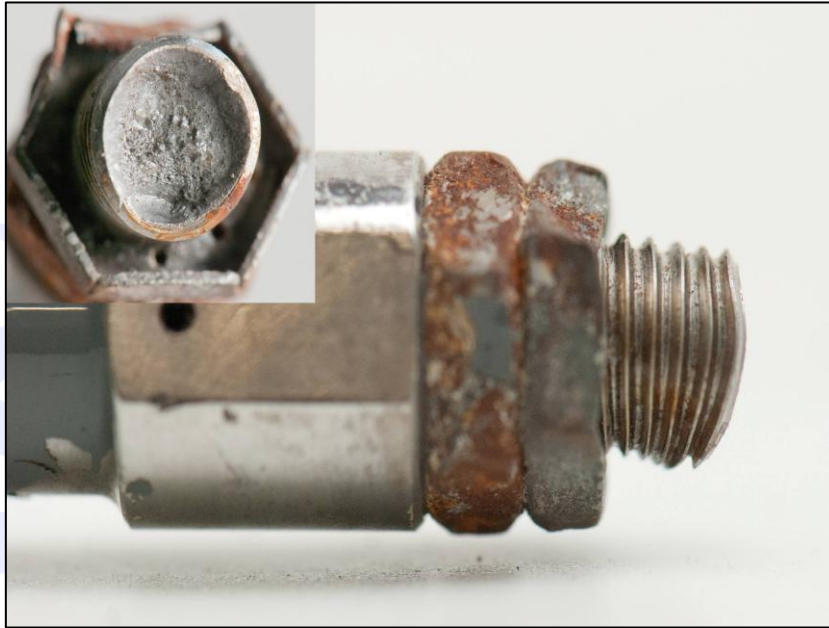
Figure 22 – Bending and deformation with a 45°-incline.

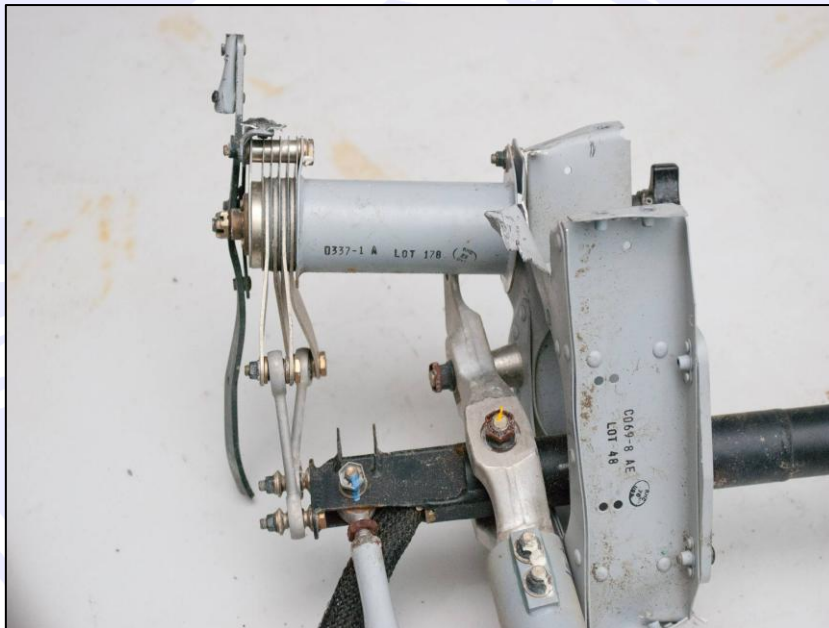
The cyclic control featured aspects, such as dents and deformation, mainly in deflection (Figure 23).

Figure 23 – Bending and deformation in the movable parts of the cyclic control caused by overload.

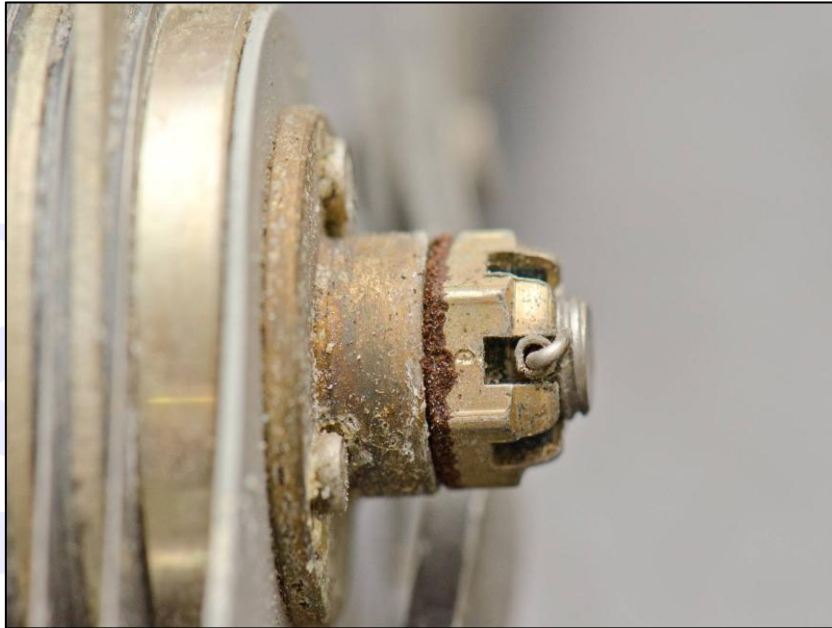
The cyclic friction system was set in the counterclockwise stop position or minimum friction position.

Figure 24 – Cyclic friction adjustment bolt at the counterclockwise stop: no friction applied.

In Figure 24, it is possible to observe that the nut and bolt of the mechanism present signs of corrosion throughout the surface. In this counterclockwise stop condition, there is no separation of the nut-bolt from the mechanism stop. When the knob of the cyclic friction adjustment was turned in a clockwise direction, there was separation between the nut-bolt and the mechanism stop, as shown in Figure 25.

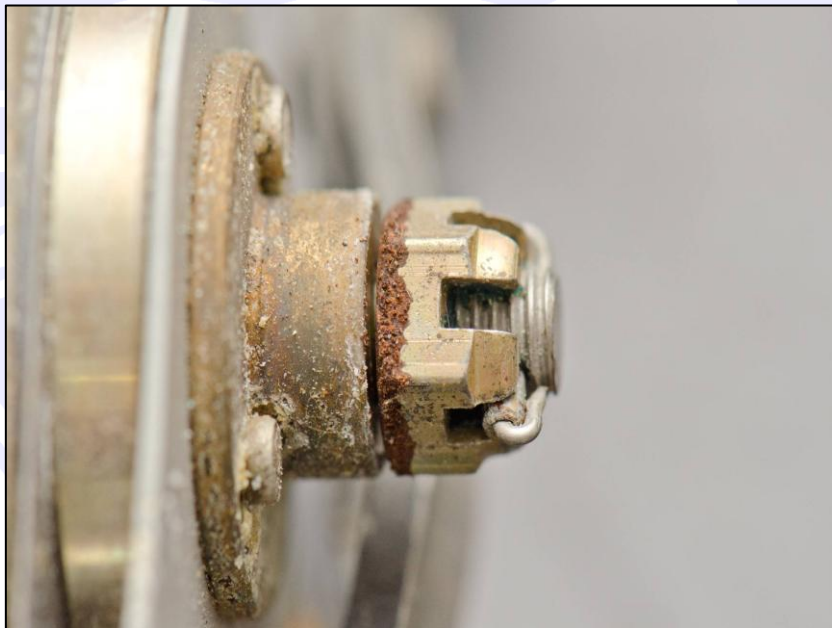
Figure 25 – Separation between the nut and bolt of the friction adjustment mechanism stop.

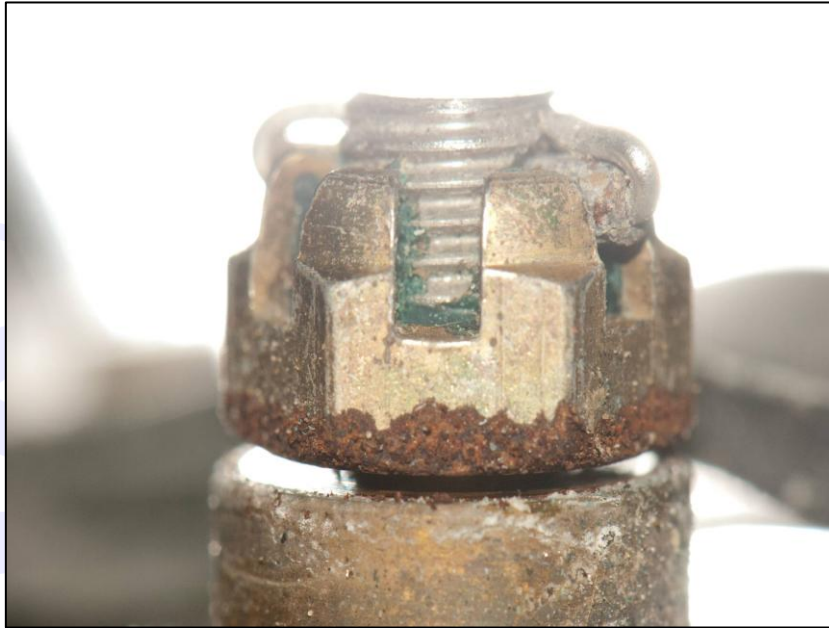
At this time, it was possible to see that there was no corrosion inside the stop of the “nut-bolt” system (Figure 26), indicating that these surfaces were not exposed during the time the aircraft remained submerged in saline water.

Figure 26 – Absence of corrosion inside the “stop” of the nut-bolt system.

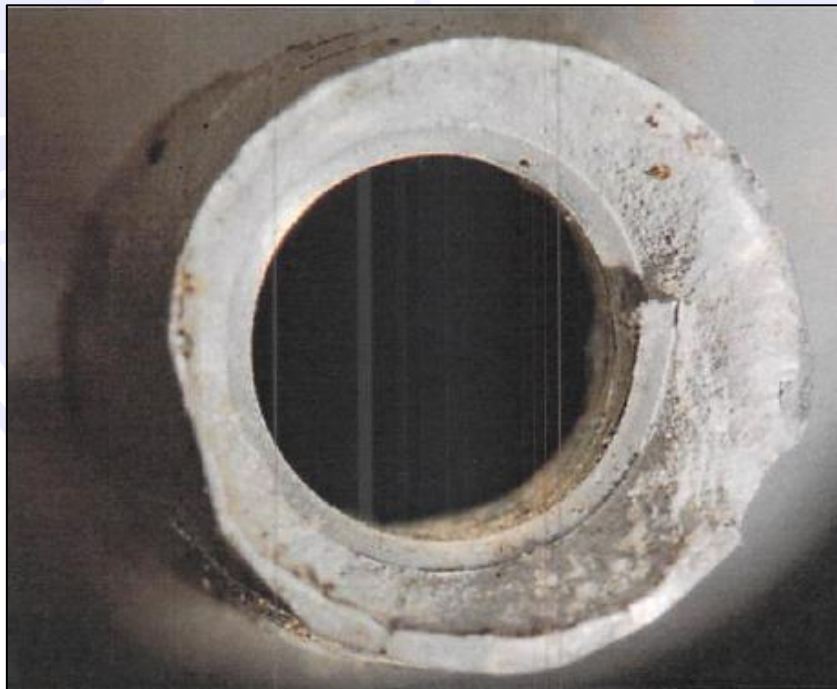
In the analysis of the frame, only signs of fracture due to overload were found. The existing corrosion in the observed parts did not seem to have begun prior to the accident. Aspects, such as the 45°-incline of the fracture surface (Figure 27), and plastic deformations in the flight control tubes (Figure 28), in addition to other aspects such as "fish mouth" in the breakage of the tubes (Figure 29), which are characteristic of failure due to overload, were observed in the fractures of the frame.

Figure 27 – Flight control tube broken as a result of overload, with a 45°-incline on the fracture surface.

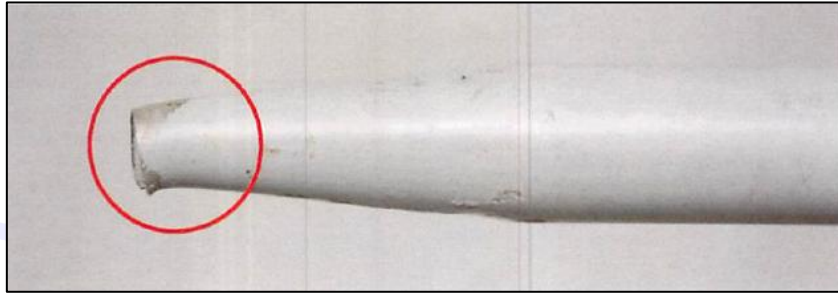
Figure 28 – Flight control tube broken as a result of overload, showing plastic deformation.

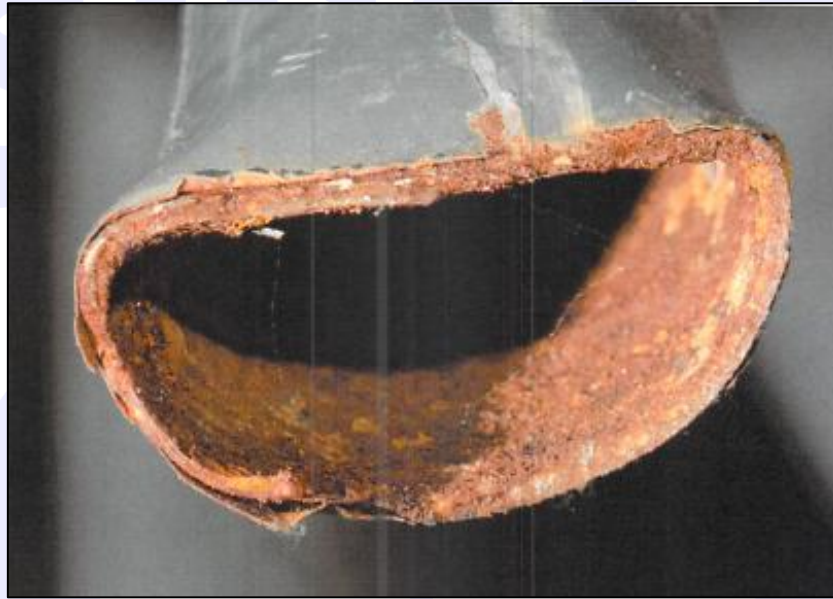
Figure 29 – Frame tube broken as a result of overload, with “fishmouth” type deformation at the point of breakage.

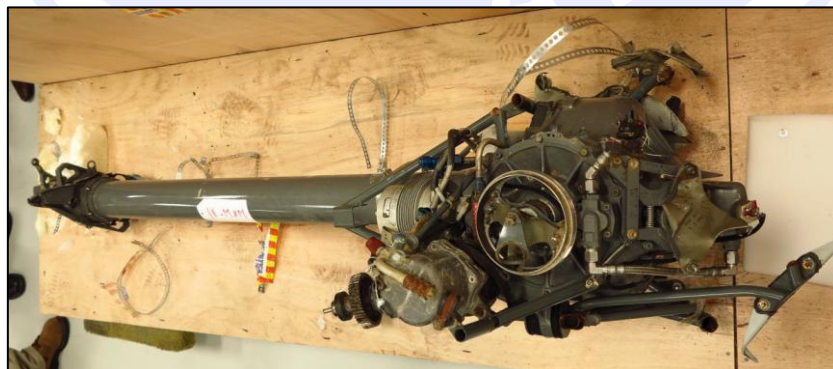
The report of the analysis stated that no evidence was found of material or mechanical failure that could result in abnormal operation of the component.

Figure 30 – Main transmission of the aircraft analyzed at the manufacturer's headquarters.
