**COMANDO DA AERONÁUTICA**  
**CENTRO DE INVESTIGAÇÃO E PREVENÇÃO DE**  
**ACIDENTES AERONÁUTICOS**

**FINAL REPORT**  
**A-523/CENIPA/2015**

<b>OCCURRENCE:</b>	<b>ACCIDENT</b>
<b>AIRCRAFT:</b>	<b>PT-HZE</b>
<b>MODEL:</b>	<b>HB-350E</b>
<b>DATE:</b>	<b>20AUG2012</b>

This is the Final Report of the 20 AUG 2012 accident with the HB-350B aircraft, registration PT-HZE. The accident was classified as “undershoot landing”.

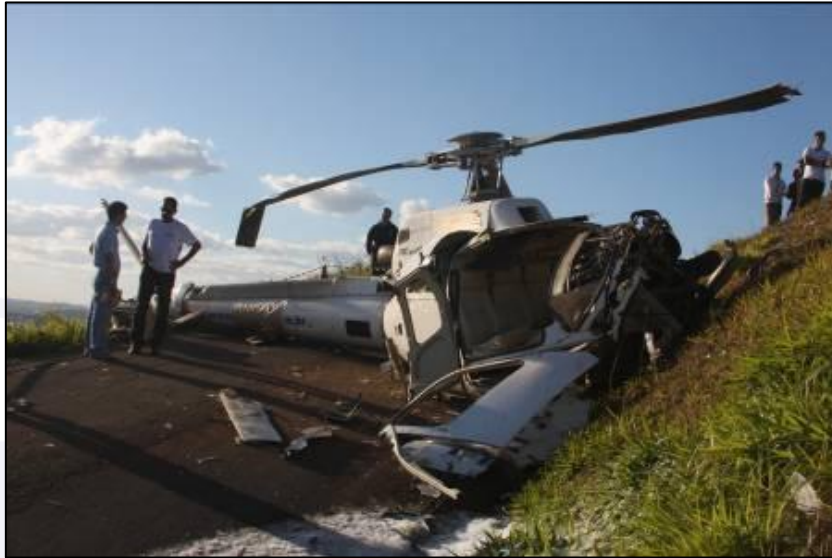
The aircraft collided with a slope adjacent to the threshold 09. The wreckage remained concentrated.

Figure 1 - Aspect of the wreckage.

The aircraft sustained substantial damage as a result of the violence of the impact with the ground and from the collision of the main rotor blades with the slope adjacent to the threshold 09.

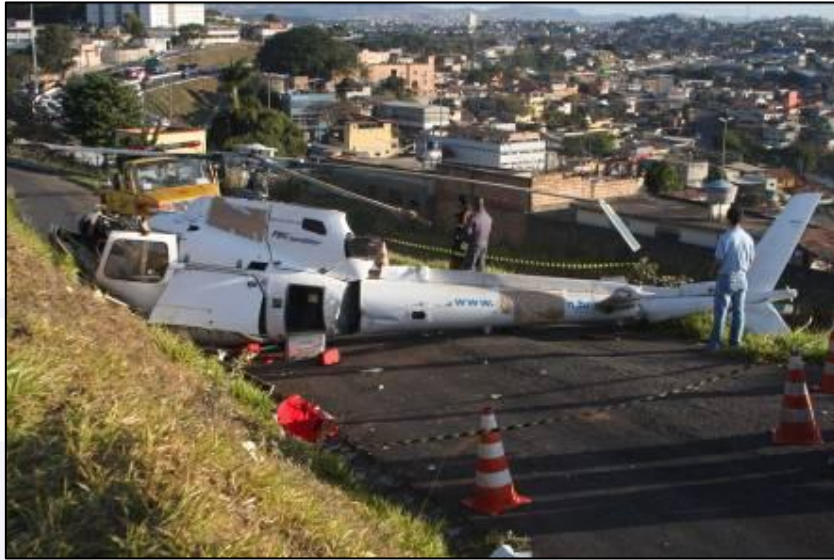
The instructor said that, in order to avoid a frontal collision with the slope, he made a *flare* and changed the approach axis in 90°, making it possible to position the aircraft on the small lane which gave access to the north apron of the aerodrome.

Figure 2 - View of the aircraft on the north apron access lane.

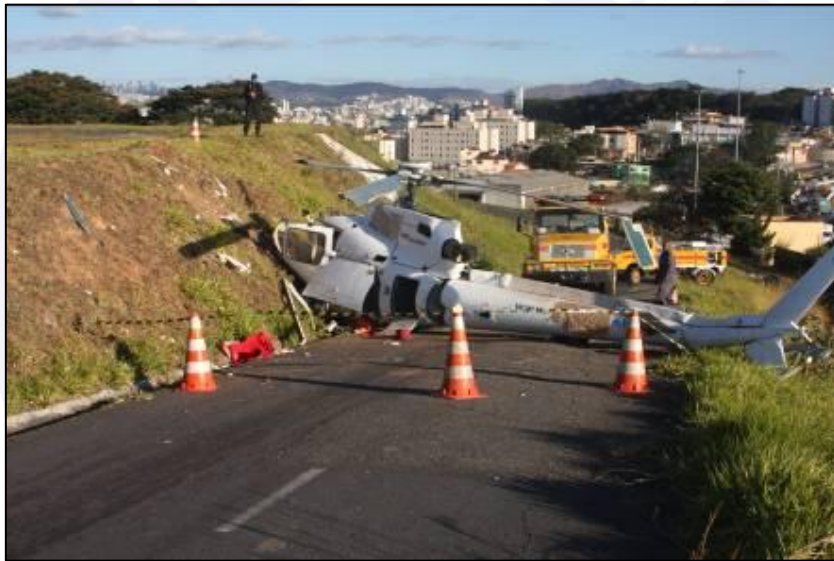
Just short of the threshold 09, there was a slope. Downward wind currents form in that threshold on account of the big and abrupt unevenness, generating eddies in the sector. Upon arriving at that sector, strong winds that pass over the obstacle-free area of the airport are directed downwards.

Figure 3 - Slope adjacent to the threshold 09.

The investigation verified that descending currents of air are commonly observed at the threshold 09. They are formed by the wind, which blows over the obstacle-free area of the airport before encountering the terrain unevenness in that sector, taking some pilots by surprise. Previous knowledge of these recurrent situations, which present a certain level of danger to the air activity, is crucial for the safety operation of flights. In the case in question, it was possible to observe that there was poor perception on the part of the pilots as to the risks involved with the continuation of the flight under those conditions, together with inadequate flight planning.

Take the necessary measures before the *EFAI Escola de Pilotagem LTDA.*, in order to make sure that it includes, as a critical criterion of its training program, the analysis of the prevailing wind conditions, mainly in relation to the possibility of occurrence of downdraft and windshear in the training area.

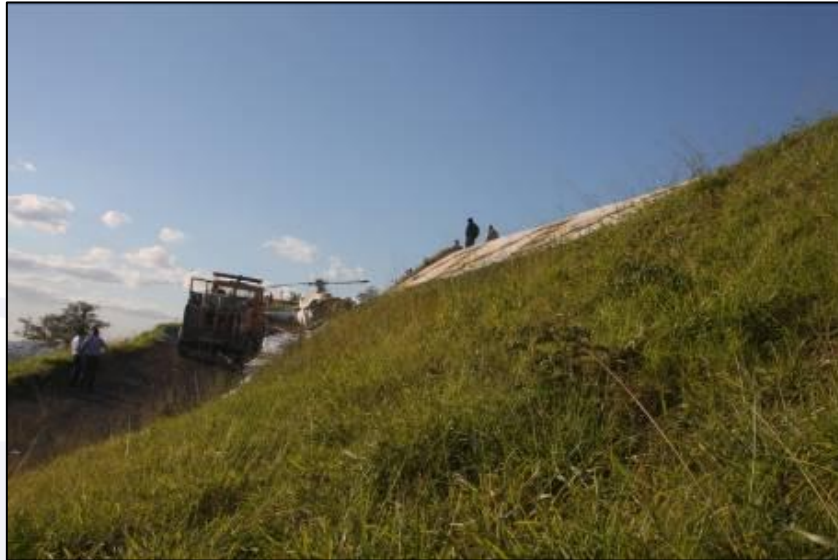
The instructor also said that he was taken by surprise by the descending current of air, which threw the aircraft against the ground.

Figure 4 - Pronounced slope short of threshold 09.

In the instructor's view, the aircraft entered this descending current, which rendered the flight impossible to be recovered, and forced the aircraft downward against the ground.
