**FINAL REPORT**  
**A - 526/CENIPA/2015**

<b>OCCURRENCE:</b>	<b>ACCIDENT</b>
<b>AIRCRAFT:</b>	<b>PT-MFW</b>
<b>MODEL:</b>	<b>PA-31T2</b>
<b>DATE:</b>	<b>06 NOV 2012</b>

This is the final report of the 6 November 2012 aeronautical accident with the PA-31T2 aircraft, registration PT-MFW. The occurrence was classified as fuel starvation/exhaustion.

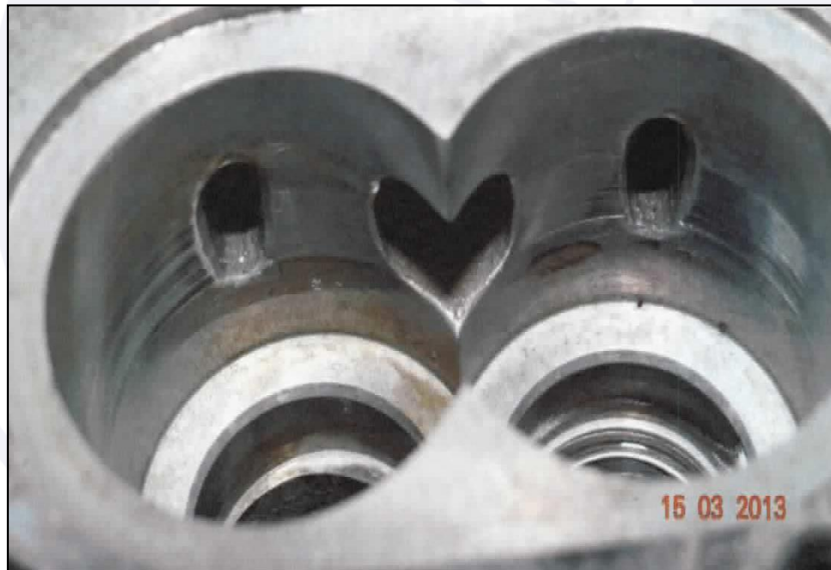
The main fuel pump of the engine had marks in the housing of gears and in the interior of the frame, an indication of lack of fuel, due to the fact that the gears sustain a quick temperature increase (approximately four seconds) in the absence of fuel, which cools them.

Overheating makes the gears expand and rub the pump frame, leaving the marks verified in the Figures 1 and 2. Another characteristic indication of lack of fuel was found in the teeth of the pump gears (Figures 3 through 5). They indicate the occurrence of cavitation in the fuel pump.

Figure 1 – View of the fuel pump frame, showing marks of rubbing in the housing of gears.

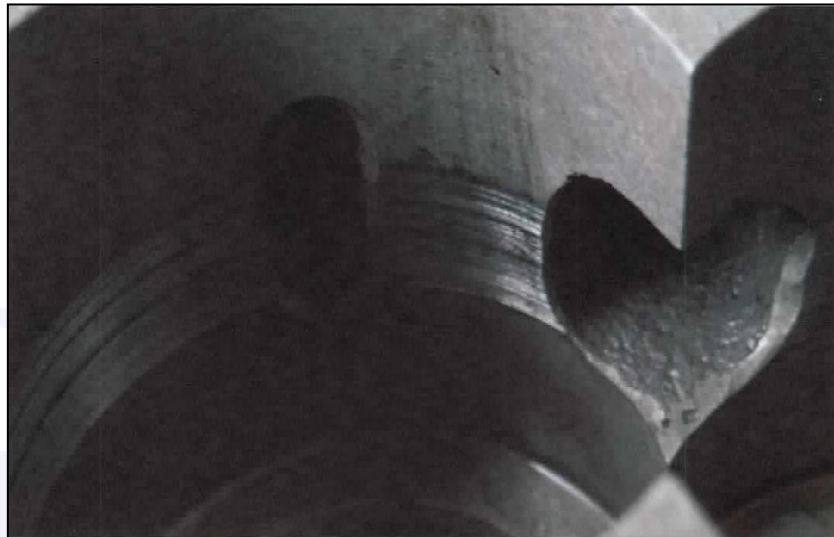
Figure 2 – Closer view of the fuel pump, with marks of rubbing in the housing of gears.

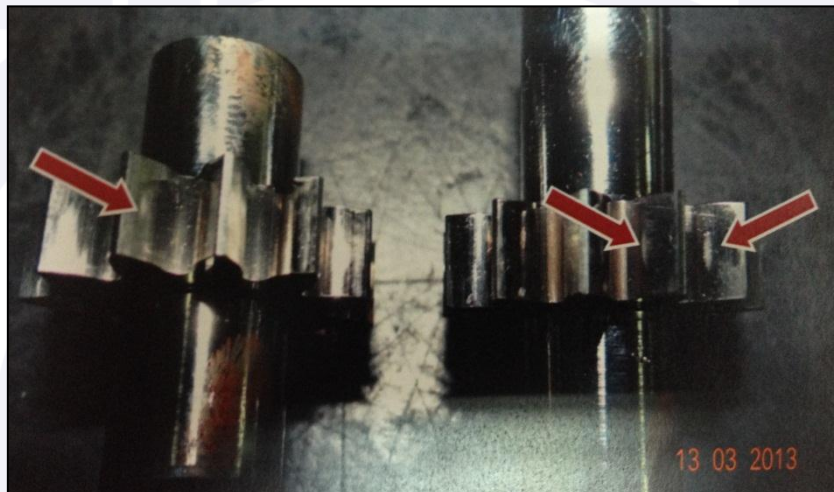
Figure 3 – General view of the fuel pump gears with signs of cavitation.

Likewise, the exam of the engines showed that they were operating but not developing power. The main evidence was the phenomenon of cavitation observed in the fuel pumps of both engines. This phenomenon occurs when there is lack of fuel, resulting in an abrupt pressure increase and quick elevation of temperature in the pump. Besides, it is worth stressing that, with the lack of fuel, the gears expanded for not being cooled, and rubbed the pump frame.

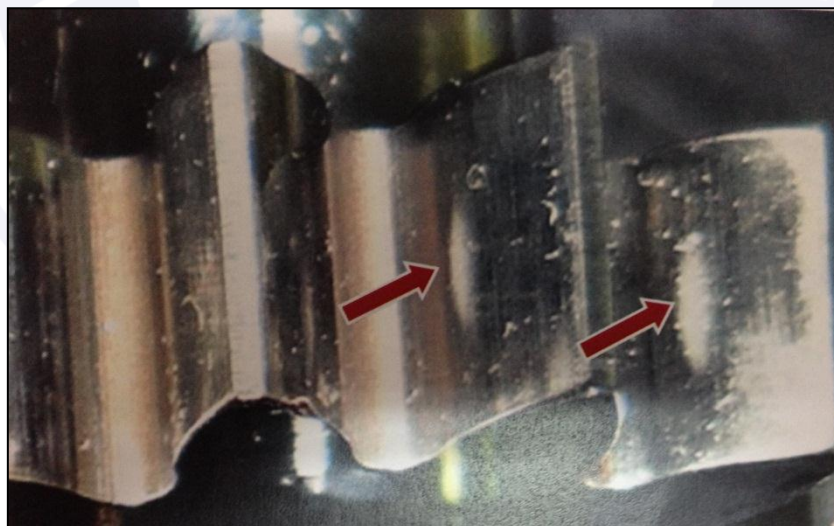
Figure 4 – View of the gear with signs of cavitation.

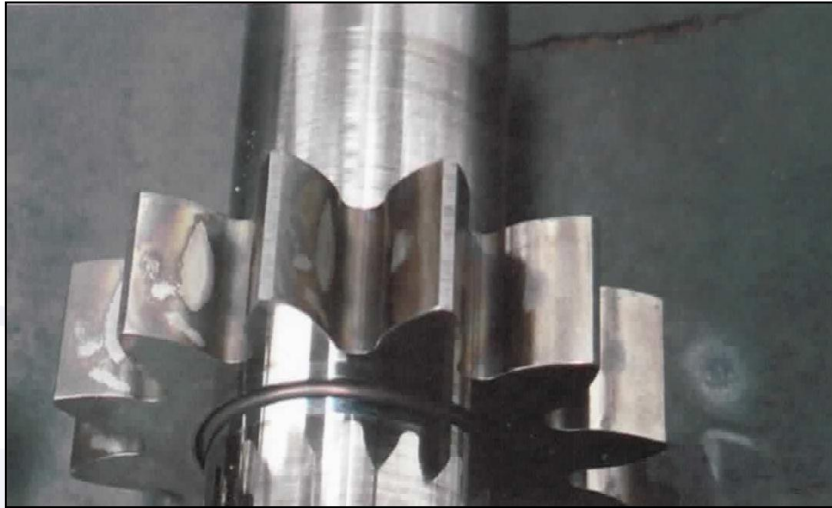
Figure 5 – Evidence of cavitation in the pump-gear teeth.

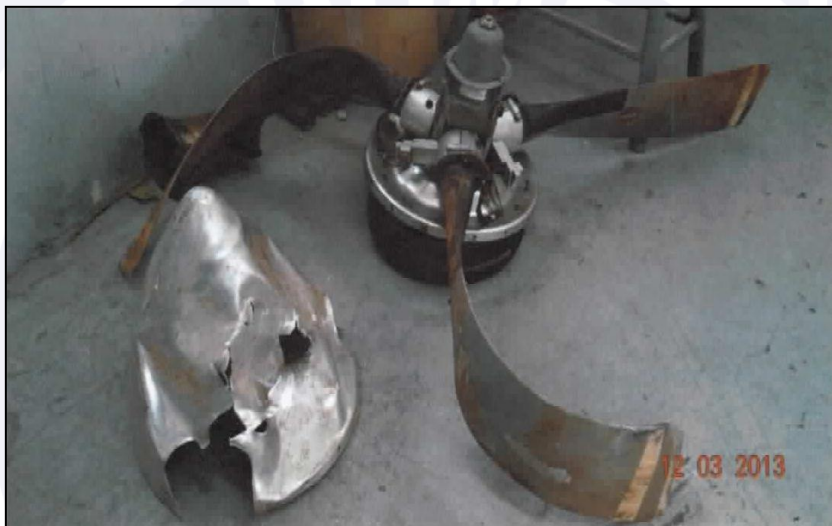
The propellers also showed evidence that the engines were not developing power. In figures 6 and 7, it is possible to observe that the blades had folded a characteristic of lack of power at the moment of the collision with the ground.

Figure 6 – Left-Engine propeller.

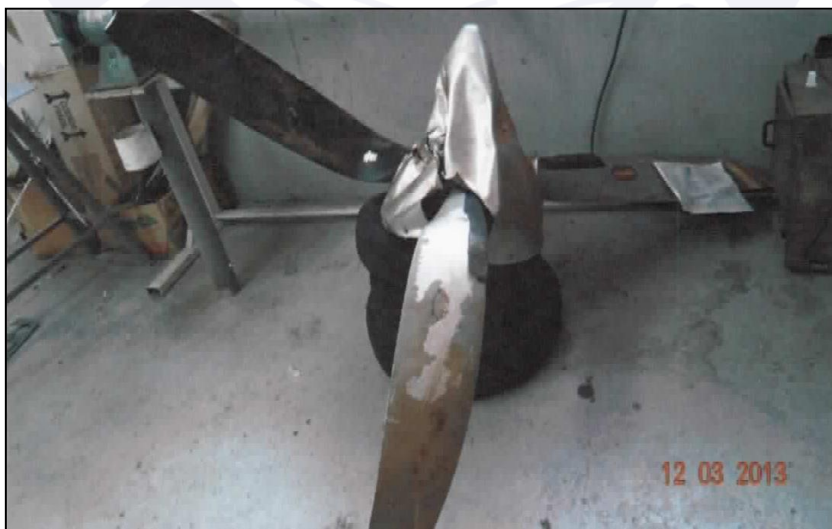
Figure 7 – Right-Engine propeller.

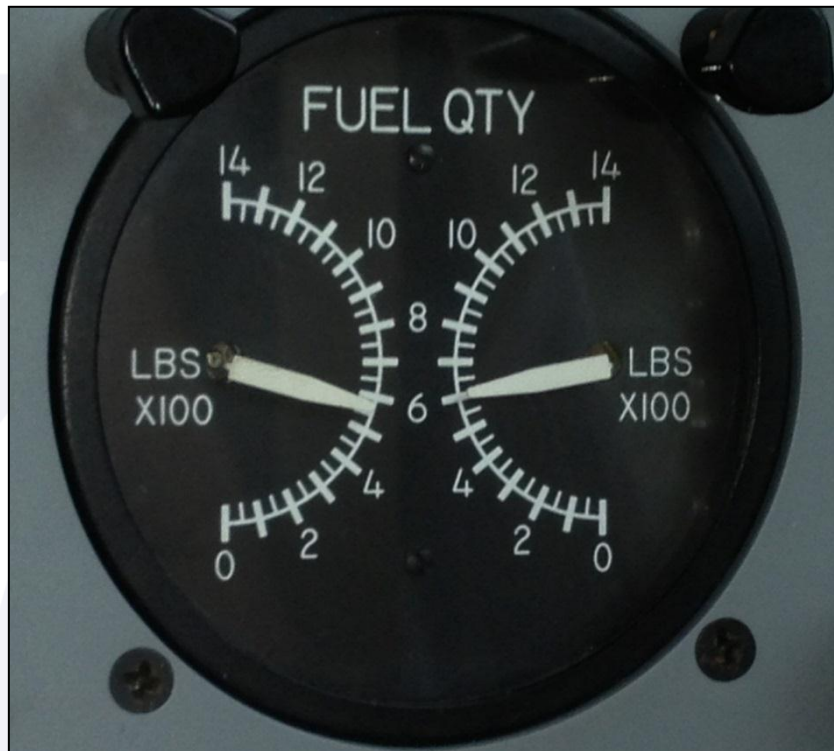
Initially, the aircraft had approximately 1,200 lb. of fuel in the tanks, according to the fuel quantity indicators (Figure 8), that is, 600 lb. in each wing tank. In the sequence, the aircraft was refueled with 481 liters (858 lb.) of aviation kerosene (Jet A-1) (Figure 9). Therefore, the fuel gauges had to show an additional 429 liters of fuel in each wing tank, i.e., each tank had to show 1,029 lb., with a total of 2,058 lb. in the aircraft.

Figure 8 – Initial indication of the fuel gauge (1,200 lb.).

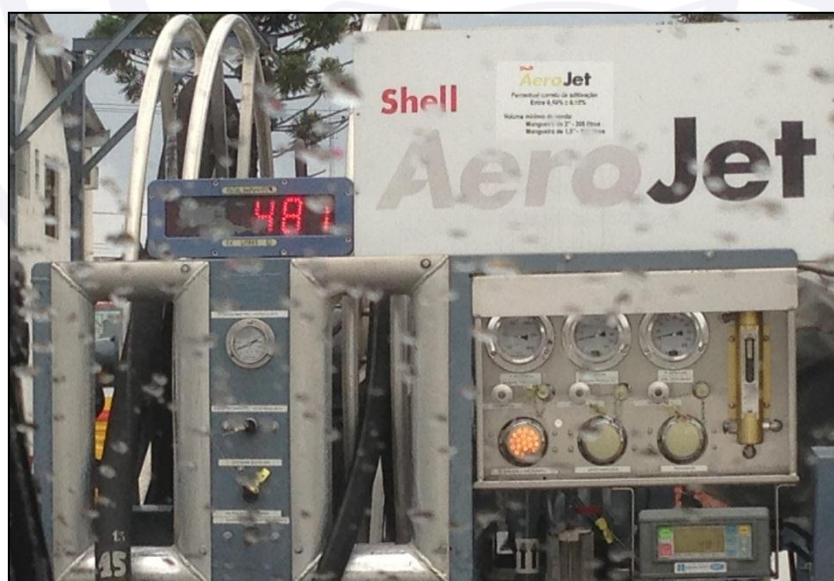
Figure 9 – Provision of 481 liters (858 lb.) of Jet A-1.

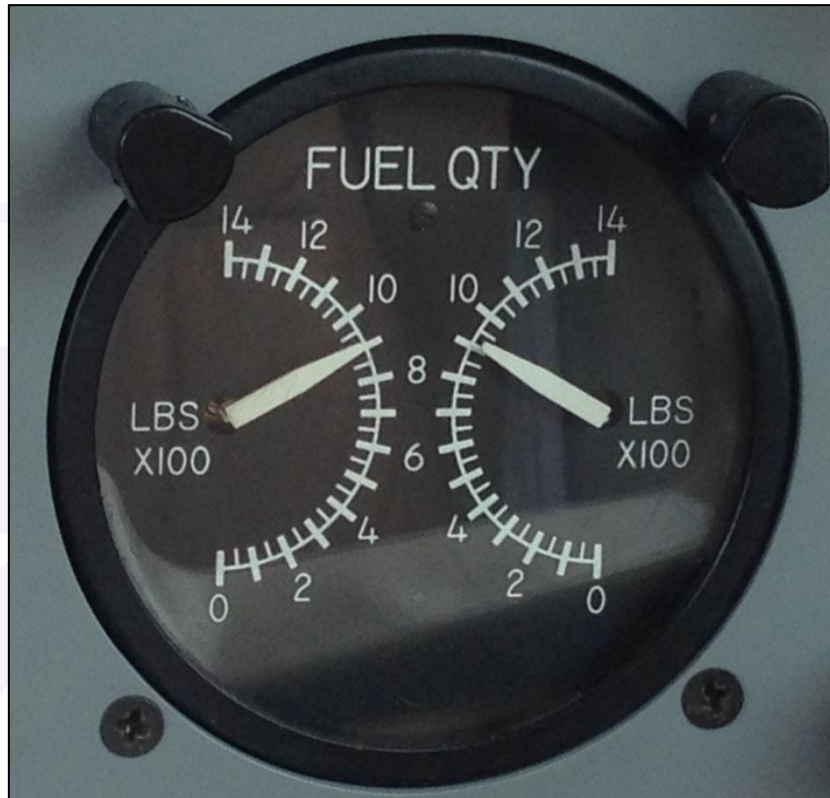
However, what the fuel quantity indicator really showed was 900 lb. of fuel in each wing tank, that is, a total of 1,800 lb. with a difference of 258 liters of fuel, considering that

the fuel quantity indicators in this type of aircraft did not have an acceptable level of dependability.

Figure 10 – Final indication in the fuel gauge (1,800lb).
