**COMANDO DA AERONÁUTICA**  
**CENTRO DE INVESTIGAÇÃO E PREVENÇÃO DE**  
**ACIDENTES AERONÁUTICOS**

**FINAL REPORT**  
**A-531/CENIPA/2015**

<b>OCCURRENCE:</b>	<b>ACCIDENT</b>
<b>AIRCRAFT:</b>	<b>PT-YAK</b>
<b>MODEL:</b>	<b>AS-350-BA</b>
<b>DATE:</b>	<b>22FEB2012</b>

This is the final report of the 22 February 2012 accident with the AS-350-BA aircraft, registration PT-YAK. The accident was classified as system/component failure.

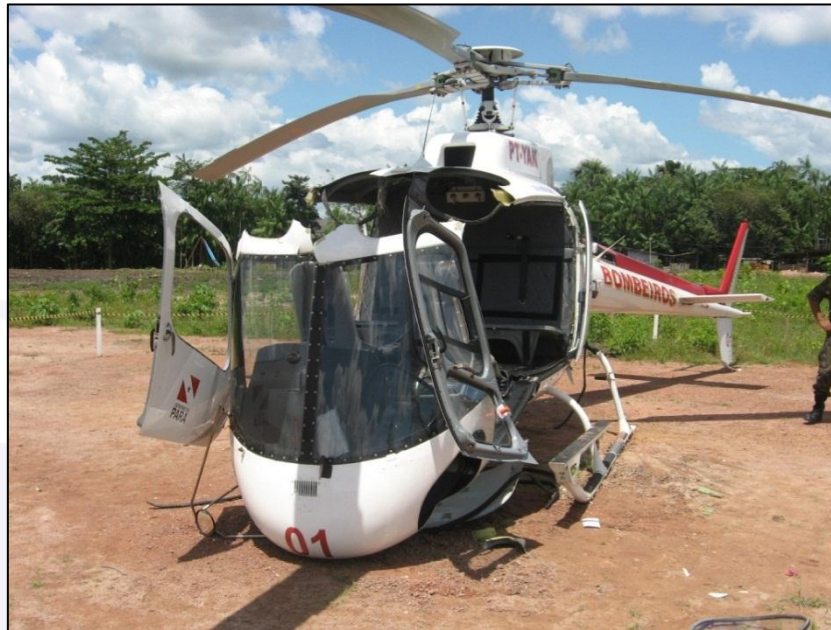
There was substantial damage to the aircraft cabin, tail boom, tail rotor activation tree and starflex.

Figure 1 – aircraft after the complete stop.

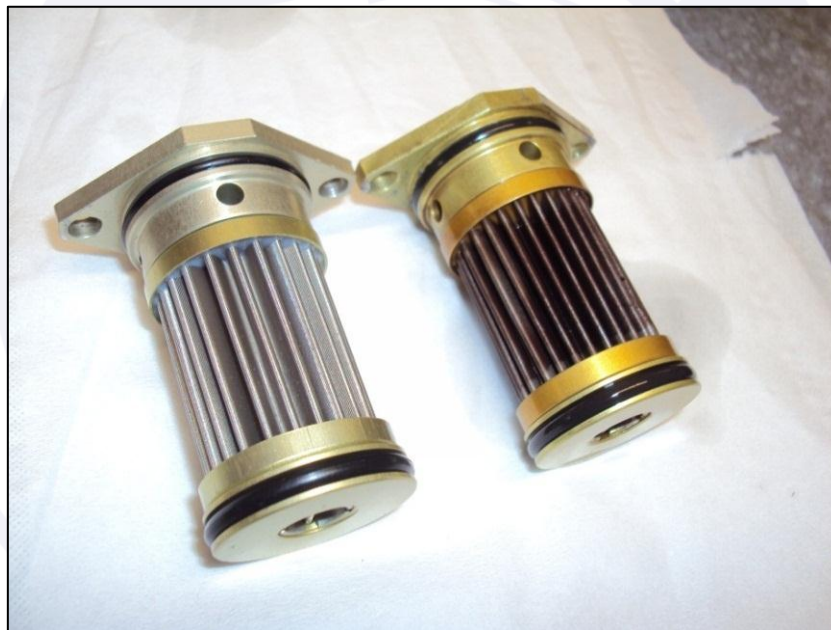
Figure 2 – on the right, a filter removed from the aircraft FCU, compared with a brand new one (on the left).

In France, the bench test was done in the presence of SERIPA I and IAE/DCTA representatives. A third filter was installed (a new one) in the fuel line returning from the FCU. Eventually, it retained just a few particles of dirt in its screen.

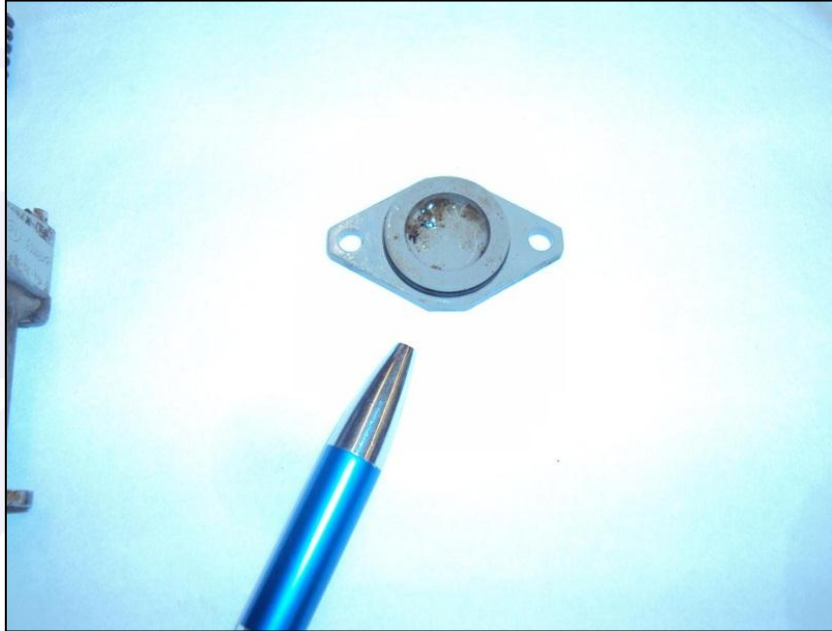
Then, the lid of the *anticipator came* was removed, showing a large amount of oxidation, both in the lid and in the very *came* (Figures 3 and 4).

Figure 3 – View of the anticipator came with oxidation.

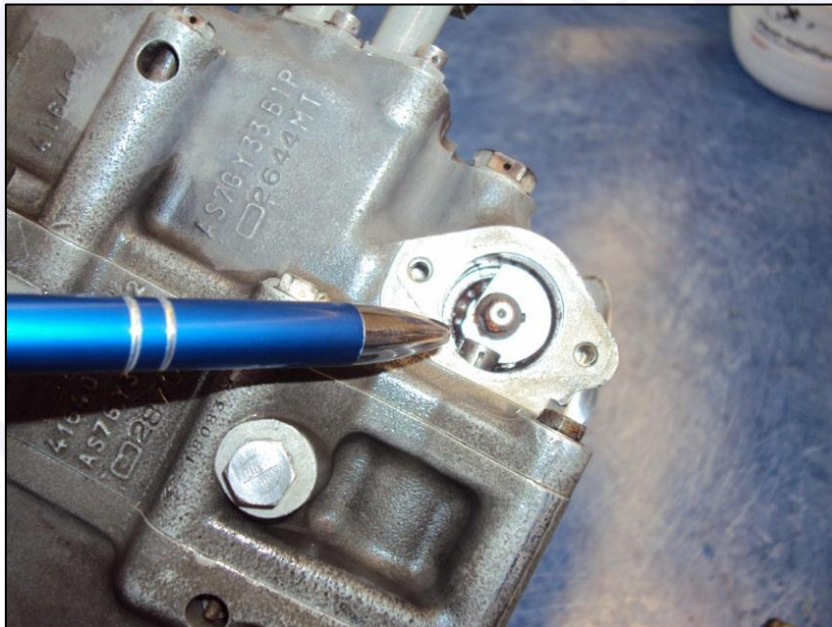
Figure 4 – View of the oxidation in the lid of the anticipator came before disassembly.

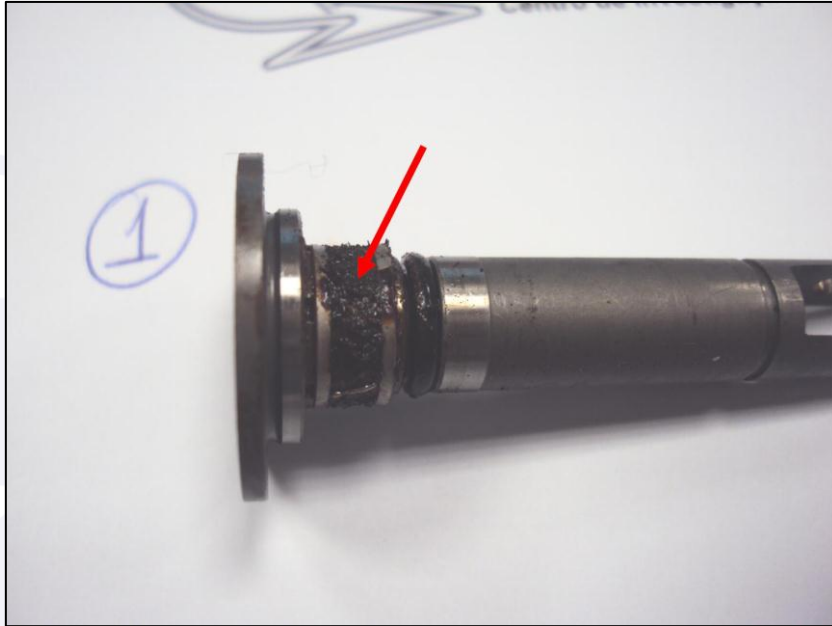
When the NG (compressor turbine rotation) piston was removed, the technicians observed that it was stuck on account of the presence of oxidation in the fuel strainer (Figure 5).

Figure 5 – View of the NG piston with lots of contamination in the fuel filter.

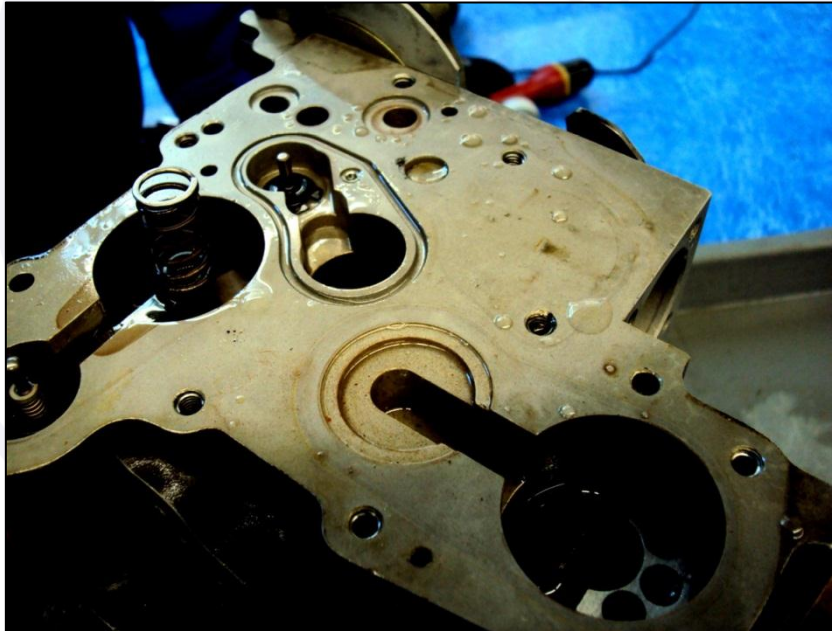
During the disassembly of the FCU, water was found in its interior, as shown in Figure 6.

The result of the analysis indicated that the fuel contamination was not microbiological. It had been caused by oxidation resulting from the presence of water.

Figure 6 – Finding of water in the FCU interior during the disassembly.

The test of the fuel taken from the filters of the FCU revealed that the contamination did not have a microbiological origin, but had been caused by particles, in this case, oxidation caused by the presence of water. Therefore, the oxidation found was originated by the presence of water in various sections of the FCU.
