COMANDO DA AERONÁUTICA
CENTRO DE INVESTIGAÇÃO E PREVENÇÃO DE
ACIDENTES AERONÁUTICOS

FINAL REPORT
A-543/CENIPA/2015

OCCURRENCE:	ACCIDENT
AIRCRAFT:	PR-JGM
MODEL:	AS350B2
DATE:	15JULY2011

This is the Final Report of the accident involving the AS350B2 aircraft, registration PR-JGM, on 15 July 2011. The accident was classified as controlled flight into terrain – CFIT.

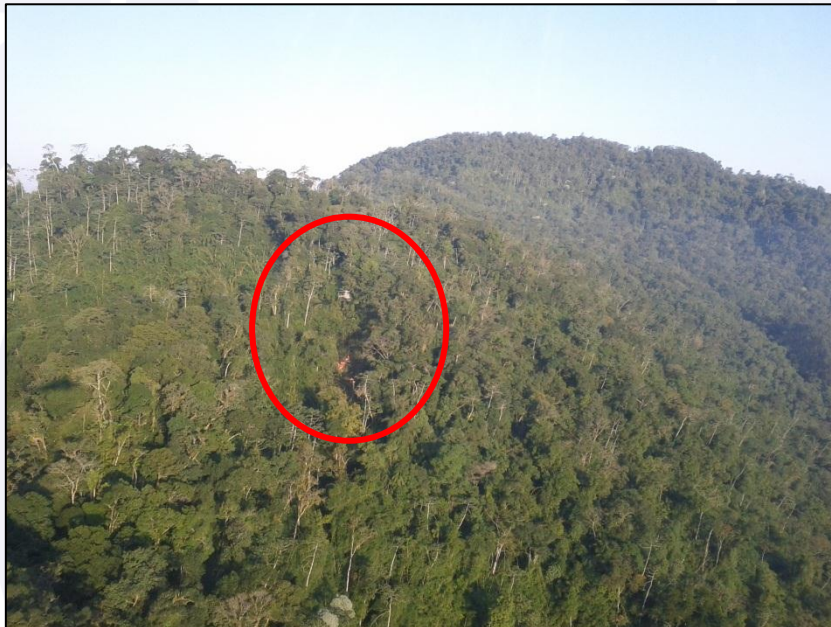
Figure 2- Location where the helicopter crashed

The first impact with the trees on the hill occurred at an angle of approximately 45° at an elevation of 1,700 ft.

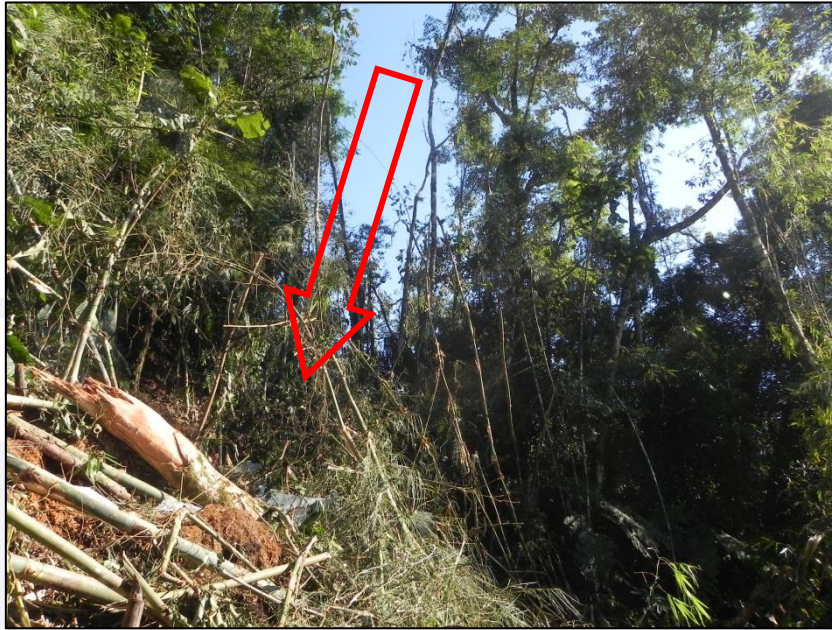
After the impact with the trees, the helicopter turned 120° to the left in relation to its longitudinal axis.

Figure 3 – View of the trajectory and impact of the helicopter with the ground.

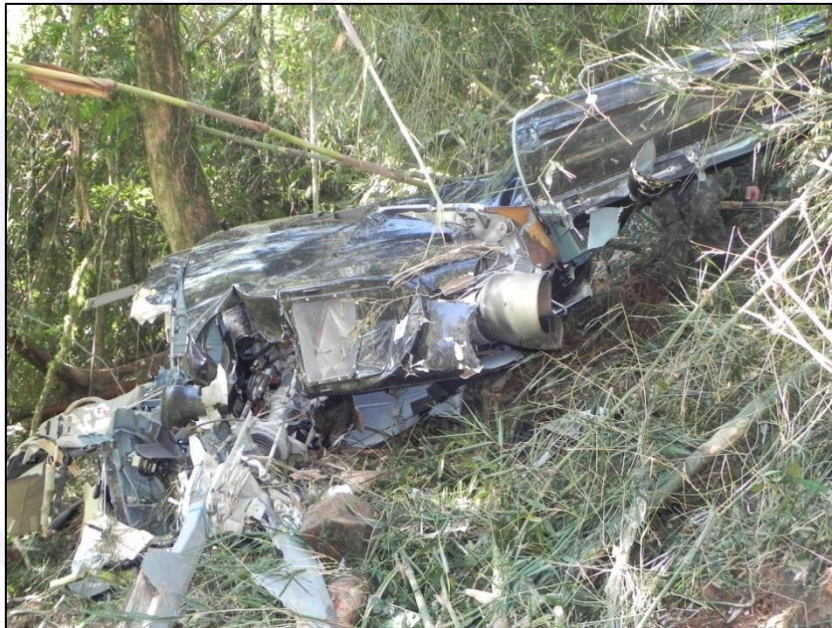
After the impact with the ground, the helicopter continued moving 15 more meters before stopping. Most of the wreckage remained concentrated, except for the fuel tank, which was found near the point of impact with the ground.

Figure 4 – Location where the helicopter stopped.

Based on the physical evidence and on the marks of impact of the helicopter rotor with the trees and with the ground, it is possible to affirm that the helicopter engine was developing power at the moment of the accident.

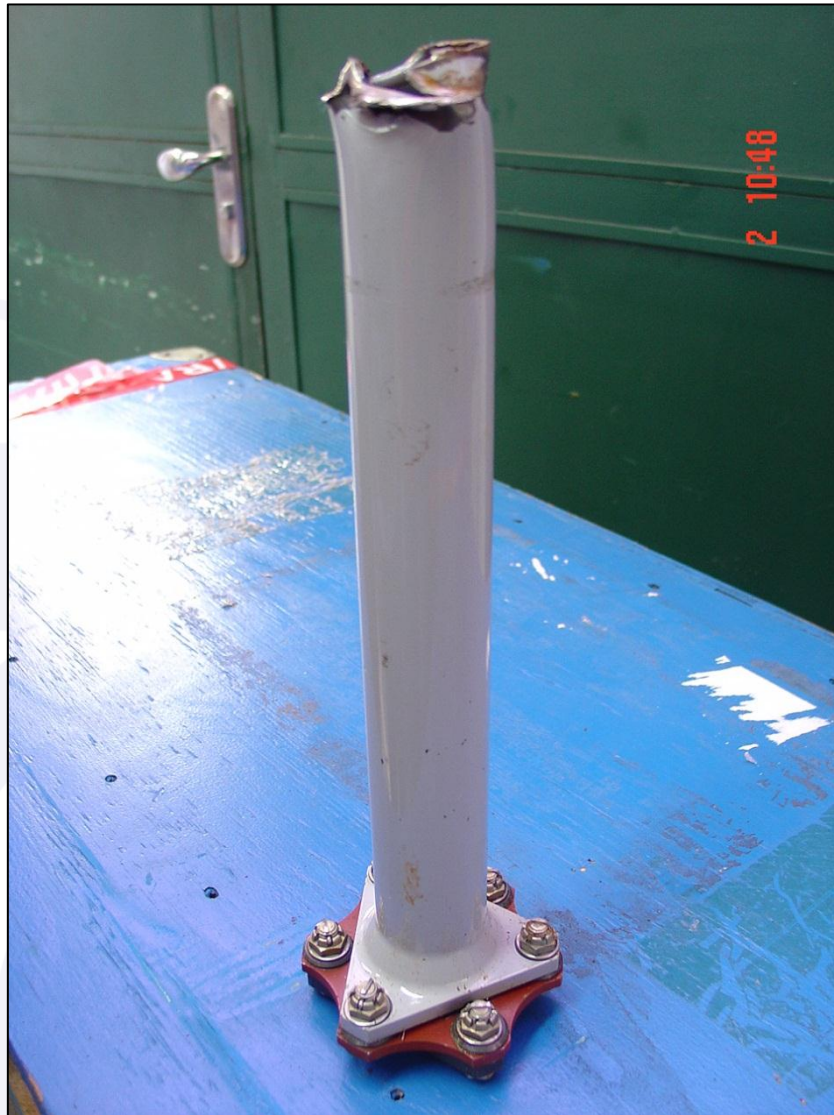
The aircraft components analyzed presented twists and ruptures characteristic of impact with power.

Figure 5 – Connecting shaft between the engine and the main box showed rupture close to the point of attachment to the main box.

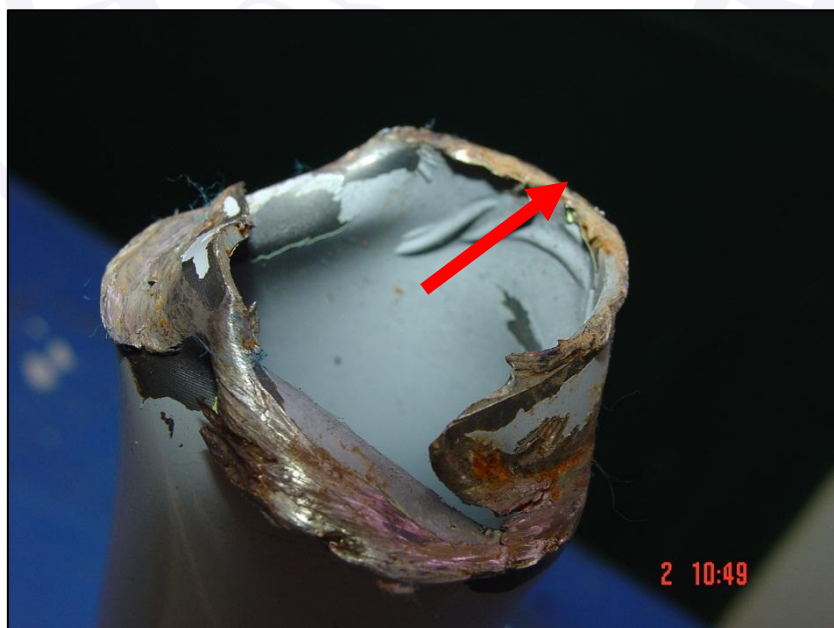
Figure 6 – Point of rupture in the shaft. In the inner part, there are signs of wrinkling at an angle of 45° , and signs of rupture due to torque effort coming from the engine.

According to this report, there was evidence that the engine was operating and developing power at the moment of collision of the aircraft with the trees.

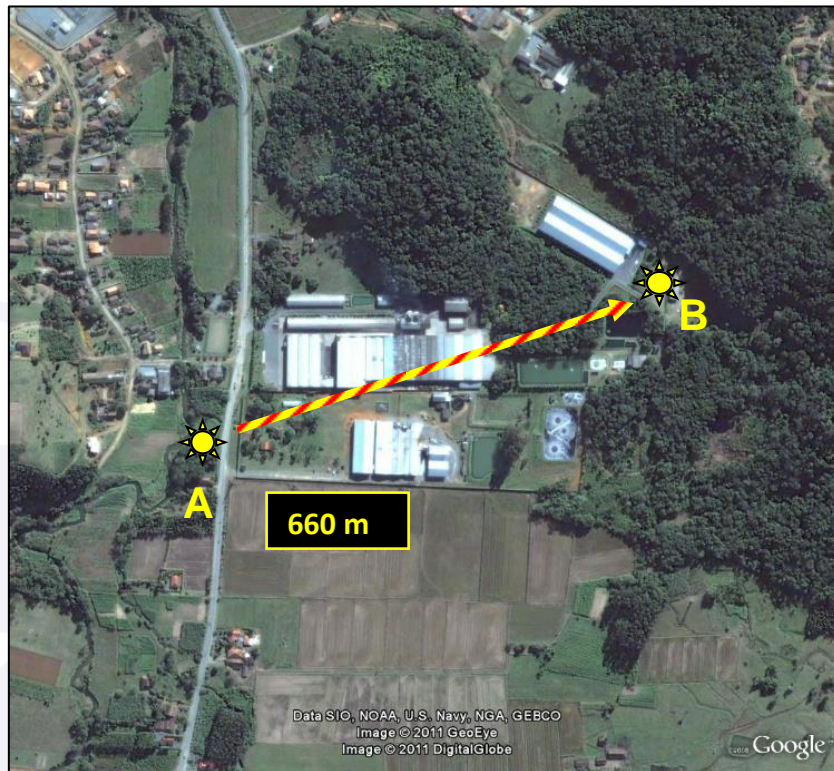
The investigation commission verified the existence of discrepancies between the coordinates of the place from which the helicopter took off and the coordinates of the helipad that was being built in the company headquarters by the aircraft owner/operator and that were informed to the inspecting agencies (CINDACTA II and ANAC).

The two places are separated by a distance of 660 meters, as can be seen in Figure 7.

The commission verified that the physical characteristics of the location were in discordance with the pertinent legislation governing this type of operation (Brazilian Aeronautical Homologation Regulation 91 – RBHA 91 – item 91.327).

Figure 7 – Discrepancies in the location of the *Nanete* company helipad (A - registered / B - real).

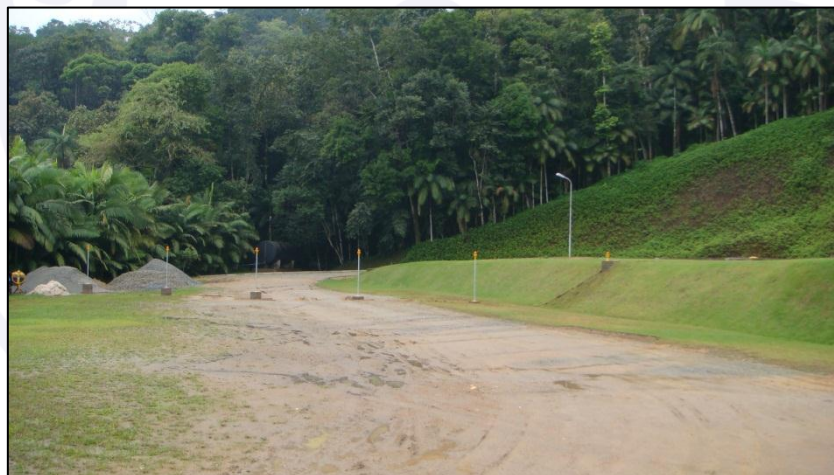
In the location where the takeoff took place and that was being utilized by the operator since 28 January 2011 (point B of Figure 7), the commission observed the presence of obstacles which could violate the Basic Plan of the Helipad Protection Zone, as well as the ground infrastructure (signage, accessibility, pavement) among other physical characteristics.

Figure 8 – Obstacles in the location utilized for the takeoff.

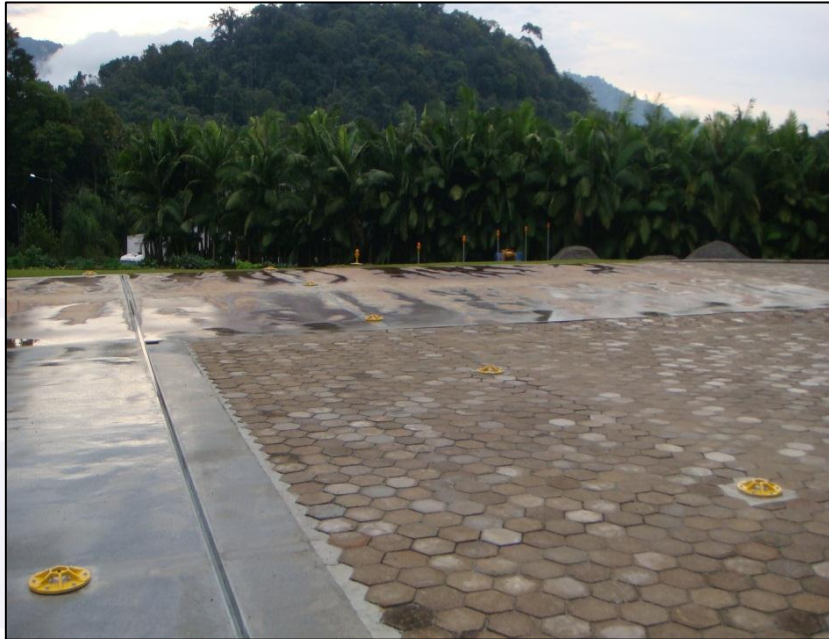
Figure 9 – Obstacles in the helipad of the *Nanete* company.

According to all indications, this location was being utilized by the operator without being registered before the inspecting agency. Since the operator did not forward the term of notification reporting the completion of the construction work to the inspecting agency, it is possible that such work had not been finished yet.
