COMANDO DA AERONÁUTICA
CENTRO DE INVESTIGAÇÃO E PREVENÇÃO DE
ACIDENTES AERONÁUTICOS

FINAL REPORT
A-546/CENIPA/2015

OCCURRENCE:	ACCIDENT
AIRCRAFT:	PR-SEK
MODEL:	AW139
DATE:	19AUG2011

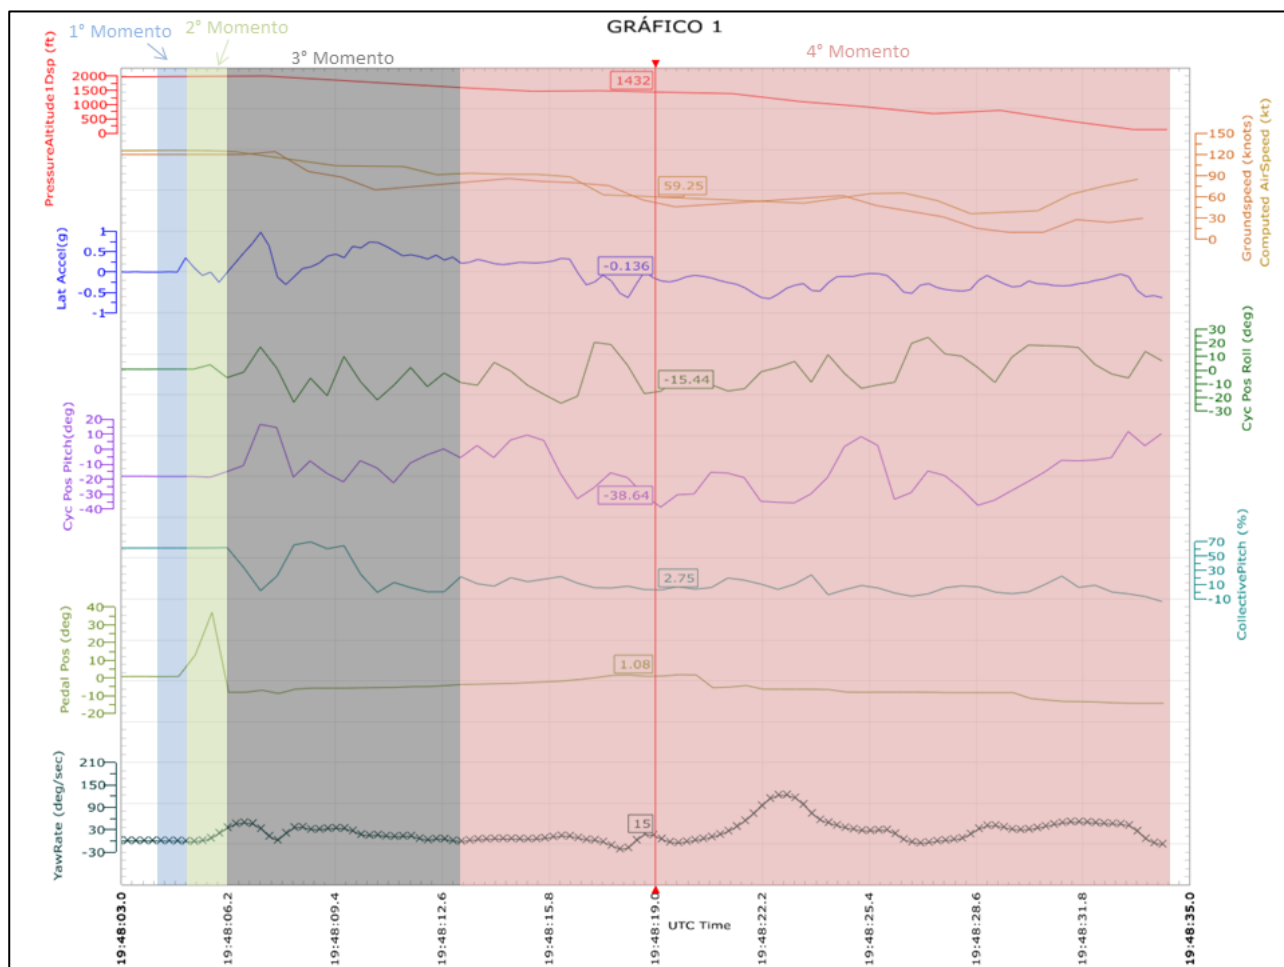
Time/Duration	Sequence of events	Recorded evidence (CVFDR)
From 19:48:12.8 to 19:48:33.8	Loss of hydraulic system number 2.	PUMP2 and PUMP4: Output pressure in the hydraulic pumps below 163 bar.
	Cyclic control inputs incongruent with aircraft movements.	Recording of cyclic movements varying with high amplitude in random directions.
	Collective control inputs incongruent with aircraft movements.	Recording of low amplitude/high frequency collective movements.
	Total loss of aircraft control.	Recording of extensive aircraft attitude variations.
	Copilot informs APP-Macaé about loss of hydraulic systems.	Recording of copilot's voice while informing type of emergency.

Figure 1 - Flight parameters and position of controls as recorded in the CVFDR.

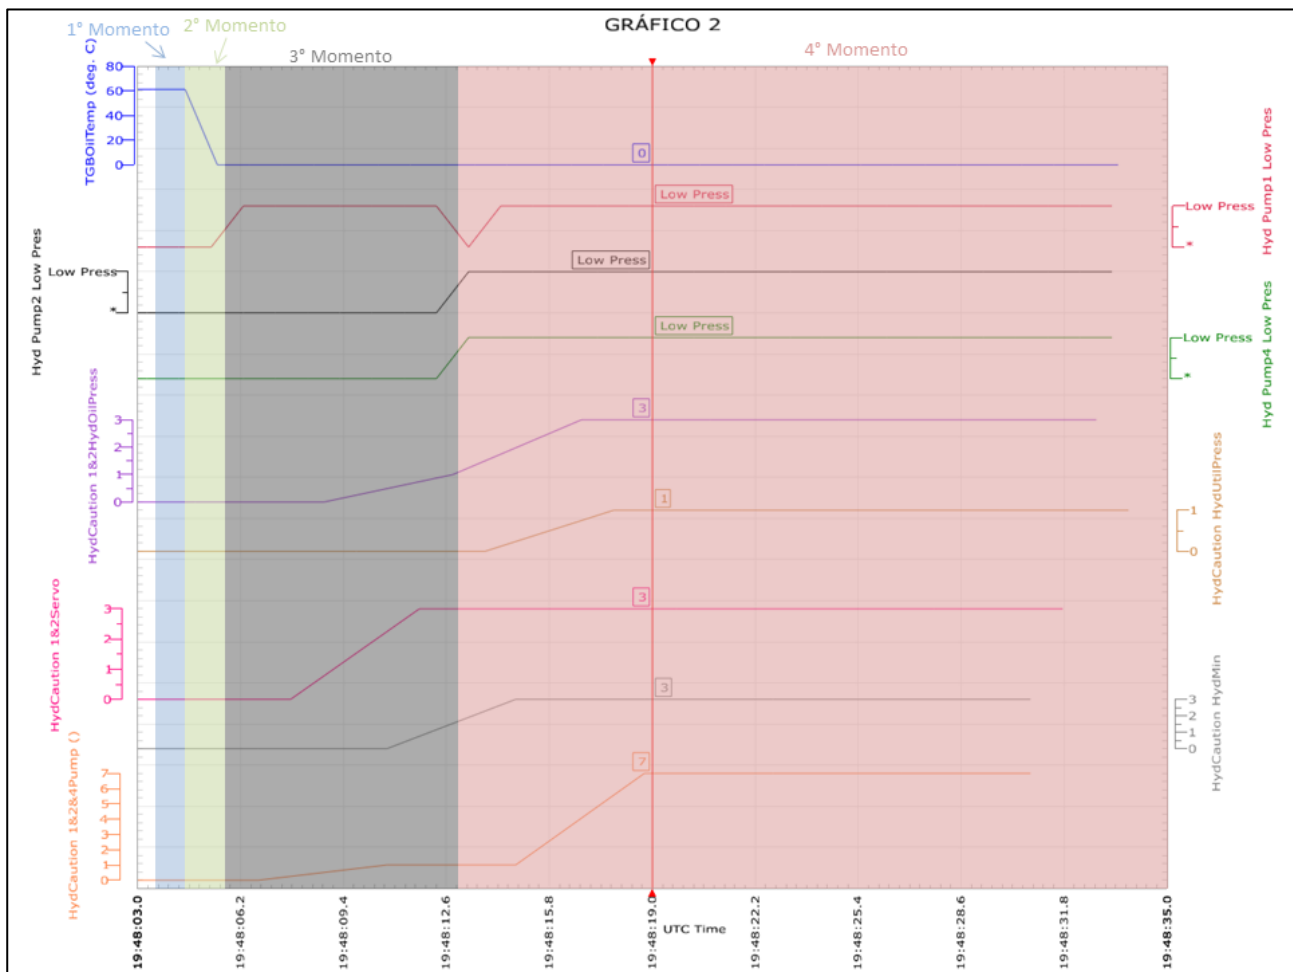
Figure 2 - Hydraulic parameters recorded in the CVFDR.

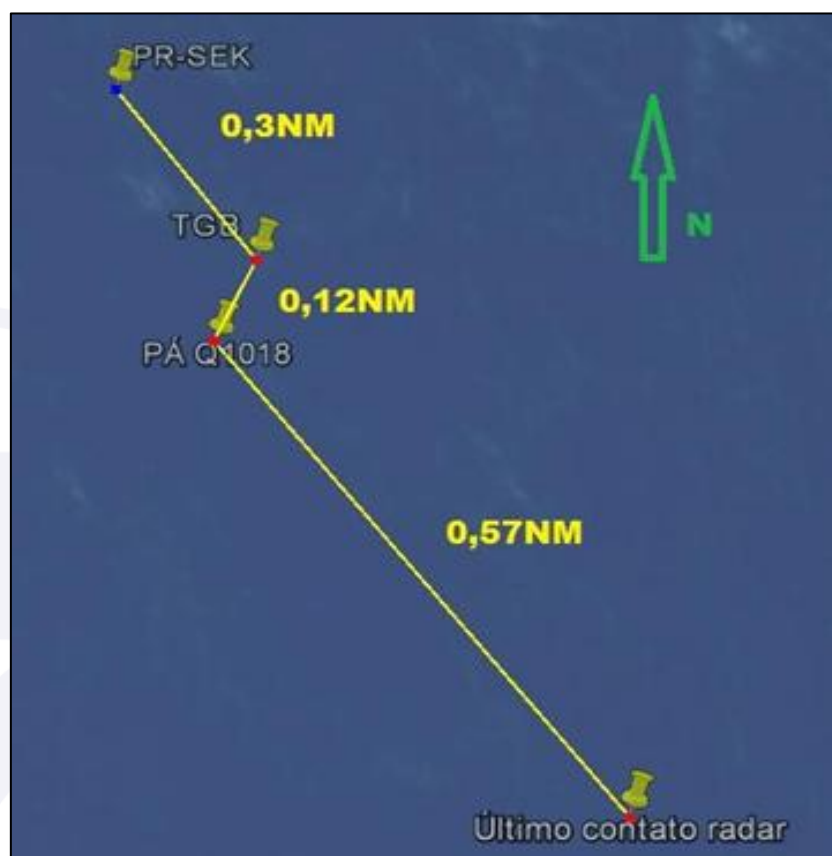
The wreckage distribution was linear, as can be seen in Figure 3. One of the tail rotor blades and the remainder of the tail rotor assembly detached from the aircraft at two distinct moments before the impact, and were found separated from the fuselage and main rotor.

Figure 3 - Last radar contact of the aircraft in relation to the positions where the Q1018 blade, tail rotor assembly, and aircraft wreckage were located.

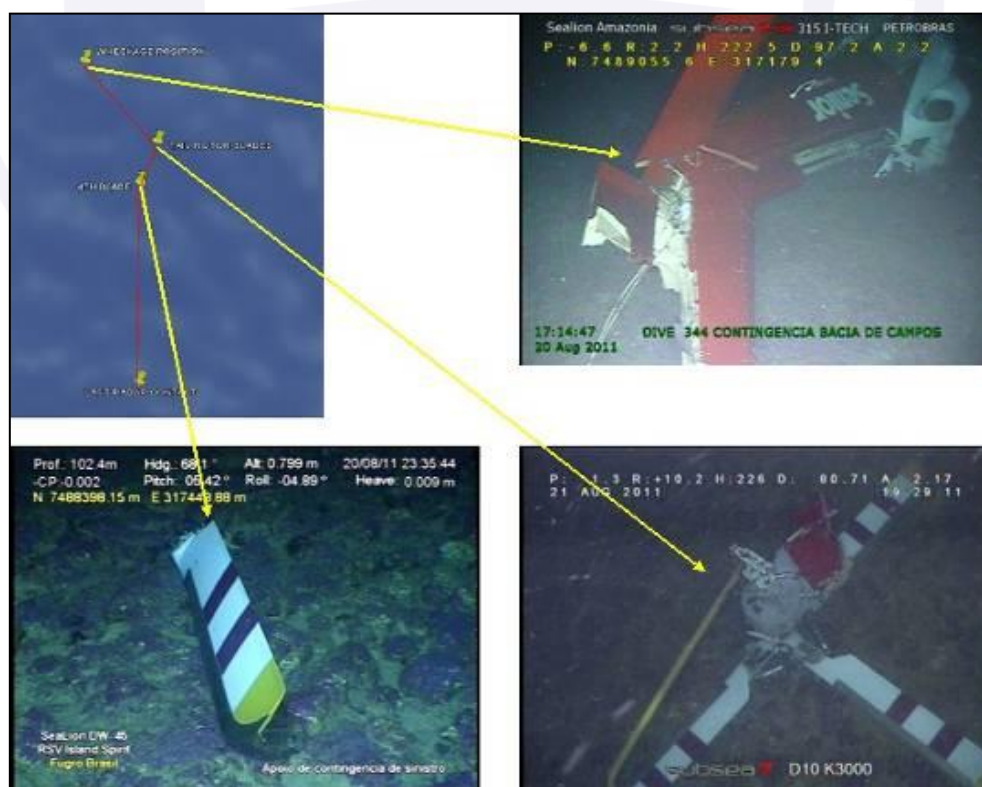
The blade that detached was found at a distance of .12 nautical miles (230 meters) short of the TGB location and, approximately, .42 nautical miles (800 meters) short of the fuselage position, as shown in Figure 4.

Figure 4 - Wreckage distribution in relation to position and distances.

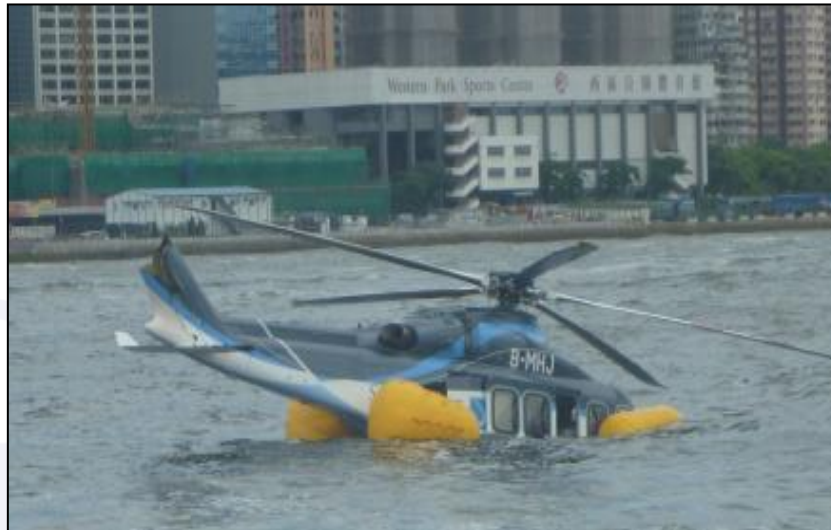
In this occurrence, the TRSOV installed in the hydraulic system n° 2 was in operation during the entire maneuver, and the aerodynamic reactions were less abrupt than the ones sustained by the PR-SEK (Figure 11).

Figure 11 - Accident involving the B-MHJ aircraft in Hong Kong, China.

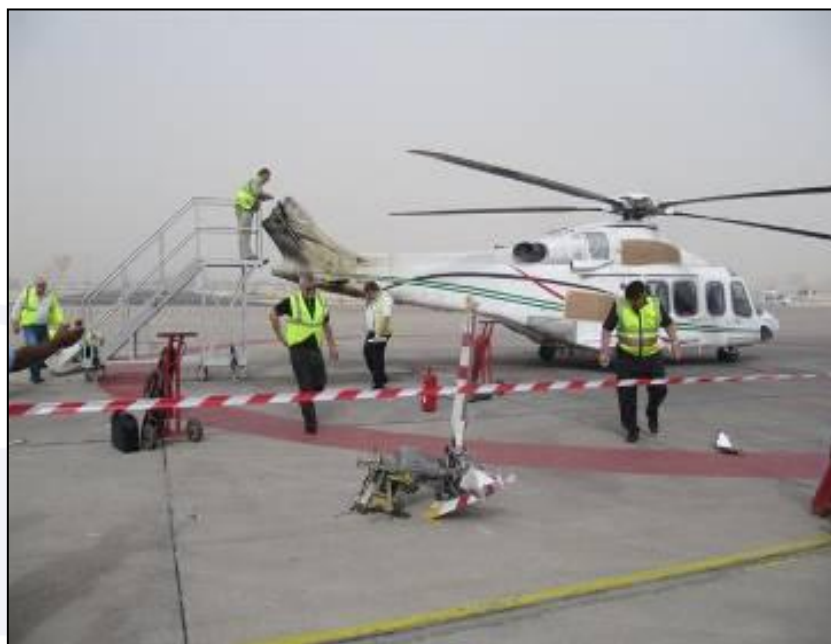
In Qatar, on 2 May 2011, another AW139 aircraft, registration A7-GHA, while operating an off-shore flight with eleven POB, had one of the tail-rotor blades separated, and this was followed by separation of the whole tail rotor assembly and TGB (Figure 12).

Figure 12 - Accident involving the A7-GHA aircraft in Doha, Qatar.

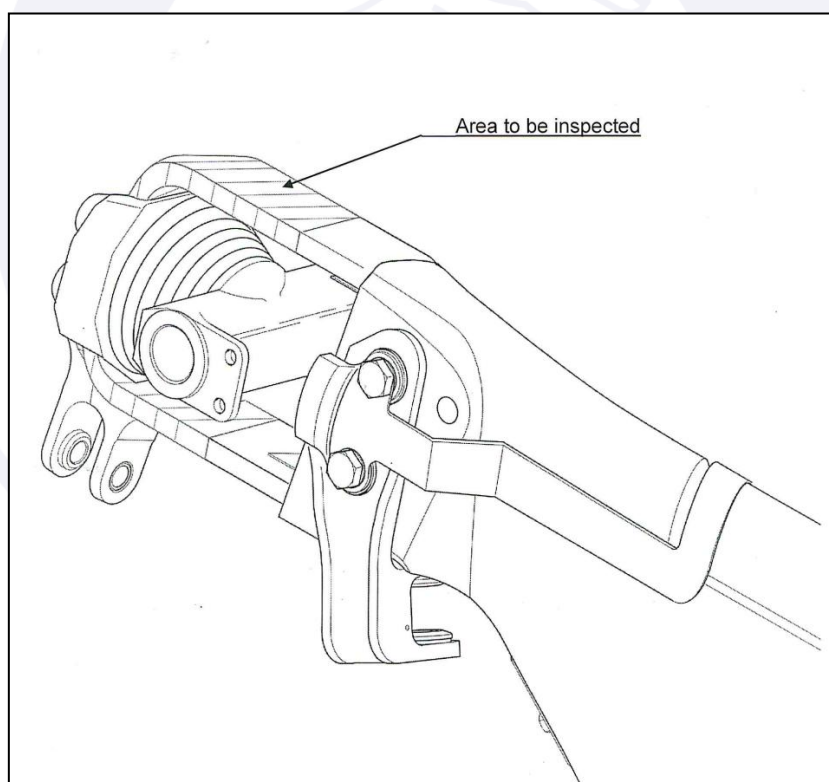
Figure 13 - Area to be inspected by the Technical Bulletin 139-251.

On 6 May 2011, AGUSTA issued the Mandatory Technical Bulletin BT139-251, which introduced a periodical preventative inspection of AW139 aircraft tail rotor blades. The bulletin introduced a visual inspection and a hammer-tapping check on the root of the tail rotor blades, with the objective of identifying cracks or signs of damage. The area to be inspected was exactly the same area fractured in PR-SEK aircraft accident (Figure 13).

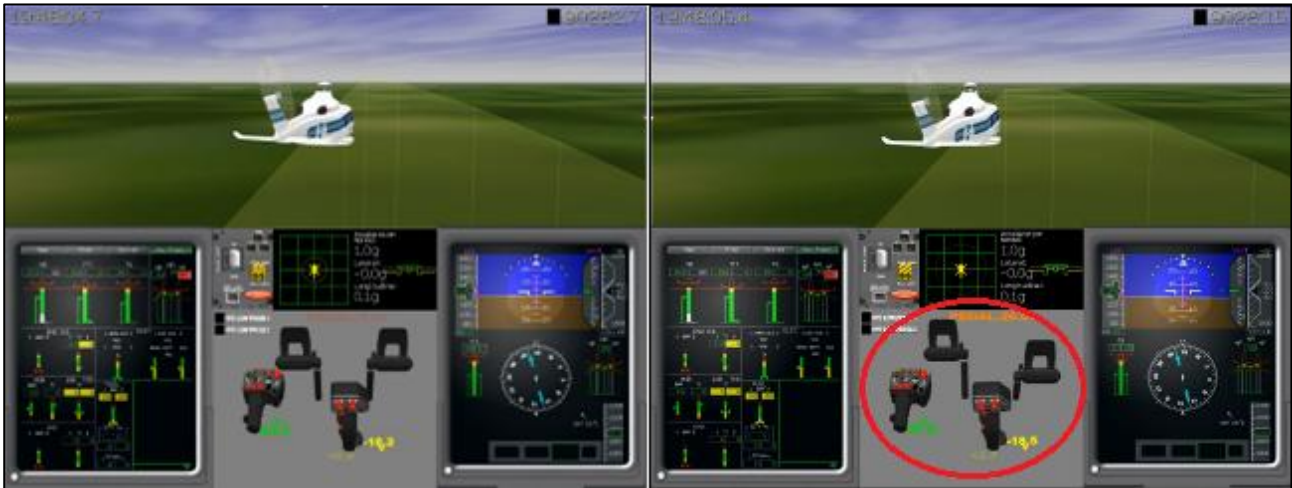
Considering that the helicopter was flying with the autopilot engaged it is possible that the control input of the pedal to the left was made by the autopilot, which promptly reacted and stabilized the initial heading change (Figure 14).

Figure 14 - Image of the FDR data animation immediately before and during the first event - separation of the tail rotor blade. The cyclic remained stable, and the left pedal was depressed to 60% of its course.

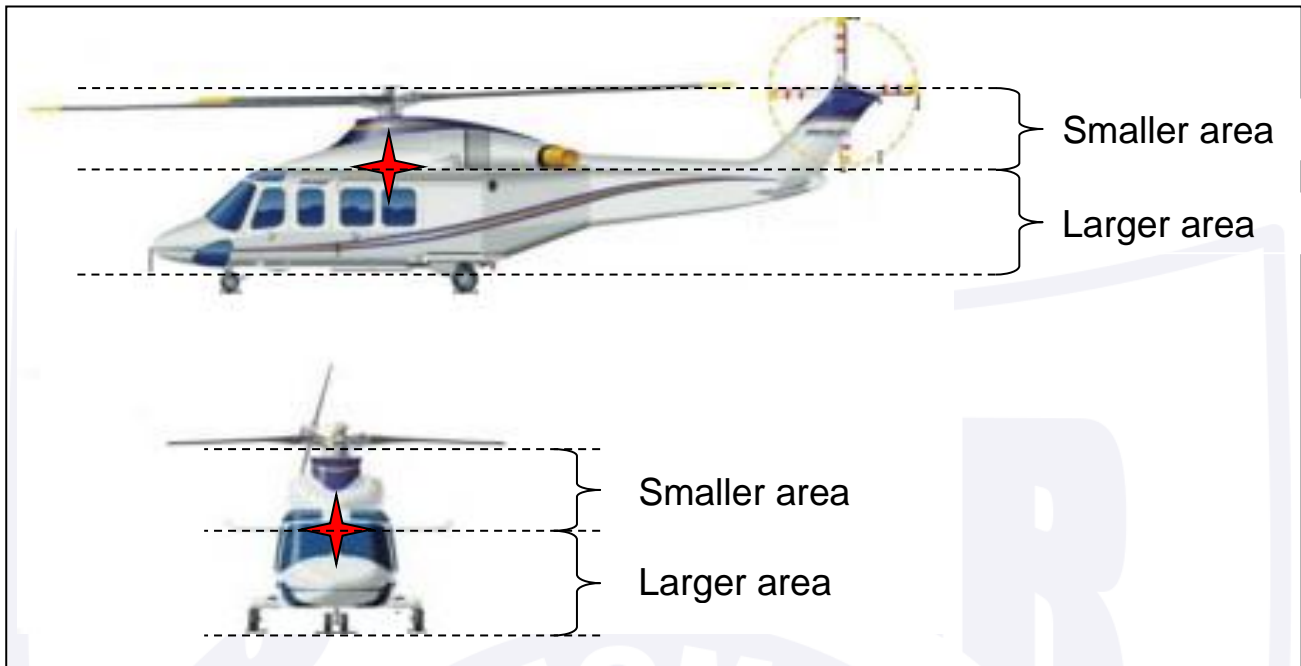
The exposure of the left side of the fuselage to the relative wind (on account of the right yaw) generates, in a helicopter, a roll to the left. Such roll is explained by means of the sum of two components: the difference of the areas below and above the center of gravity in the fuselage, and the aerodynamic reaction of the main rotor to the deceleration caused by the fuselage drag (Figure 15).

Figure 15 - Effect of the fuselage areas' law in relation to the helicopter's CG along the vertical axis.

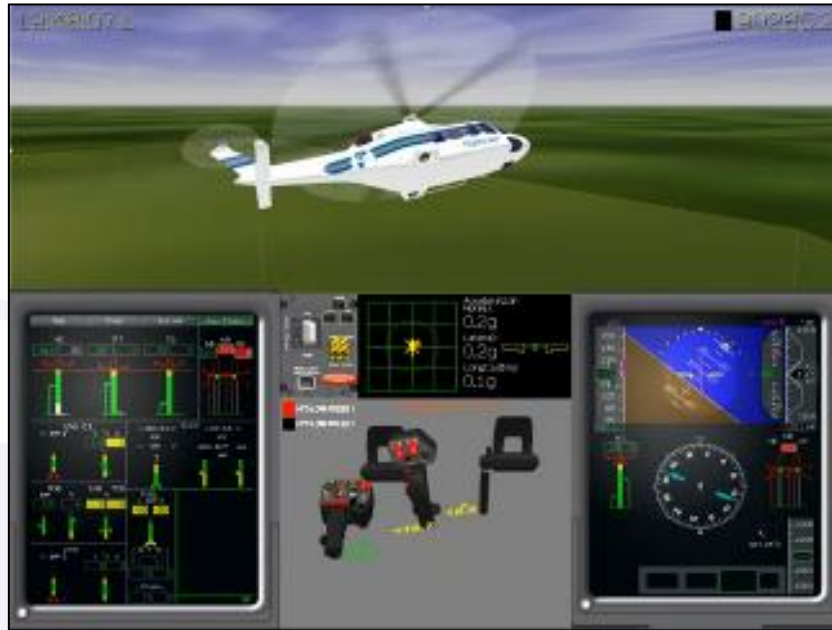
In consequence of the difference between the upper and lower parts of the fuselage in relation to the center of gravity, and on account of the pilot's control inputs, the helicopter increased the amplitude of the roll, reaching 120° to the left in relation to the longitudinal axis (Figure 16).

Figure 16 - Image of the CVFDR data animation in the second event - separation of the TGB - the cyclic moved forward and to the left, and the collective moved downward, with a roll of up to 120°. The low-pressure warning light illuminates, indicating loss of the Hydraulic System n° 1.

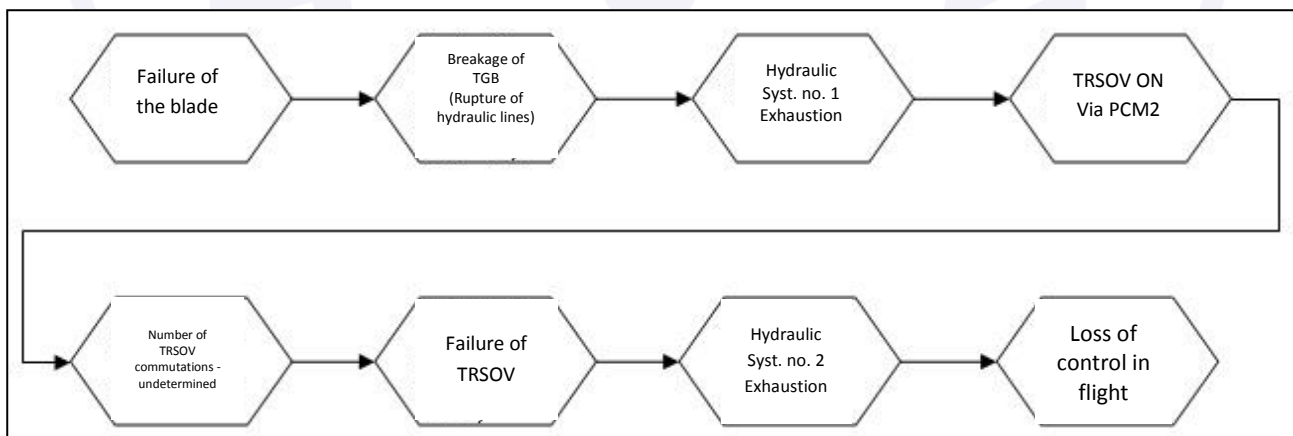
The possible connection existing between the failures of one of the tail rotor blades and the burn of the pilot valve coil can be demonstrated by the sequence of events which occurred between the failures, as shown in Figure 17.

Figure 17 - Possible connection between the failure of the tail rotor blade and the burn of the pilot valve coil.
