COMANDO DA AERONÁUTICA
CENTRO DE INVESTIGAÇÃO E PREVENÇÃO DE
ACIDENTES AERONÁUTICOS

FINAL REPORT
A-547/CENIPA/2015

OCCURRENCE:	ACCIDENT
AIRCRAFT:	PR-STO
MODEL:	A188B
DATE:	02MAR2012

This is the Final Report of the 02 March 2012 accident involving the A188B aircraft, registration PR-STO. The accident was classified as inflight collision with obstacle.

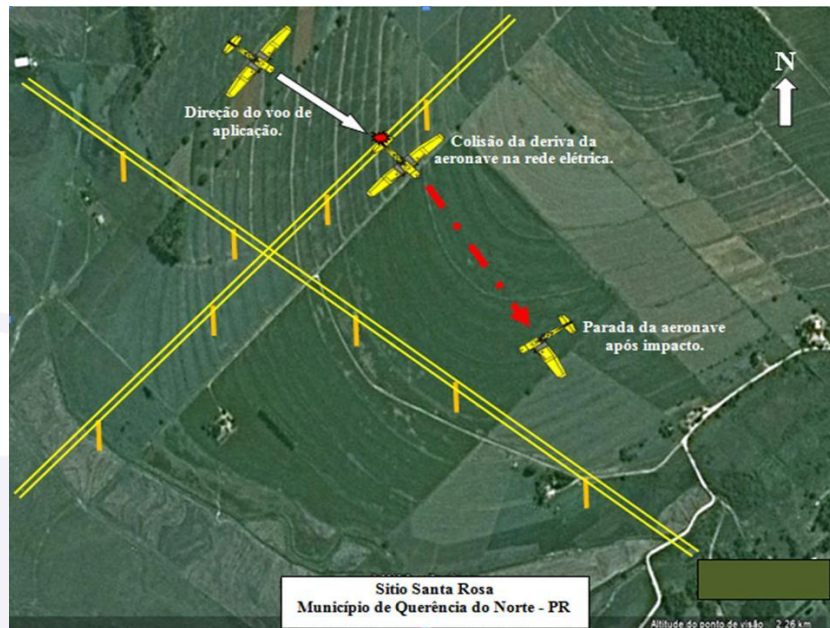
The aircraft trajectory is depicted in Figure 1.

Figure 1 – Croquis showing the aircraft trajectory.

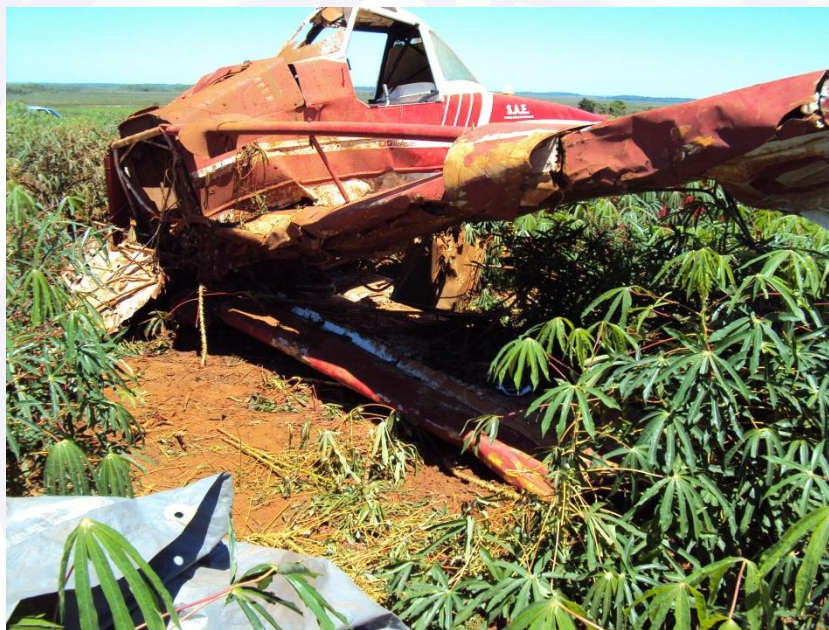
The aircraft wreckage remained concentrated. The aircraft first impacted electric wires and then crashed into the ground. The right wing detached from the fuselage and was found under it. The aircraft final position was at an angle of 90 degrees with the original trajectory.

Figure 2 – Position of the aircraft after the crash.
