COMANDO DA AERONÁUTICA
CENTRO DE INVESTIGAÇÃO E PREVENÇÃO DE
ACIDENTES AERONÁUTICOS

FINAL REPORT
A - 561/CENIPA/2011

OCCURRENCE:	ACCIDENT
AIRCRAFT:	PR-CEC
MODEL:	R-44 II
DATE:	10SEPT 2011

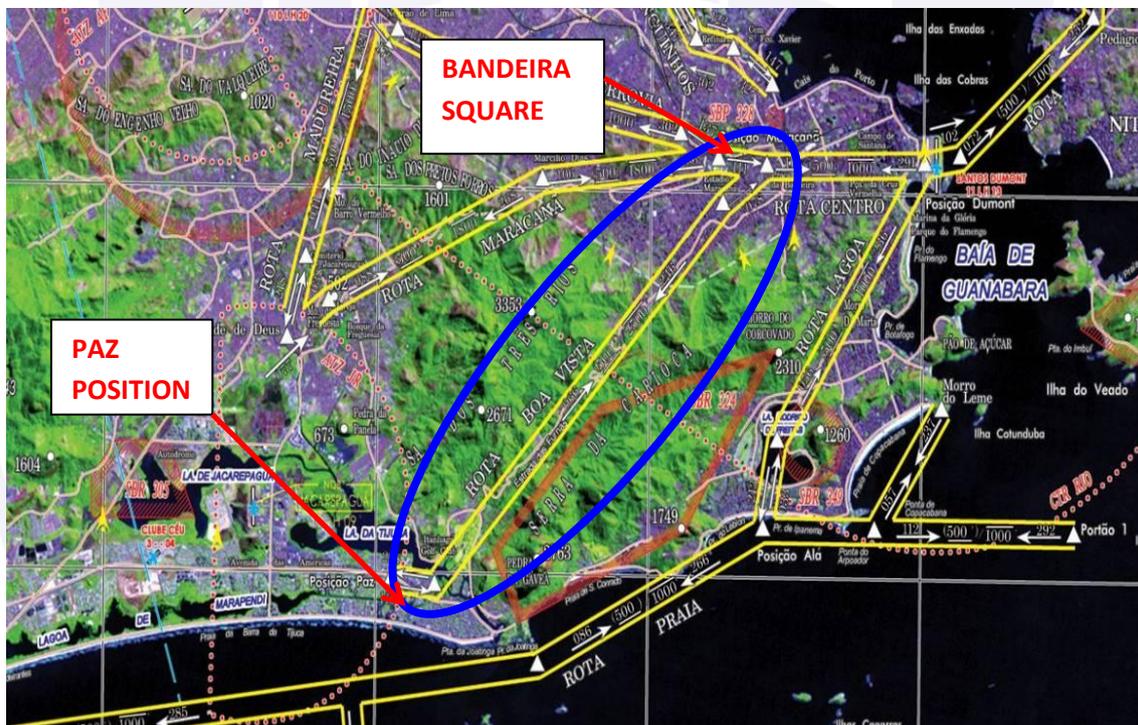
Figure 1 – Helicopter Special Routes (REH) of Rio de Janeiro Terminal, with Boa Vista REH in highlight.

The pilot of the PR-CEC chose Boa Vista REH to fly from Marina da Glória to the destination.

The vertical limits of the Boa Vista REH are 500ft AGL (lower) and 2500ft AGL (upper). Both ends of the route are at sea level. However, for the most part of the route the aircraft flies over the *Tijuca* massifs, a mountain range with high peaks nearby (*Pedra do Conde* - 2,726ft high)

For keeping the Boa Vista REH corridor limits, the aircraft has to fly over Furnas Road in a valley.

Analyze the possibility of restricting the operation in the *Boa Vista* REH to the day-time period, with the purpose of preventing the possibility of inadvertent entry in IMC due to the meteorological and geographical characteristics of the region, and the consequent navigational disorientation in a mountainous area.

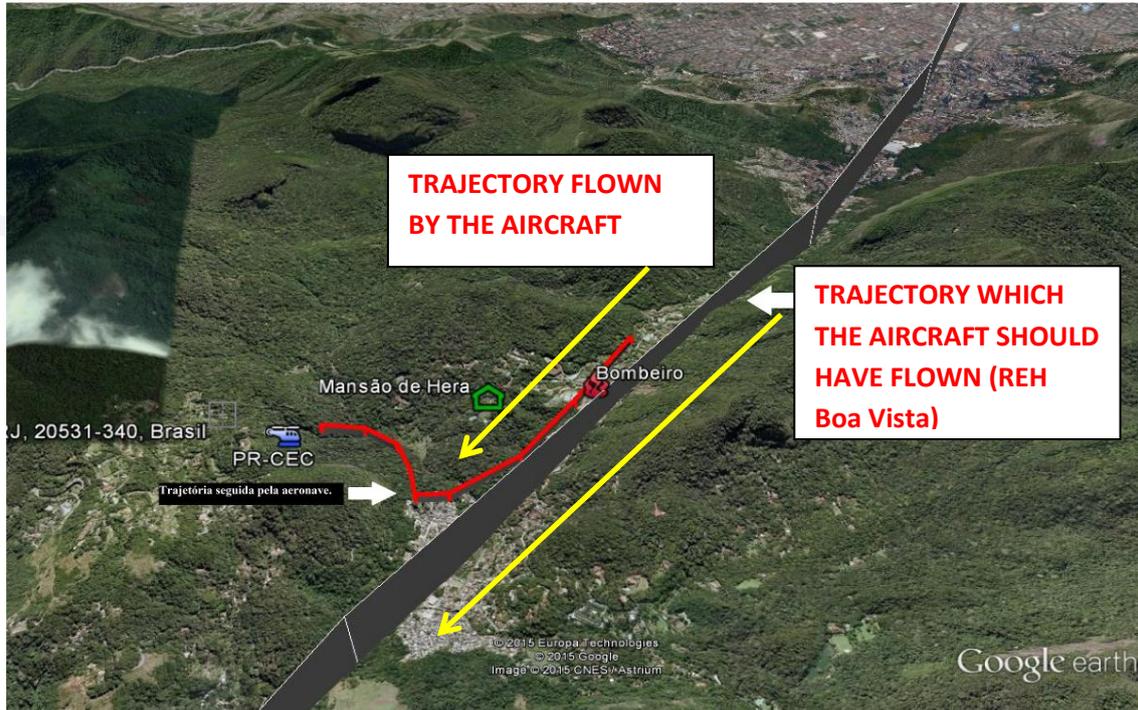
The accident aircraft was under radar contact with Rio de Janeiro Terminal Area Control until moments before the accident, when it got out of the line-of-sight condition.

At the final moments, the radar showed a slight deviation to the right of the route, with the aircraft heading varying clockwise.

Figure 2 – Trajectory flown by the aircraft until radar contact was lost.

This hypothesis is corroborated by the trajectory of the aircraft detected by the APP-RJ radar, showing that the aircraft joined a corridor between the mountains, and, at the final moments of the flight, made a slight deviation to the right of the route.

The last position of the aircraft detected by the radar was near the crash site, and radar contact was lost on account of discontinuation of the line of sight condition. Therefore, it is suspected that the pilot believed in the corridor in an opposite direction. However, he made a turn of just 90° to the right, and the tail rotor collided with a tree located at the top of an elevation.
