**COMANDO DA AERONÁUTICA**  
**CENTRO DE INVESTIGAÇÃO E PREVENÇÃO DE**  
**ACIDENTES AERONÁUTICOS**

**FINAL REPORT**  
**A - 605/CENIPA/2014**

| <b>AIRCRAFT:</b> | <b>PR-CRR</b> |
| <b>MODEL:</b> | <b>T206H</b> |

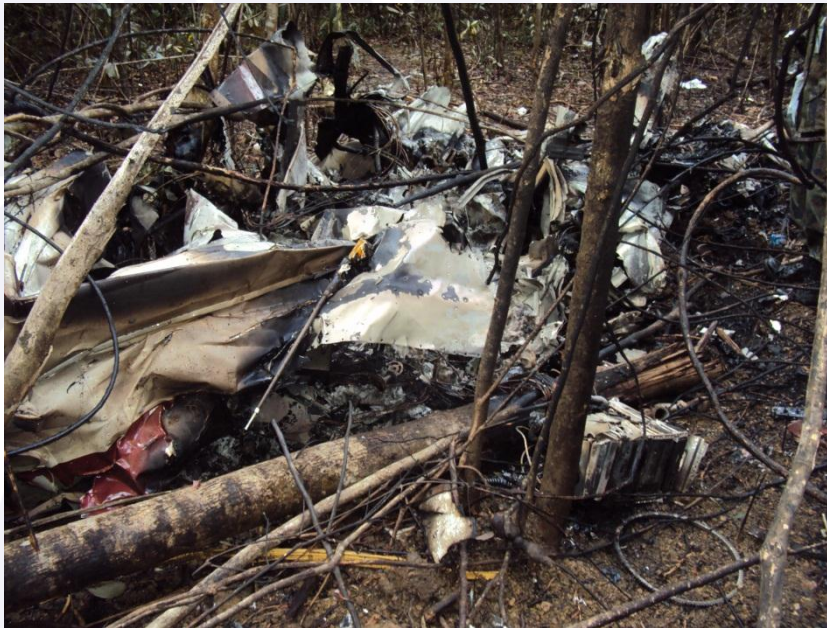
The T206H Cessna aircraft was found later in the morning in a thicket area at a distance of approximately 7 km (3.9 NM), on the 235° radial of SBMQ. It was completely destroyed on account of collision with trees and post-impact fire.

The aircraft first struck a tree and then crashed into the ground at a pitch-down angle of 30° in a 332° direction, apparently with level wings. On account of the impact, aerodynamic structures and control surfaces were broken, with the aircraft debris spreading in a linear fashion

Figure 2 – Wreckage in the crash site.

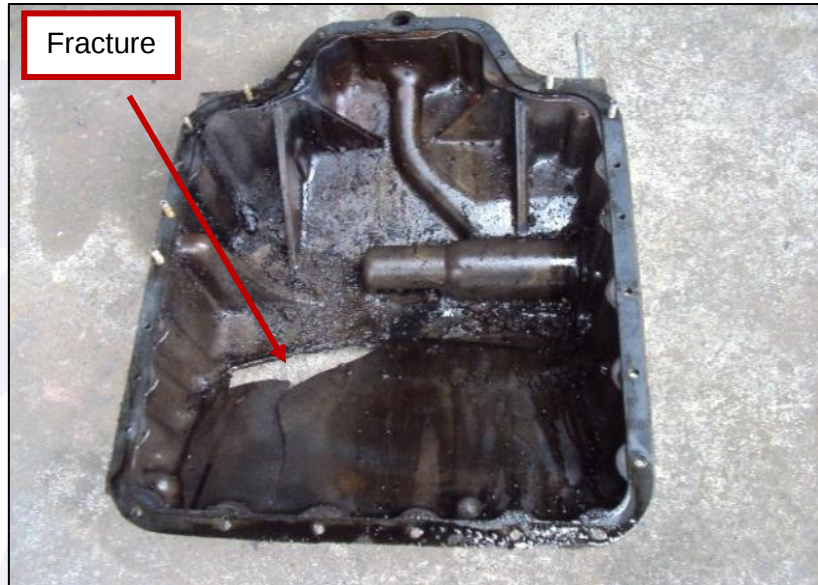
The opening of the engine revealed the presence of a retaining ring and a washer which were loose inside the oil sump of the engine carter (Figures 3 and 4). The oil sump had a fracture on its base.

Figure 3 – Oil sump.

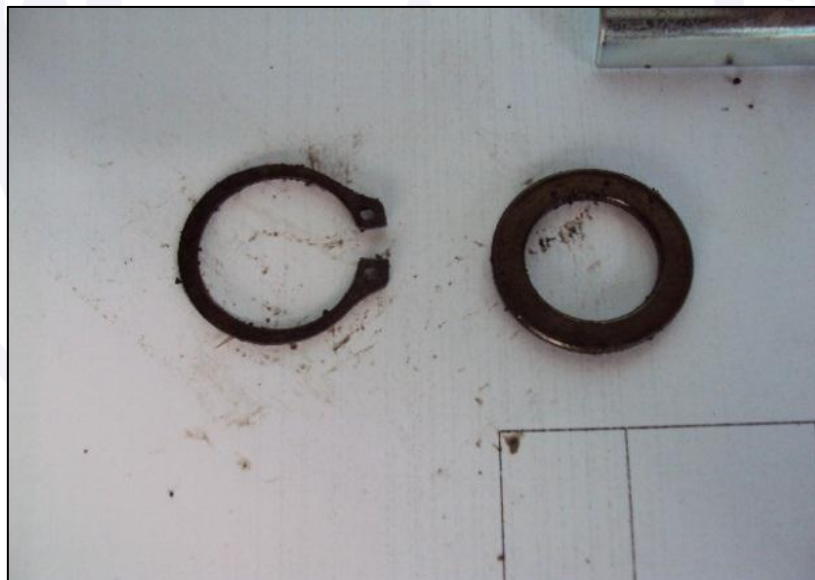
Figure 4 – Ring and washer found loose in the oil sump.

After measuring the washer found in the sump, one verified that it was another type of spacing washer with a smaller diameter (.5 in)

In addition to the retaining ring, a washer identical to the one utilized in the *turbo scavenge and hydraulic pump* component was also found in the oil sump.

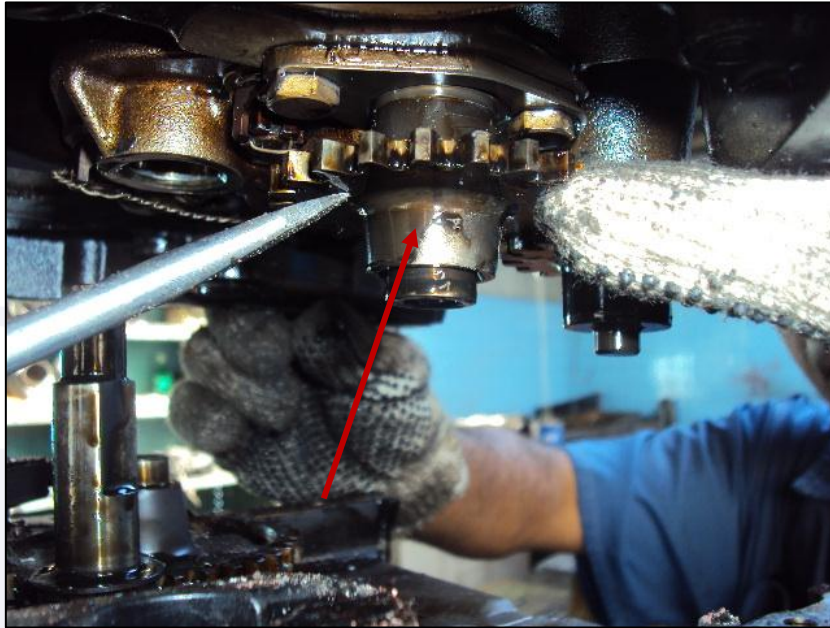
When the lid of the accessories' control gears was opened, one verified that the external retaining gear (PN STD-1737) was not in the fit located in the shaft PN 72246 (Shaft, fuel pump idler) of the gear assembly (PN 71664), which was out of its position. In such situation, the referred gear would not have control over the mechanic fuel pump (Figures 5 and 6).

Figure 5 - Shaft (P/N 72246) without the retaining ring.

In a correct assembly, in accordance with the Lycoming PC-315-12 (page: 1-11), there is, between the retaining ring and the gear, a spacing washer (Washer, fuel pump idler thrust, P/N 70474) with an internal diameter of .625 in. One verified that this spacing washer was not in the shaft P/N 72246 (Figure 5), nor was it found in the interior of the engine.

The opening of the engine revealed a series of discrepancies. One of them was that the gear retaining ring responsible for transmitting the rotation of the crankshaft to the mechanical fuel pump was missing.

The spacing washer normally located between the retaining ring and the gear was also missing.

The absence of the retaining ring allowed the gear to move out of place, thus failing to activate the fuel pump gear, causing lack of fuel to be burnt in the cylinders.

Review the process of manufacture and assembly of TIO-540-AJ1A engines, aiming to find a possible failure capable of concurring to a faulty installation of the following components: P/N STD-1737 (external retaining ring), P/N 71664 (Gear Assy, Fuel pump idler), and P/N 70474 (Washer, fuel pump idler thrust).

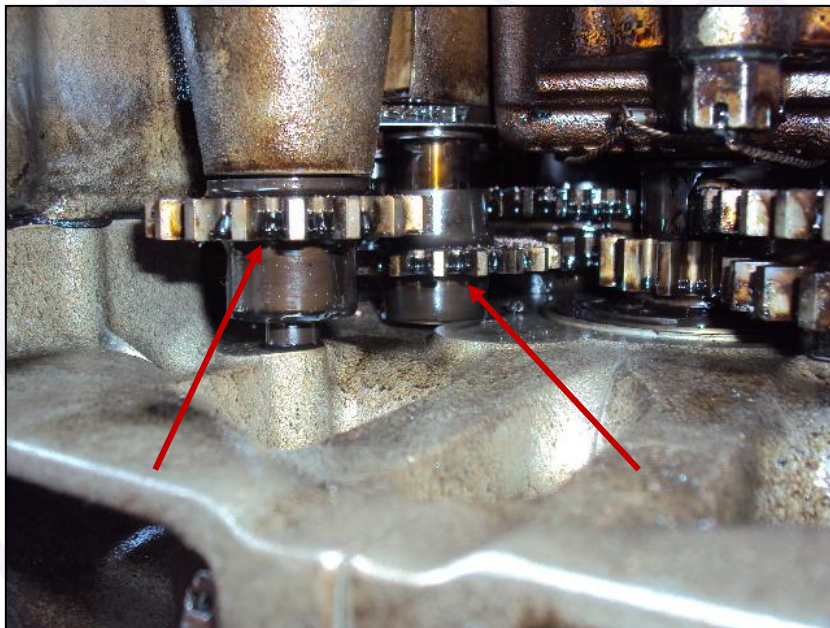
According to the Lycoming Parts Catalog PC-315-12 (pages 1-11 and 1-12), the PN 71664 gear transmits the rotation movement of the crankshaft by means of the control gear of the accessories for activation of the fuel pump (Figure 6).

Figure 6 - Gear P/N 71664 out of position and misaligned with the fuel pump control gear.

The retaining ring (P/N STD-1737) holds the gear in the proper fitting position relative to the other three gears to maintain the movement of the mechanical fuel pump shaft.

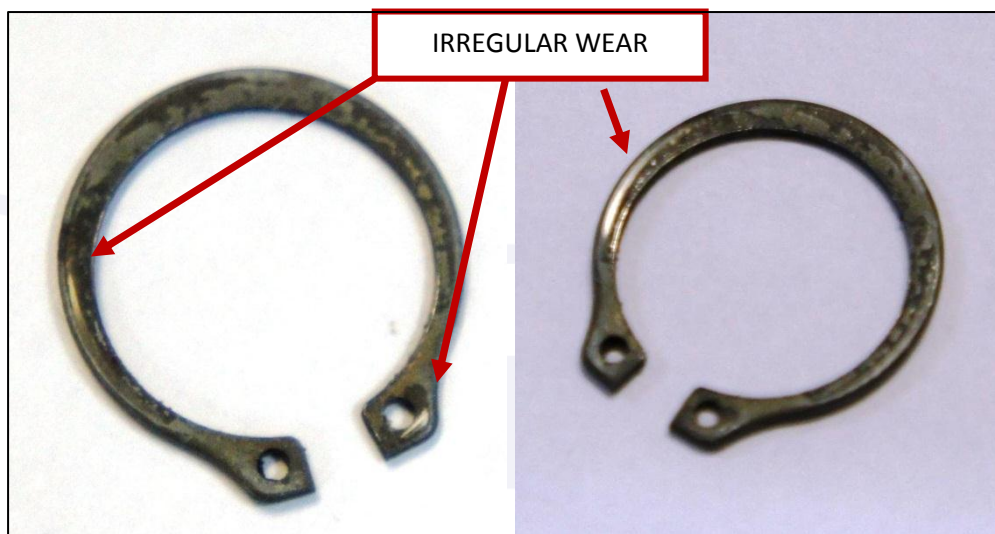
Upon examining the retaining ring PN STD-1737, one verified that it had irregular wear on one of the faces (Figure 7).

Figure 7 - External retaining ring (P/N STD-1737) with marks of rubbing.

This retaining ring was then found in the oil sump, showing irregular wear on one of the sides, suggestive of (irregular) rubbing on the gear, possibly for not having fully fitted in the shaft groove (or due to the lack of the spacing washer).

In this latter situation, the gear may not have been adjusted properly and the existing play would have caused the irregular wear and expelling of the retaining ring from the shaft groove, possibly during takeoff, when vibration is stronger.

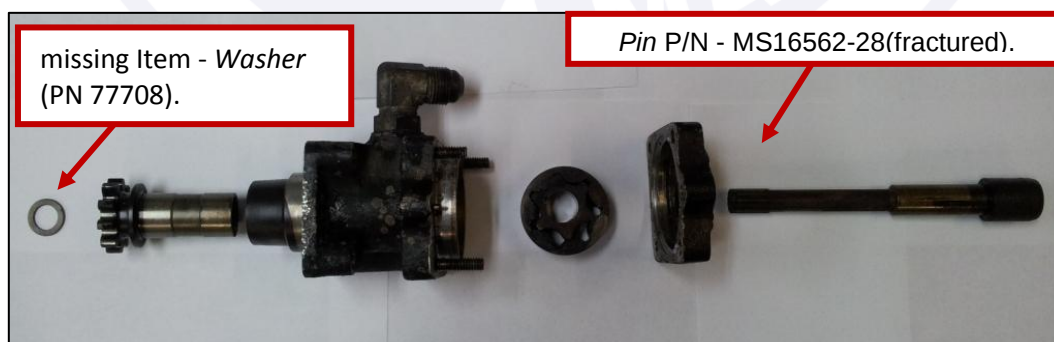
The referred pump was disassembled for verification, which confirmed that the item "Washer, retaining shaftgear" (P/N 77708) was missing.

Still during the disassembly of the *turbo scavenge and hydraulic pump*, a fracture of the item P/N MS16562-28 (PIN, 3/32 dia. X 3/4 long, slotted – described in the Lycoming Parts Catalog PC-315-12 [TIO-540-AJ1A], pages 2-9 and 2-10) was observed close to the structure of the "Shaft, Hydraulic pump drive" (P/N 29E22367), as can be seen in Figures 8 and 9.

The item PIN (P/N MS16562-28) has the function of blocking the "Washer, retaining shaftgear" (P/N 77708) so as to maintain the position of the "Shaftgear, Hydraulic pump drive" (P/N 29H22368), item no. 12, page 2-10 of the Parts Catalog PC-315-12.

Figure 8 - Turbo scavenge pump and hydraulic pump disassembled. The WASHER (P/N 77708) was not installed. In the picture above, it is shown just for purposes of illustration.

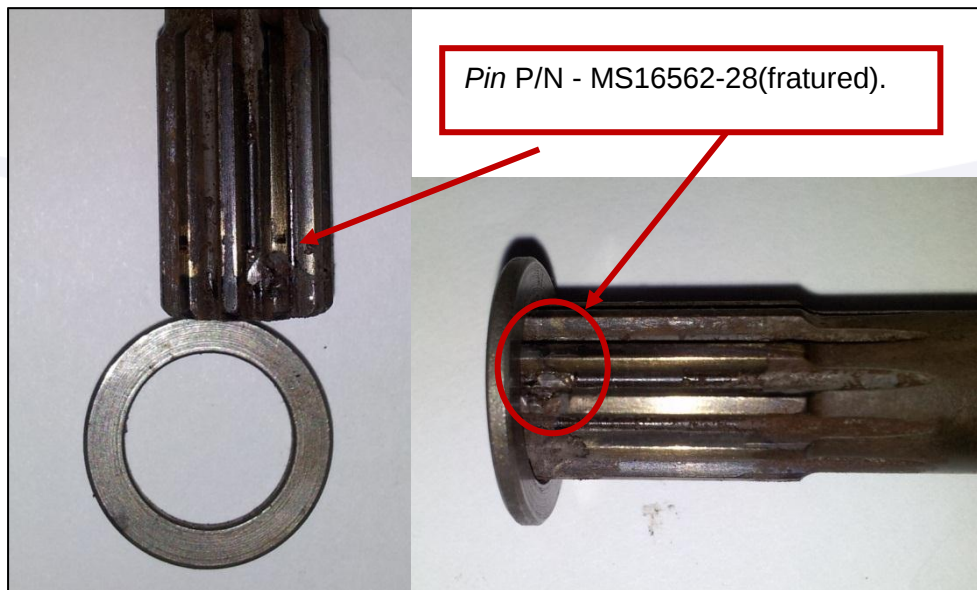
The fractured part of the item PIN (P/N MS16562-28) was not located, and the part that remained inside the item "Shaft, hydraulic pump drive" (P/N 29E22367) sustained kneading that hindered the analysis of the type of fracture.

Figure 9 - 3/32 dia. x 3/4 long, slotted PIN, (P/N MS16562-28) fractured.

After the component was disassembled, it was possible to see that the washer was missing, and that there was a fracture in the part of the shaft that holds this retaining washer close to the gear. It was not possible to determine the reason for the fracture because it had sustained kneading, leading to the conclusion that it was functioning at the moment of the engine failure.

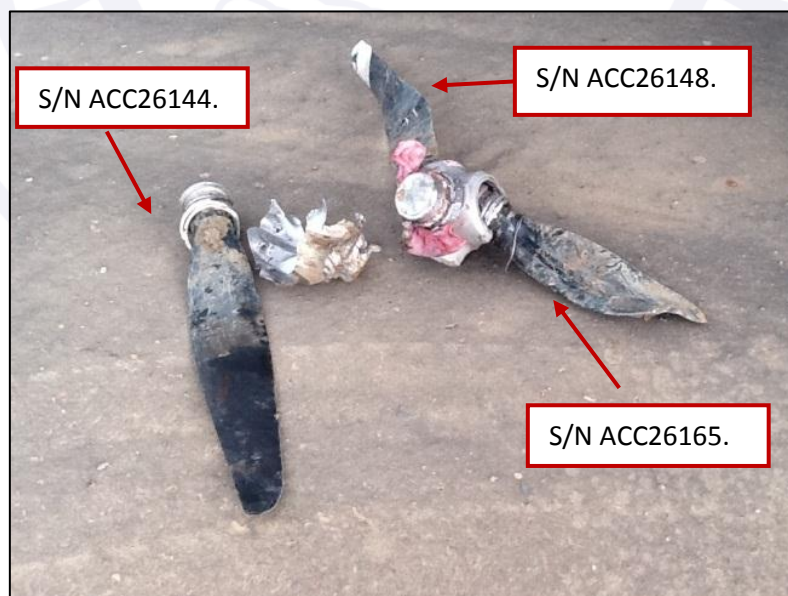
The B3D36C432 McCauley propeller, S/N 08193 (Figure 10), was also examined. The exam led to the conclusion that it initially collided with a tree, resulting in its separation from the engine and fracture of the cube.

Figure 10 – Propeller blades.

An analysis revealed that the blades of the McCauley propeller (SN 08193) struck the ground either at slow rotation or even with no rotation at all.

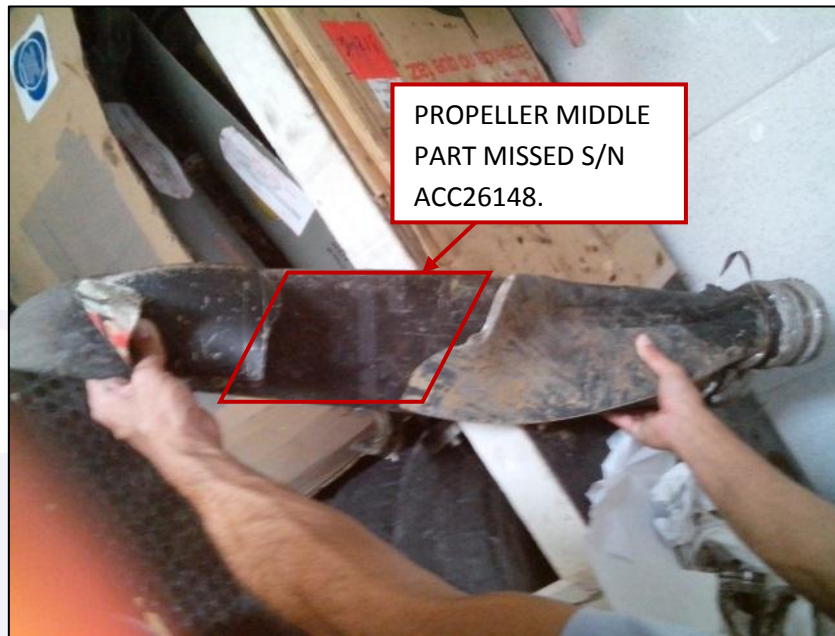
One of the propeller blades was fractured due to pressure in the direction of the longitudinal axis of the blade (from the root to the tip of the blade). It was broken into three parts, and the middle part was missing (Figure 11). The other blades were not fractured.

Figure 11 – Fractured propeller blade.

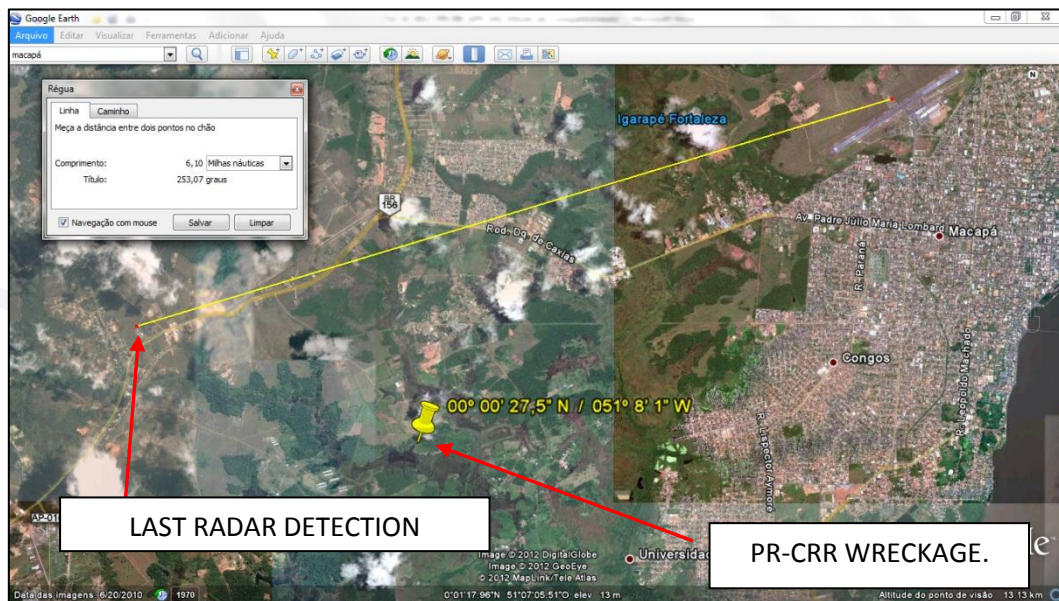
According to the APP-MQ radar re-run, the first radar detection of the aircraft was obtained when the airplane was at .5 nautical miles from SBMQ soon after departure, and the last detection was obtained when the PR-CRR was on the 253° radial at 6.1 nautical miles from SBMQ (approximately 2 minutes and 51 seconds after the first detection), and between one minute and one minute and thirty seconds after the last transmission (Figure 12), because the times registered in the radar re-run and in the ATC/PR-CRR aircraft communication transcript were not synchronized.

The Cessna T206H aircraft was found in the same morning in a thicket area at a distance of approximately 7 km (3.9 NM) on the 235° radial of SBMQ.

Figure 12 - Position of the last radar detection and location of the aircraft wreckage.
