**COMMAND OF AERONAUTICS**  
**AERONAUTICAL ACCIDENT INVESTIGATION AND**  
**PREVENTION CENTER**

**FINAL REPORT**  
**A - 623/CENIPA/2014**

<b><u>OCCURRENCE:</u></b>	<b>ACCIDENT</b>
<b><u>AIRCRAFT:</u></b>	<b>PR-HBC</b>
<b><u>MODEL:</u></b>	<b>AS 355N</b>
<b><u>DATE:</u></b>	<b>18 October 2011</b>

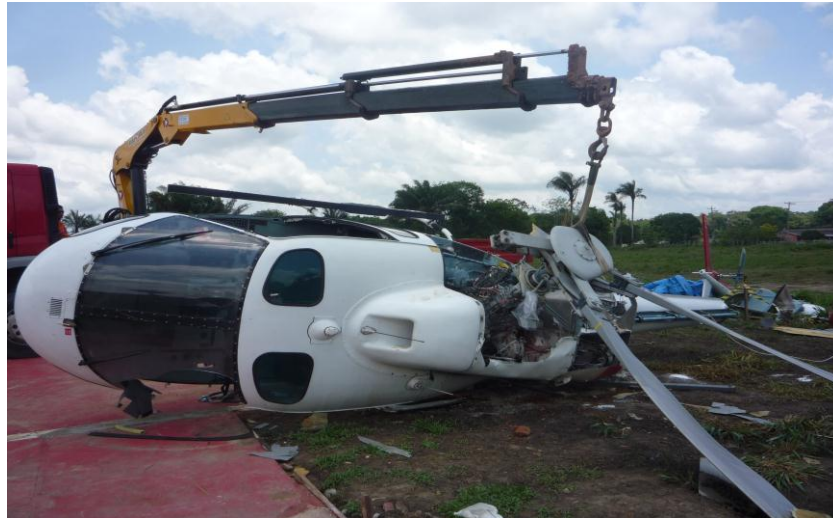
The aircraft sustained damage to its structure, breakage of the main rotor blades, abrupt stop of the engine number 2 and main transmission, and had its tail boom severed at its middle section.

Before the impact, the aircraft left skid hit the ground a few times, then the aircraft yawed to the right, and increased its incline to the left, causing the main rotor blades to strike the ground, damaging the helicopter tail boom and main structure.

Figure 1 – Final resting place of the aircraft.
