COMMAND OF AERONAUTICS
AERONAUTICAL ACCIDENT INVESTIGATION AND
PREVENTION CENTER

FINAL REPORT
I - 235/CENIPA/2013

<u>OCCURRENCE:</u>	INCIDENT
<u>AIRCRAFT:</u>	A6-EWI
<u>MODEL:</u>	B-777-21HLR
<u>DATE:</u>	4 SEPTEMBER 2013

This is the Final Report of the aeronautical incident involving the B-777-21HLR aircraft, registration A6-EWI on 4 September 2013. The incident was classified as collision with obstacle on the ground.

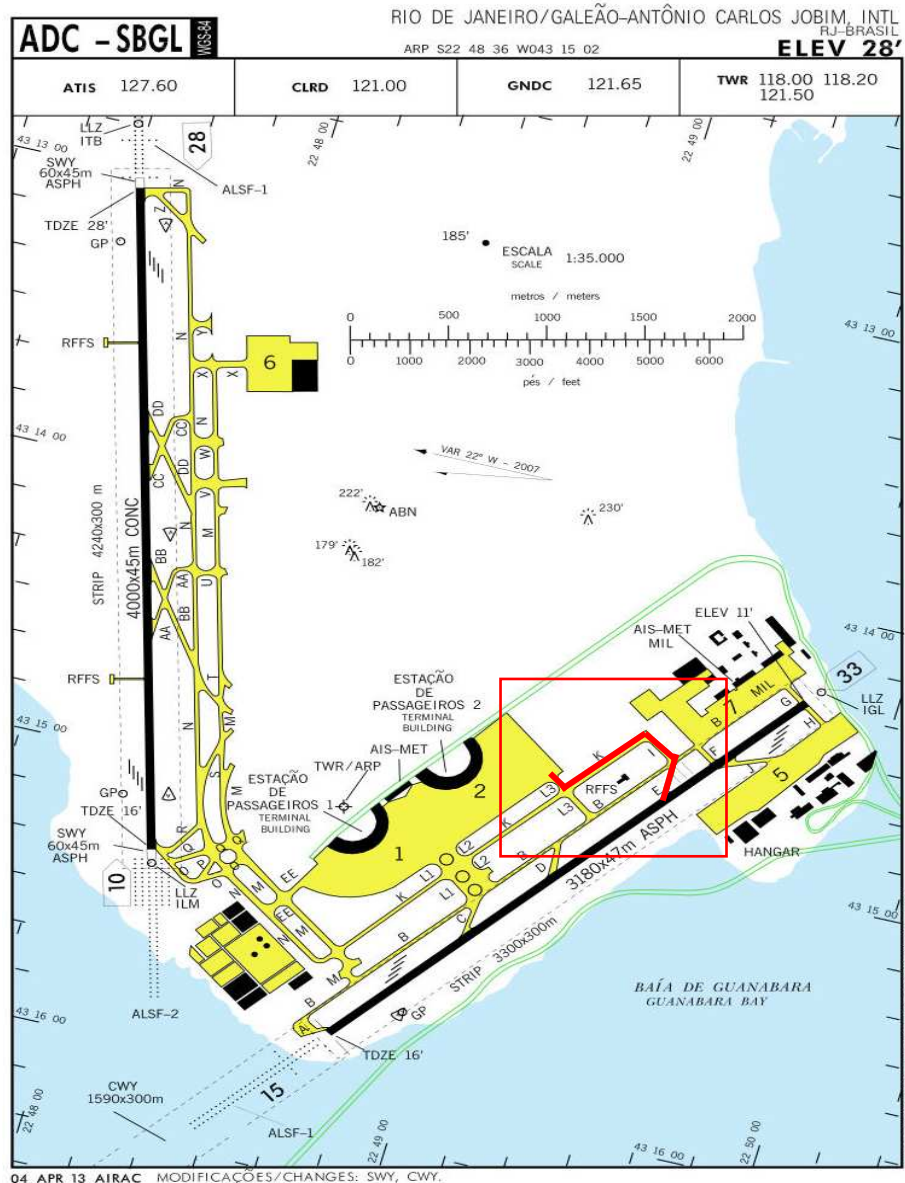
At 17:41:53 UTC, GND-GL instructed the B777 to taxi via taxiways I, K, and L3 towards the gate 45 of apron number 2.

Figure 1 – The red line shows the path followed by the B777 aircraft (EJ247) after vacating the runway, complying with the instruction given by GND-GL.

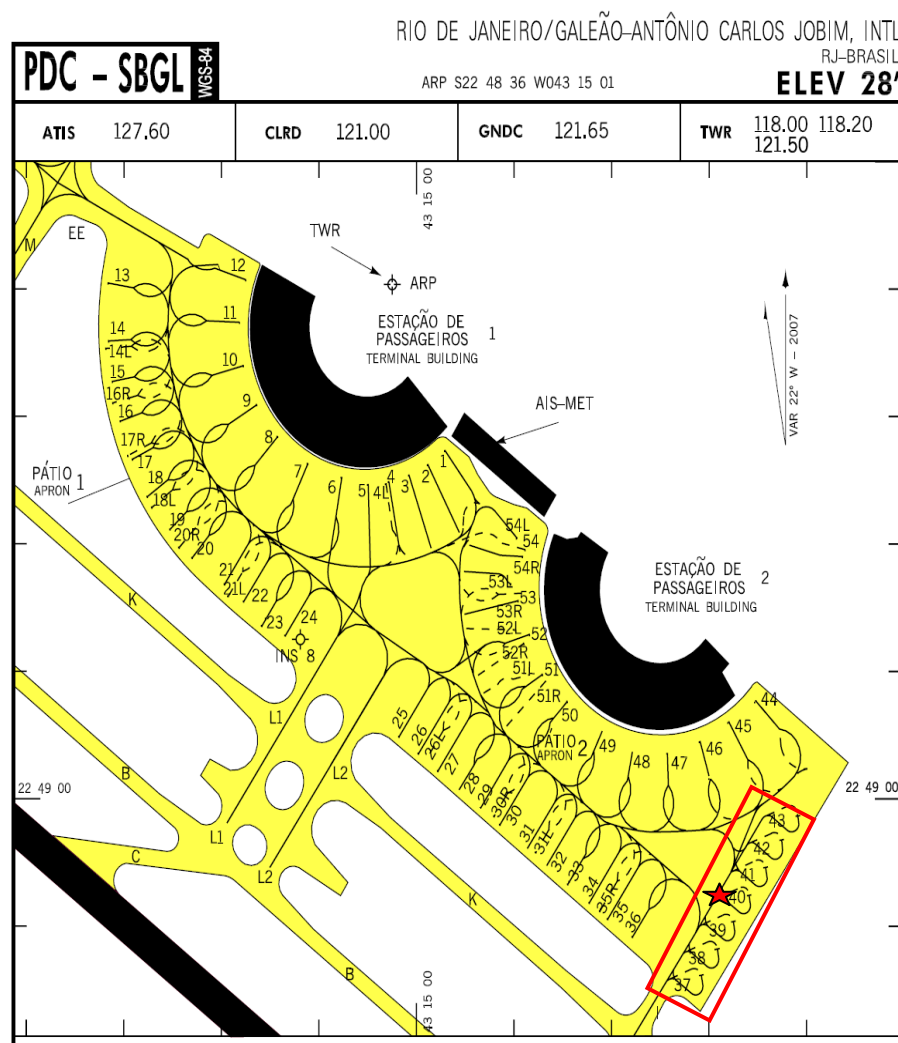
The parking stands of the remote area of apron number 2 were not compliant with the prescribed positions listed in the SBGL *Parking Display Chart* (PDC) published by the DECEA.

Figure 2 – DECEA publication, describing the positions of the parking stand of the remote area of apron number 2, and the location of the collision between the B777 and the B737.

There were “T” stop signs outside the taxi lines at 90° with the apron. Despite being used, they were not indicated in the PDC.

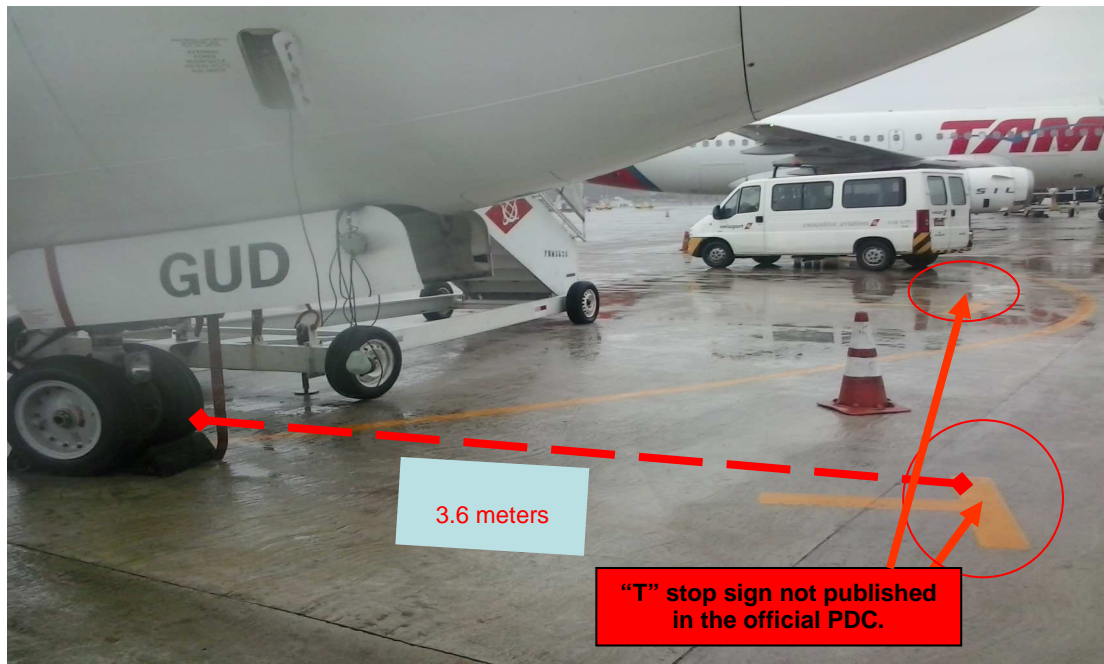
The B737 aircraft hit by the B777 was aligned with the “T” stop sign, close to the position 40, but 3.6 meters short of it.

According to information provided by INFRAERO, such displacement allowed the area in front of the parked aircraft to be used as a service track for fuel tankers, push-back tractors, and other ramp services.

Figure 3 – Position of ground markings in discordance with the PDC published by the DECEA. In the foreground, position of the aircraft hit by the B777 (3.6 meters short of the “T” sign).

During the investigation, it was observed that the aircraft final stop positions in the remote area of the apron number 2 were not in accordance with the positions declared in the SBGL Parking Display Chart (PDC), published by the DECEA.

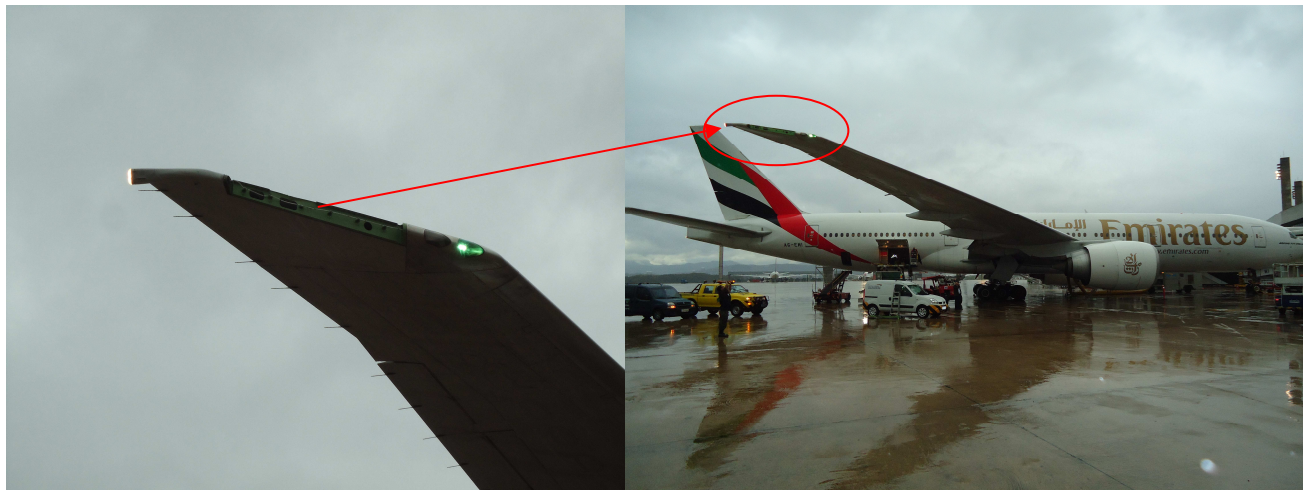
There was structural damage to the right wing tip of the B777 on account of the impact against the B737.

Figures 4 and 5 – Damage to the right wing tip of the B777 aircraft after the collision.

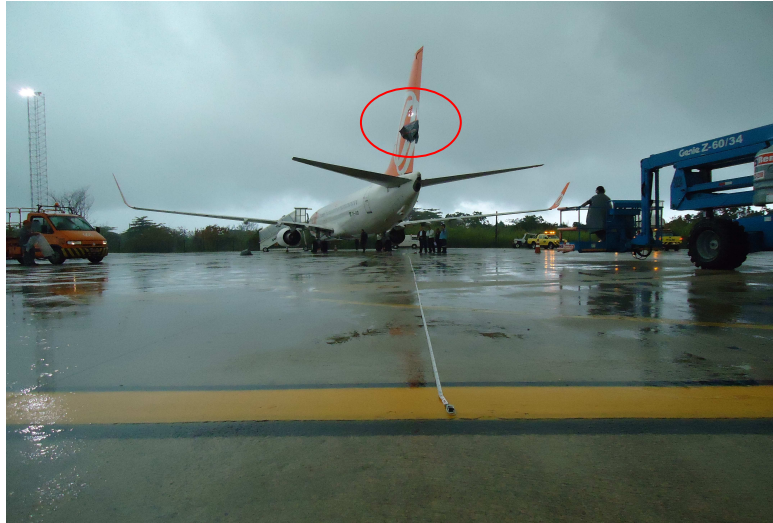
There was damage to the vertical stabilizer of the B737 aircraft, as a result of being hit by the right wing tip of the B777.

Figure 6 – Damage to the vertical stabilizer of the B737 after the collision. In the foreground, the yellow line along which the B777 was taxiing in.

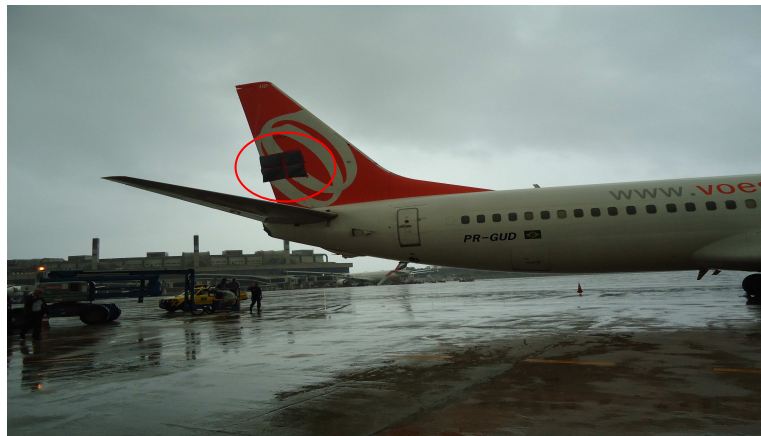
Figure 7 – Aspect of the damage to the vertical stabilizer of the B737 after the collision.
