**COMMAND OF AERONAUTICS**  
**AERONAUTICAL ACCIDENT INVESTIGATION AND**  
**PREVENTION CENTER**

**FINAL REPORT**  
**I - 067/CENIPA/2013**

| <b><u>AIRCRAFT:</u></b> | <b>CS-TOF</b> |
| <b><u>MODEL:</u></b> | <b>A-330</b> |

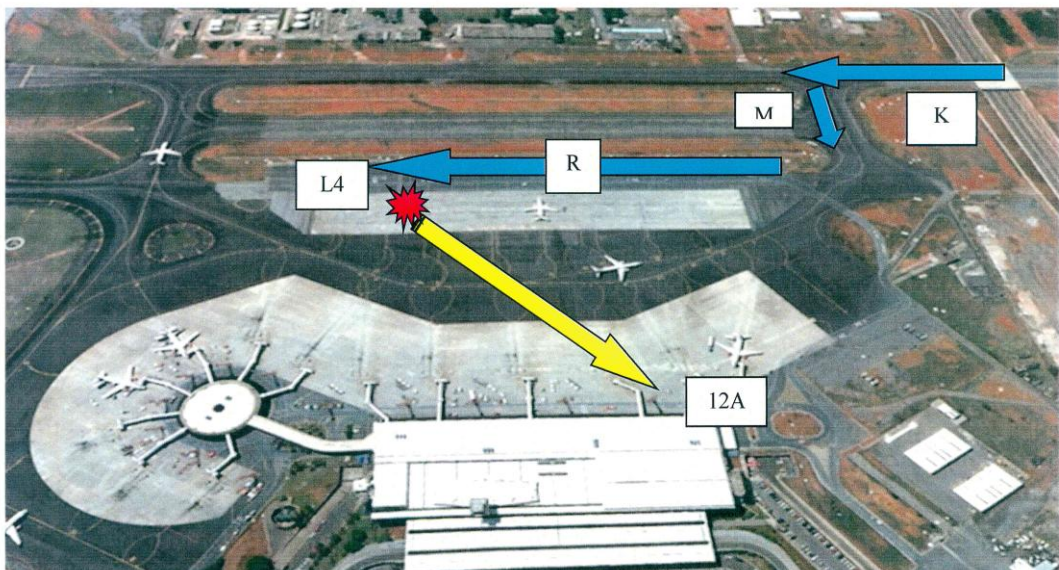
Upon joining taxiway L4, the aircraft's left wing tip collided with a floodlight tower on apron 1.

Figure 1 – Path traveled by the aircraft up to the collision with the floodlight tower at the entrance of Apron 1.

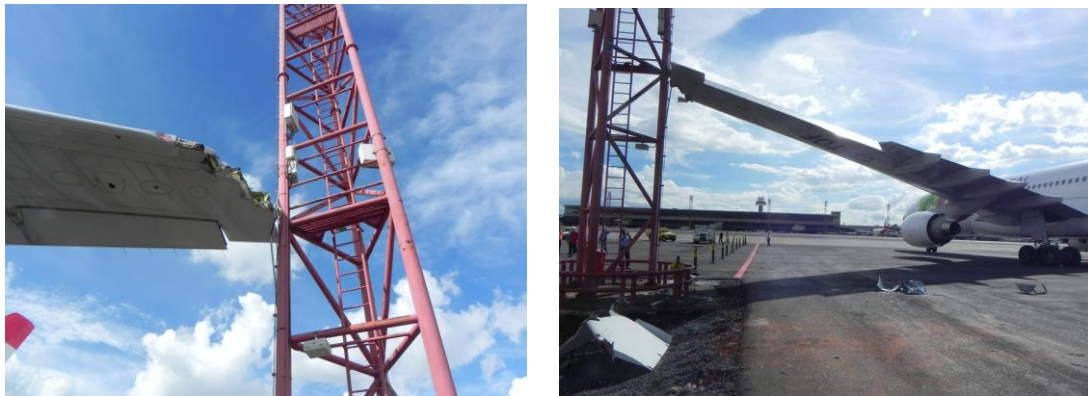
The aircraft left wing tip sustained serious damage.

There was considerable structural damage to the left wing tip on account of the impact against one of the floodlight towers of Apron 1.

Figures 2 and 3 – Aircraft situation after the collision.

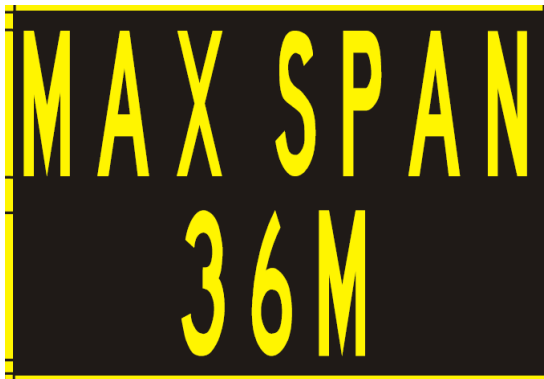
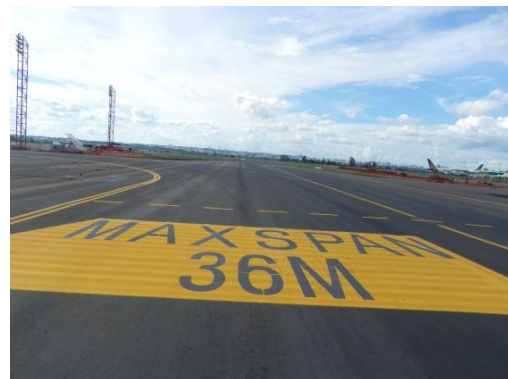
Figures 6 and 7 – Standard marking adopted by the ACI, and the marking on taxiway R, short of the entrance to taxiway L4.

The crew made an inadequate judgment by entering taxiway L4, even after having observed the marking (which was not compliant exactly with the standard adopted by ACI) of maximum wing-span available on taxiway R, and being knowledgeable of the wing-span of their airplane (60.4 meters).

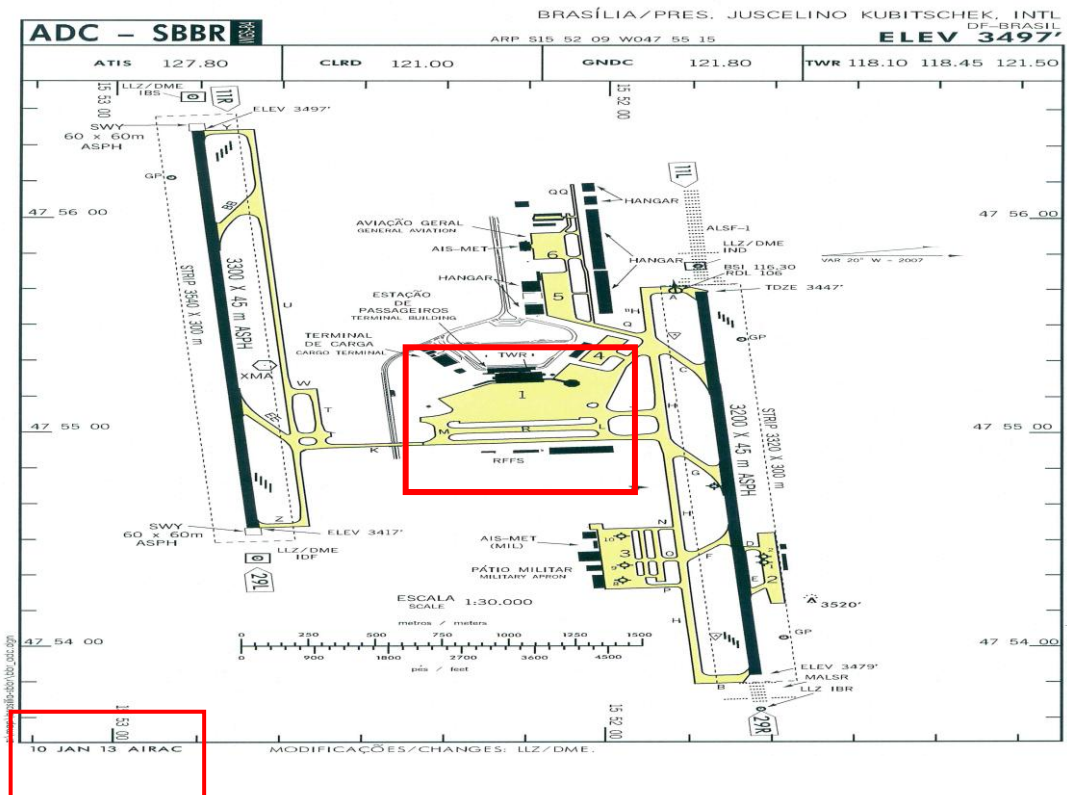
On the day of the incident, the SBBR Aerodrome Chart issued by DECEA did not depict taxiway L4, on account of the works that were being done in Brasilia Aerodrome (see the picture below). This fact is related to the AIRAC (Aeronautical Information Regulation and Control) cycle, which sets up the "international and permanent calendar established by the International Civil Aviation Organization (ICAO), setting the dates for advance publicizing of data about situations or changes relative to airports and air navigation infrastructure or about new procedures, such as utilization of GPS. The calendar is defined according to cycles of 28 days, which were instituted with the objective of publicizing the new information with sufficient advance".

Figure 8 – SBBR Aerodrome Chart (ADC) issued by the DECEA, dated 10 January 2013, and valid for the day of the occurrence.

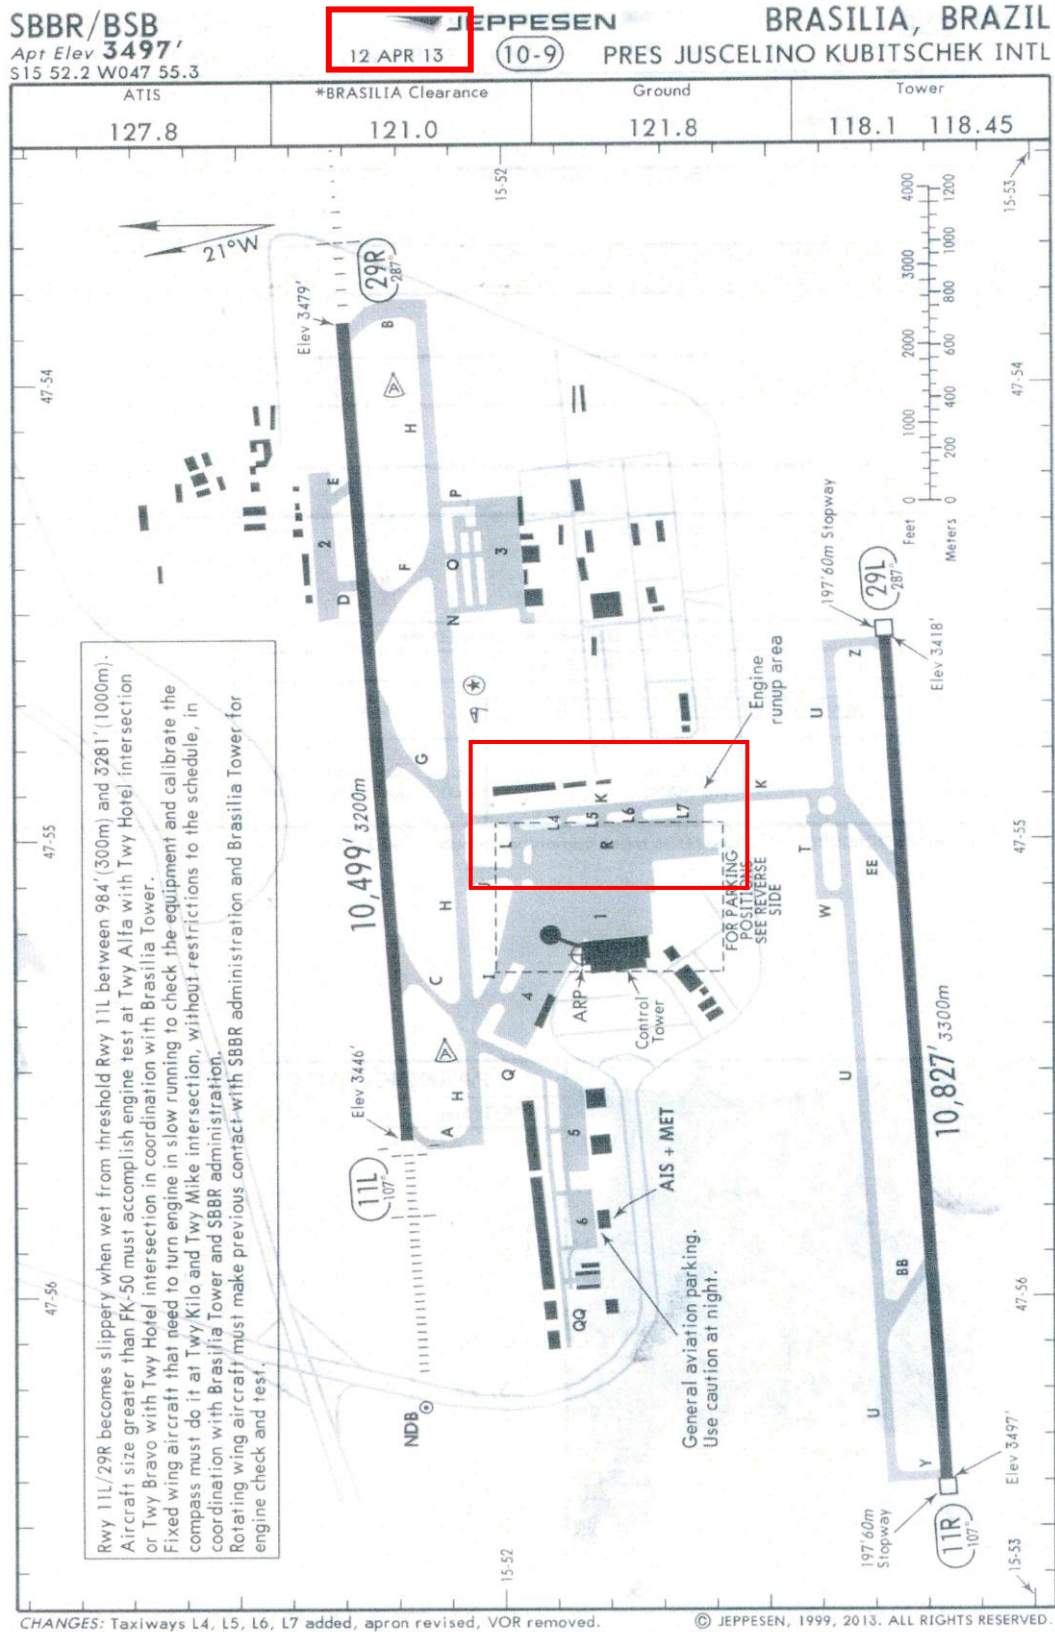
As for the Aerodrome Chart issued by Jeppesen on 12 April 2013, i.e., on the day prior to the occurrence, it already showed the taxiways L4, L5, L6 and L7, although some of them had not been built yet, according to the two pictures below.

Figure 9 – SBBR Aerodrome Chart issued by Jeppesen on 12 April 2013.

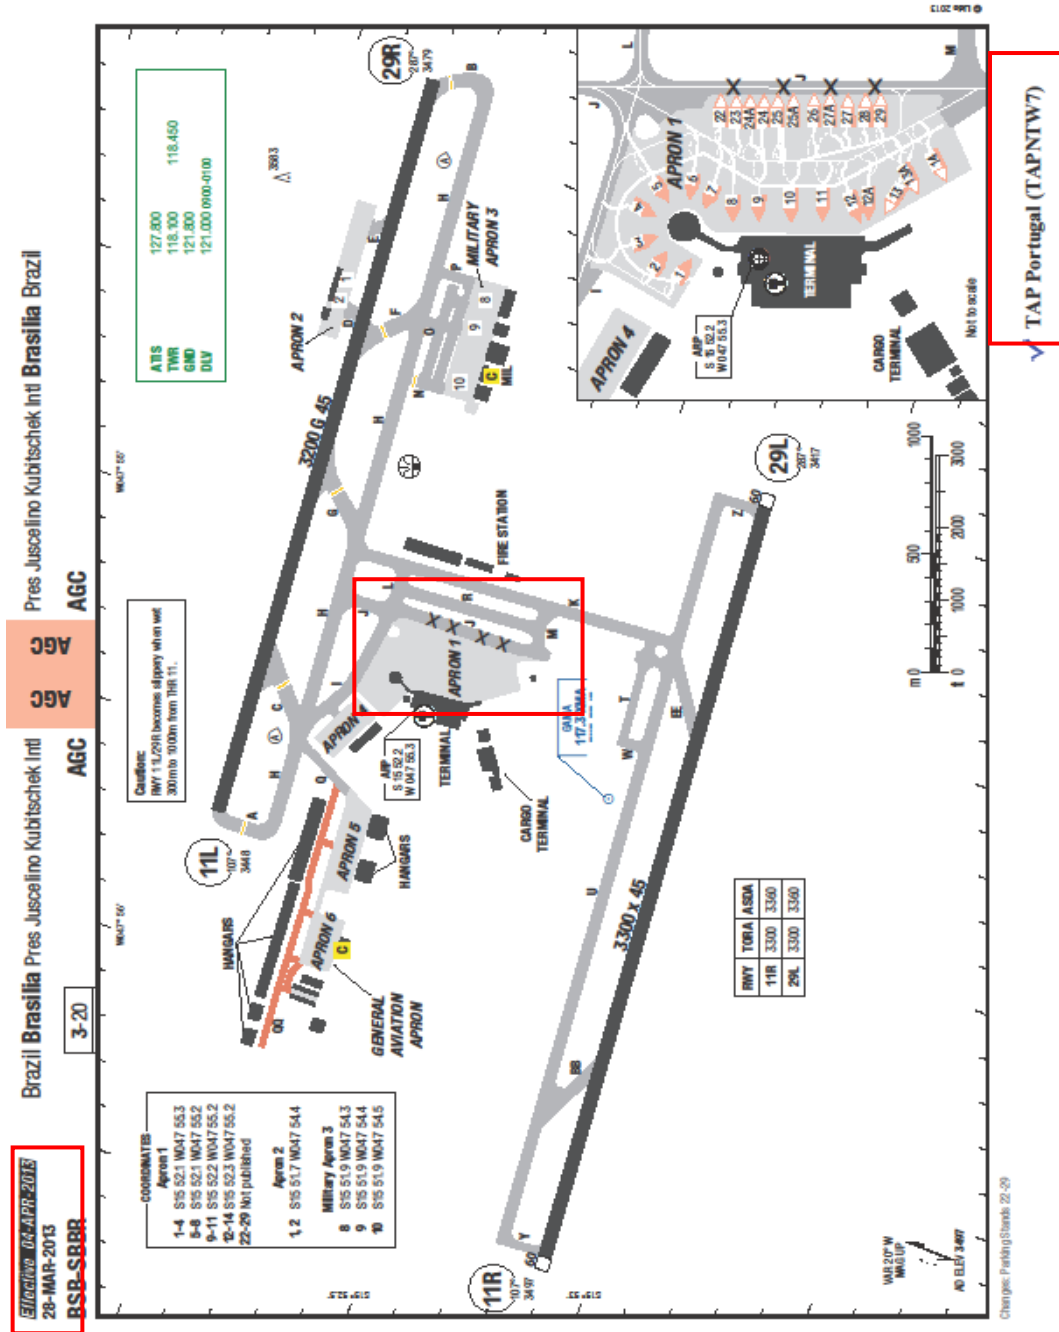
Figure 11 – SBBR Aerodrome Chart issued by the aircraft operator, dated 28 March 2013, and effective from 4 April 2013 (Chart LIDO AGC 3-20).

The crew utilized the ADC adopted by the aircraft operator, and shown in Figure 11 of this report. It had differences in relation to the other charts and in relation to the operational safety informative bulletins issued by the aerodrome operator. Such fact has the potential of becoming a latent condition, which, in association with another event, may cause an active failure.

Verify, in conjunction with Brazilian and Foreign Operators that operate in Brazilian aerodromes, the requirements of RBHA 91.101, RBHA 91.102 and RBAC 129.19 (a) (b) (c), taking into account that the investigation found out different Aerodrome Charts (ADC) associated with the Aerodrome of Brasilia, and, also, verify the Operational Safety Informative Bulletins produced and issued by the Aerodrome Operator, all of them showing discrepancies with one another and with the ADCs, and that may become latent conditions for aeronautical occurrences.
