COMMAND OF AERONAUTICS
AERONAUTICAL ACCIDENT INVESTIGATION AND
PREVENTION CENTER

FINAL REPORT
A - 042/CENIPA/2014

<u>OCCURRENCE:</u>	ACCIDENT
<u>AIRCRAFT:</u>	PR-DMG
<u>MODEL:</u>	AS-350B2
<u>DATE:</u>	8 AUG 2012

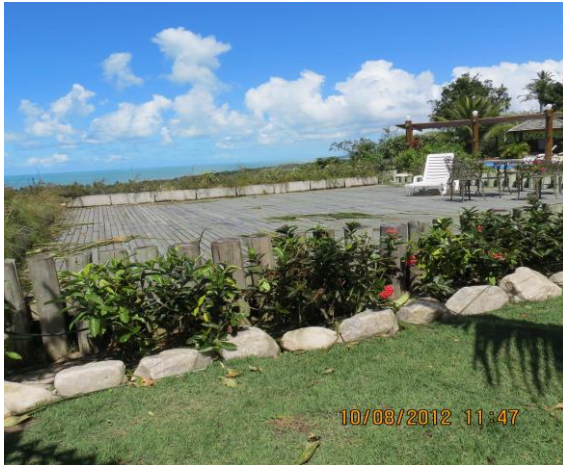
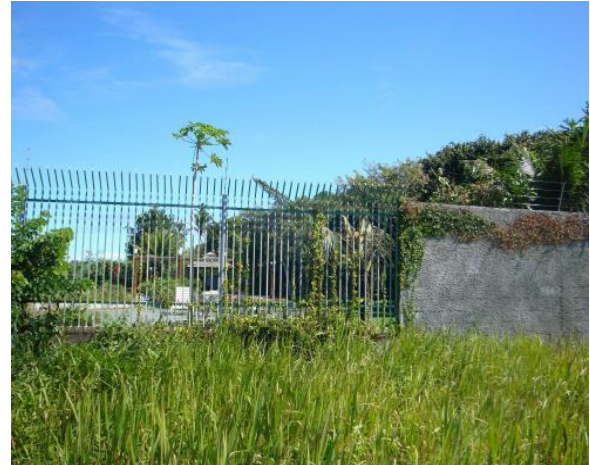
Figures 1 and 2 – Internal and external views of the intended landing spot.

It was a wooden deck in the shape of a square, with sides measuring 8 meters, located on the edge a hillside at a height of approximately 150 meters.

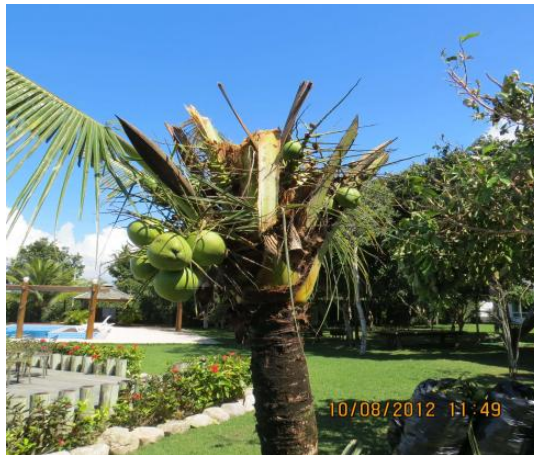
During the maneuver, the main rotor blades hit the top of a tree and the straws of two palm trees located near the deck.

Figure 3 – Palm tree hit by the helicopter.

Responding to the pilot's control inputs, the aircraft climbed about 5 meters, moving forward and to the right, and then the main rotor collided with the top of two palm trees and another type of tree.

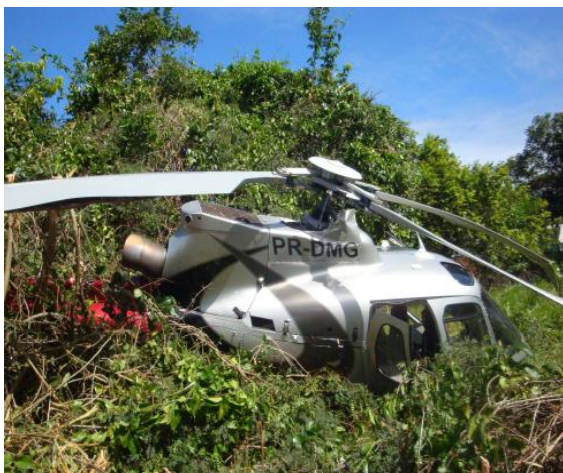
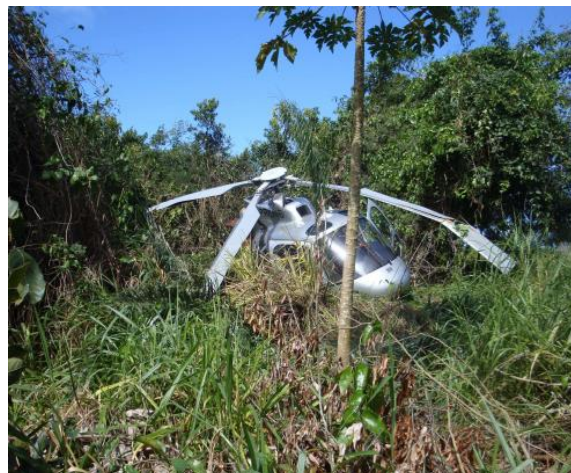
The aircraft sustained substantial damage to the fuselage, main rotor assembly, tail boom, rear transmission shaft, right hand side landing ski, tail rotor blades, and engine.

In the sequence, the aircraft collided with the ground, with the impact being softened by the vegetation.

Figures 4 and 5 – Situation of the aircraft after the collision.

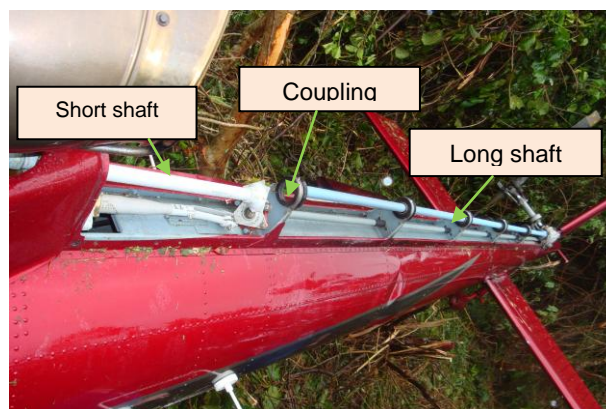
During the examination of the aircraft wreckage, it was verified that the coupling between the short shaft and long shaft of the tail rotor had broken.

The assembly did not show signs of wear on account of rotation friction, thus indicating that the breakage of the component resulted from the impact with the ground.

Figure 6 – Short shaft uncoupled from the long shaft.

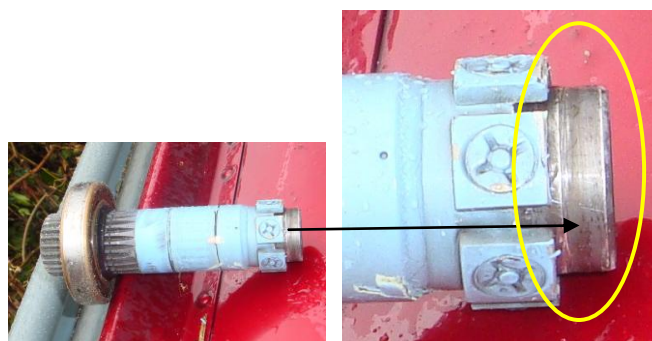
Figures 7 and 8 – Coupling without signs of rotation-related friction.

This maneuver showed that the pilot's controls were effective up to that moment. As a matter of fact, the lack of wear on account of rotation friction on the coupling of the short and long shafts of the tail rotor was evidence that the referred component broke only after the impact of the aircraft with the ground.

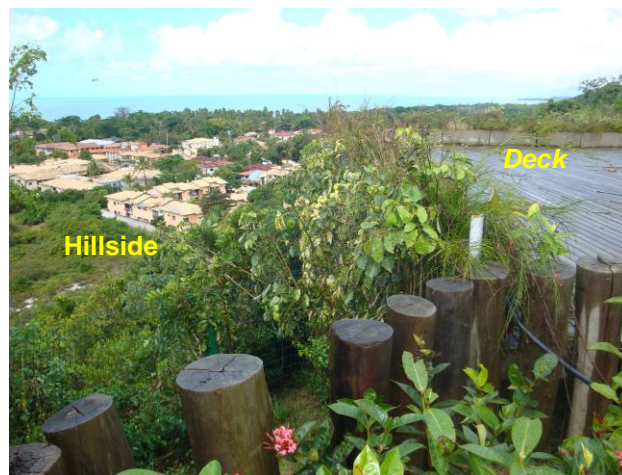
Figure 9 – View of the deck on top of the hillside.

Considering the dimensions both of the helicopter and the wooden deck, as well as the distances between the deck and obstacles (brick wall and trees) in the surrounding area, it may be said that the area chosen for the occasional landing did not meet the parameters established in the items (i) and (ii) of number 7, letter “a” of the RBHA 91.327.

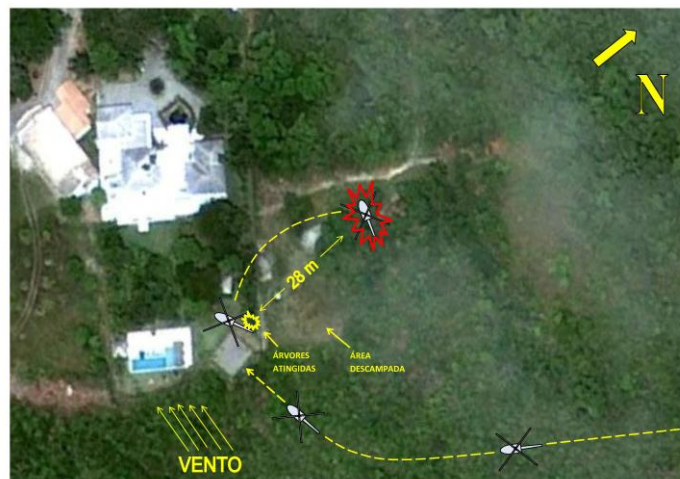
After completing the final approach for landing, and while doing the flare in order to reduce speed, the pilot heard a noise characteristic of the contact of tail rotor blades with the vegetation, and then the helicopter yawed to the left.

In an attempt to maintain control of the aircraft and avoid hitting obstacles (villa and trees) located ahead, the pilot applied the right pedal, simultaneously applying the collective upwards and moving the cyclic forward and to the right.

After passing over the brick wall of the land surrounding the villa, the aircraft moved approximately 28 meters to the right and away from the deck, with its nose turning to the right.

During this segment of the flight, the pilot lowered the collective lever. As a result, the aircraft lost altitude until colliding with the terrain.

Figure 10 – Trajectory of the helicopter from the approach for landing up to the collision with the ground.

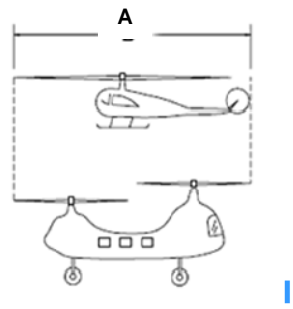
The dimension corresponding to the letter “A” in the figure below shows the larger helicopter dimension, which is obtained when the rotors are rotating.

(i) *Landing area: the landing area shall be large enough to contain, at least, a circle with a diameter that is equal to the largest dimension of the helicopter to be utilized;*

(ii) *Safety area: the landing area shall be surrounded by a safety area free from obstacles with a surface at a level not higher than the one of the landing area, projecting beyond the limits of that area with half of the total length of the helicopter to be utilized. ...*

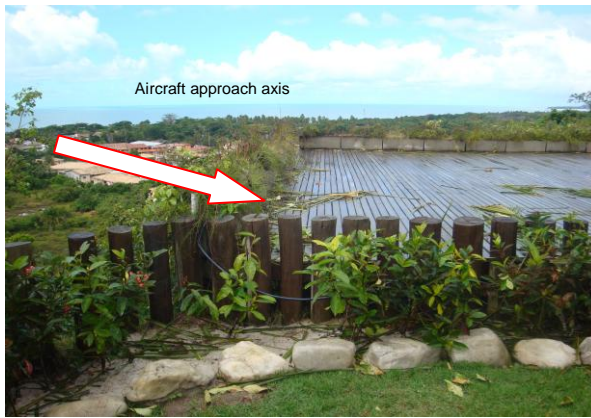
When landing was imminent, it is possible that the pilot, noticing that the aircraft was sped-up, may have performed a flare with a pitch-up higher than the ideal, causing the tail rotor blades to hit the vegetation that had grown near the edge of the deck.

Figure 11 – Vegetation on the edge of the deck.

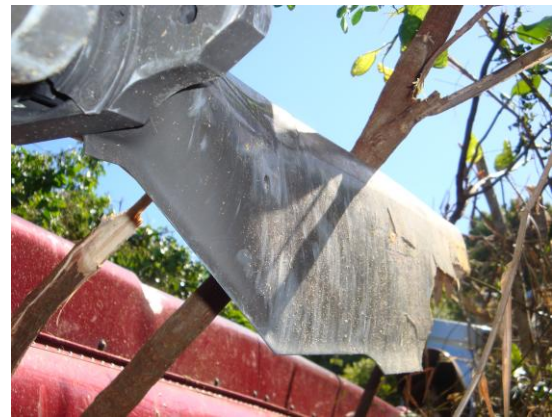
It was not possible to determine whether the damage sustained by one of the tail rotor blades resulted from the contact with the vegetation or from the impact of the aircraft with the ground.

Figure 12 – Damage to the tail rotor blades.
