FINAL REPORT
A - Nº 006/CENIPA/2010

PR-FBA

PA-25-235

11 JAN 2008

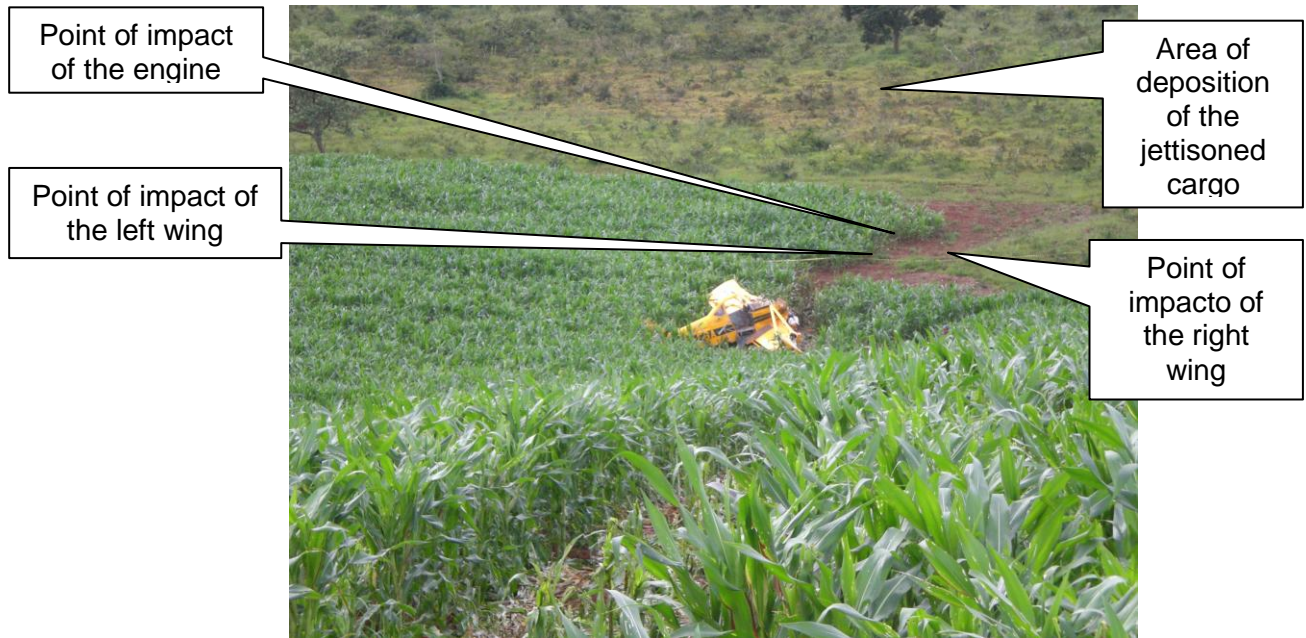
The aircraft hit the ground with the right wing first, and then the nose and the left wing. Its approximate attitude at the moment of impact was 90 degrees in relation to the ground.

Photo 01: area of the impact.

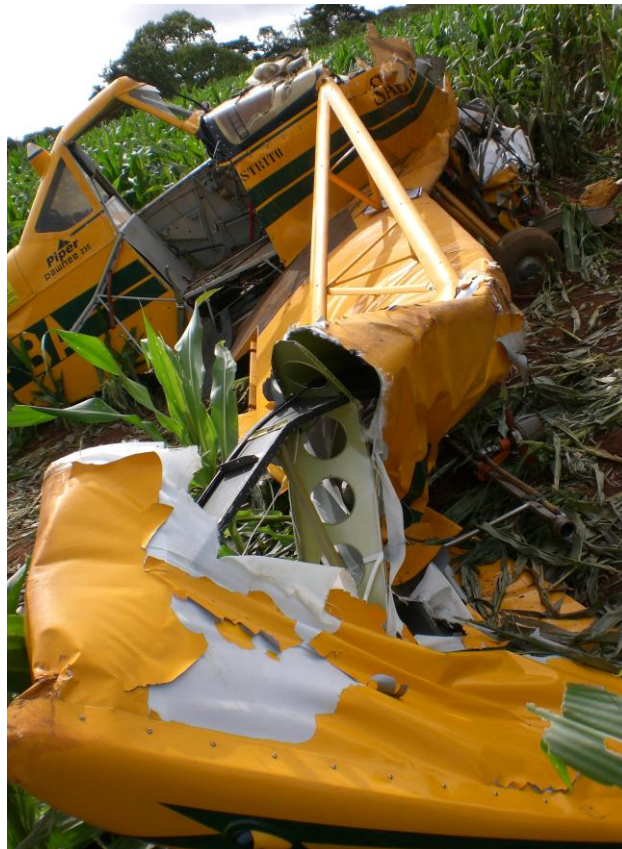
The right wing was severely damaged, with one third of it (toward the wing tip) presenting a torsion of 180° (leading edge backwards).

Photo 02: wing tip twisted due to the rotational impact derived from the spin.
