COMMAND OF AERONAUTICS
AERONAUTICAL ACCIDENT INVESTIGATION AND
PREVENTION CENTER

FINAL REPORT
A - 031/CENIPA/2013

<u>OCURRENCE:</u>	ACCIDENT
<u>AIRCRAFT:</u>	PR-FPM
<u>MODEL:</u>	EC-120 B
<u>DATE:</u>	30 April 2009

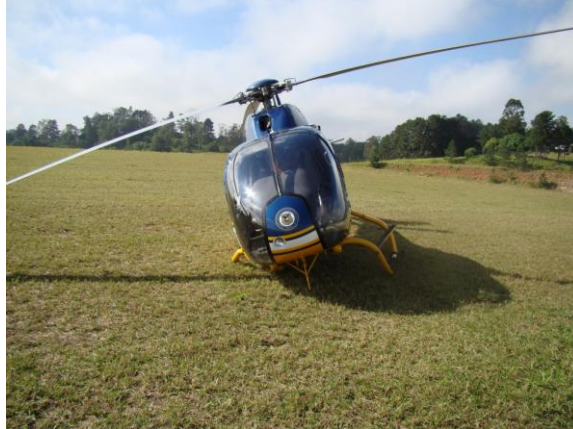
The aircraft sustained serious damage to the ski, and minor damage to the fuselage.

The impact occurred in a practically vertical direction. There was a partial opening of the skis, resulting in full damage (total loss).

The fuselage detached from the skis at the rear fixation points, with the aircraft leaning on its right side (approximately 20 degrees of inclination).

Figure n° 1 Situation of the aircraft after landing.
