COMMAND OF AERONAUTICS
AERONAUTICAL ACCIDENT INVESTIGATION AND
PREVENTION CENTER

FINAL REPORT
A - 044/CENIPA/2014

<u>OCCURRENCE:</u>	ACCIDENT
<u>AIRCRAFT:</u>	PR-GFD
<u>MODEL:</u>	C-172N
<u>DATE:</u>	09 SEPT 2012

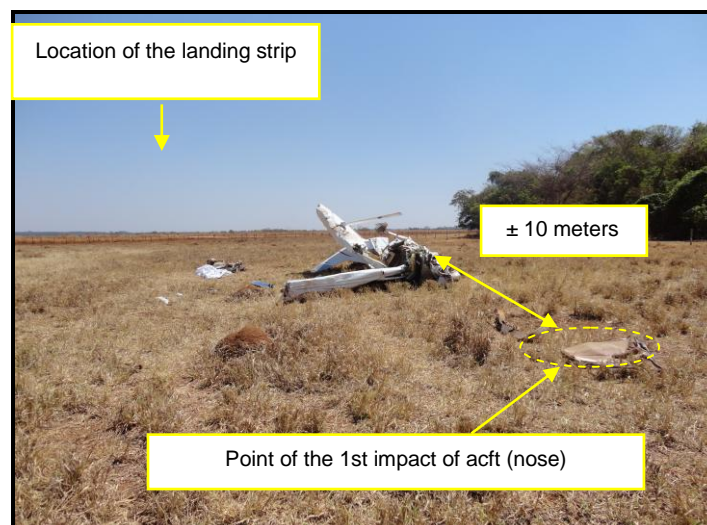
The aircraft collided with the ground at angle of approximately 80° in a pitch-down attitude with a slight inclination to the left.

Figure 3 – Position of the aircraft after the accident.

After the impact, the aircraft stopped in an inverted position, at a distance of 10 meters from the point of the first impact (nose of the aircraft). The wreckage lay-out remained concentrated, with signs of significant damage.

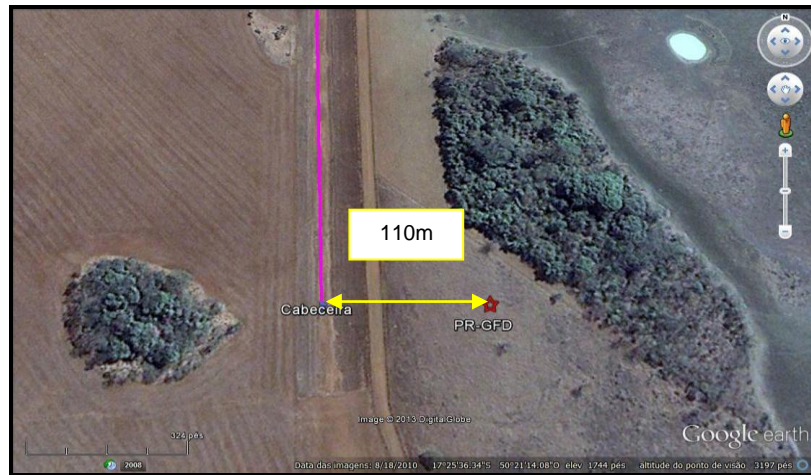
Figure 4 – Location of aircraft wreckage relative to landing strip.

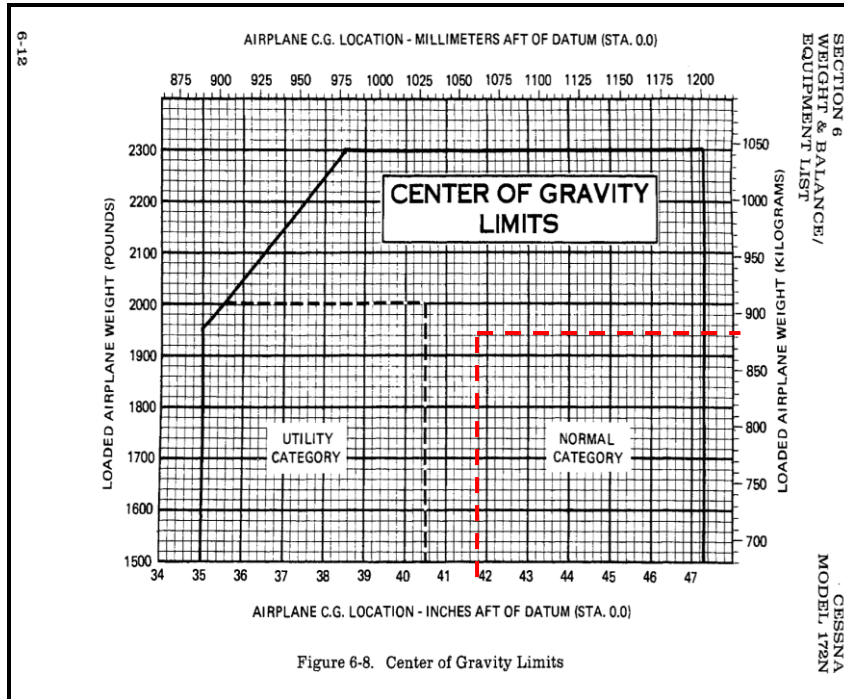
Figure 6-8. Center of Gravity Limits

According to estimated balance calculations, the aircraft center of gravity was approximately 41.8 inches behind the aircraft line of reference (firewall).

Figure 6 – Graph of the Center of Gravity limits.

According to the weight and balance data (estimated) the aircraft was within the limits established by the manufacturer.

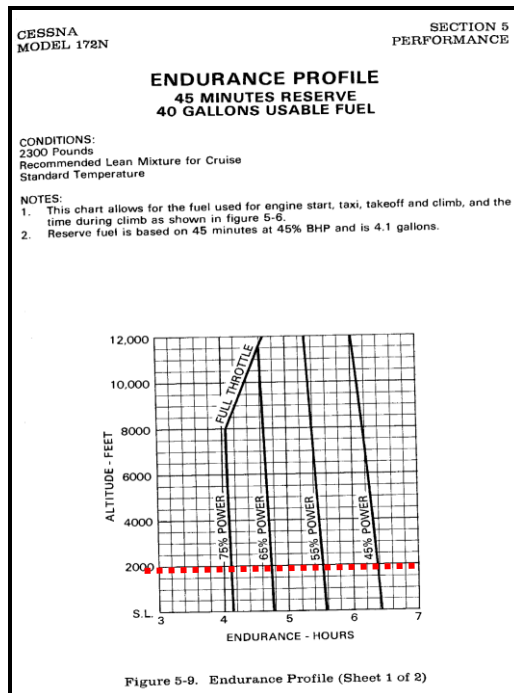
Figure 5-9. Endurance Profile (Sheet 1 of 2)

Figure 7 – Graph of the aircraft endurance.

The red dotted-line indicates the airfield altitude considered on the day of the accident.

By reviewing the aircraft endurance graph, it was verified that, for an altitude of 1,850ft (relative to the landing strip utilized), the aircraft endurance would be somewhat between 4 hours 10 minutes (75% thrust) and 6 hours 20 minutes (45% thrust), considering a full load of fuel (40 usable gallons).

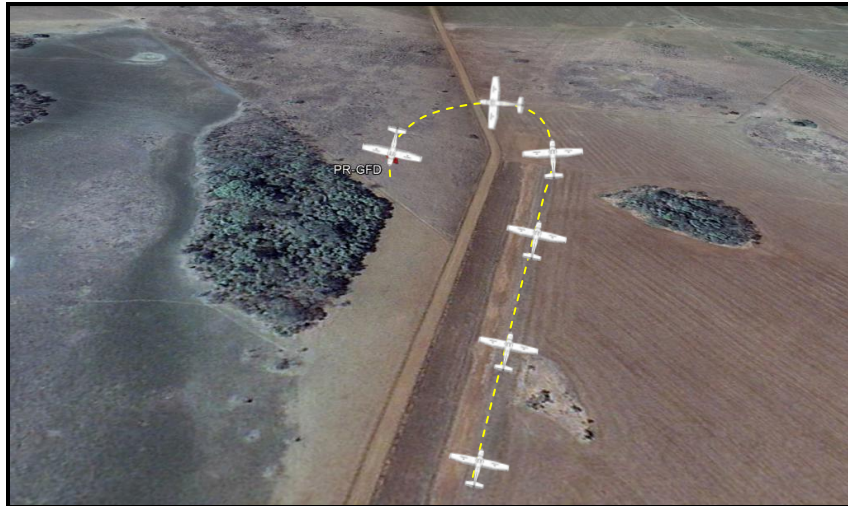
According to witnesses, the aircraft took off in the direction of threshold 18, made a left turn, lost altitude and collided with the ground.

Figure 8 – Slant view of the takeoff profile.

The takeoff profile observed by the witnesses and the angle of impact of the aircraft with the ground are compatible with the occurrence of loss of control in flight resulting from the aircraft loss of lift (stall).
