FINAL REPORT
A - 010/CENIPA/2013

<u>OCCURRENCE:</u>	ACCIDENT
<u>AIRCRAFT:</u>	PR-JBN
<u>MODEL:</u>	BELL 206B
<u>DATE:</u>	21 January 2013

This is the Final Report of the 21 January 2013 accident with the Bell 206B helicopter, registration PR-JBN. The accident was classified as loss of control in flight.

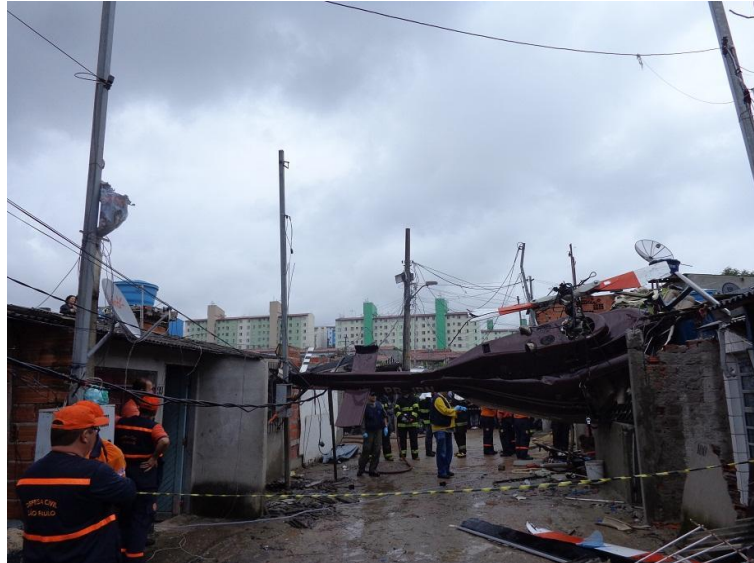
The crash resulted in fracture of the two main rotor blades, fracture of the tail rotor transmission, and substantial damage to the main transmission, cabin and landing gear (skis) structures, and bending of the tail boom.

The impact of the aircraft resulted in great deceleration of the cabin, with a horizontal component that was bigger than its vertical counterpart.

The aircraft first collided with a secondary low tension electric wiring.

The wiring twined around the main transmission, and the helicopter precipitated onto the roofs and concrete slabs of two houses, fracturing the two main rotor blades, while the tail boom collided with a lamp post and the structure of another house.

The wire-cutting system on the front part of the helicopter fuselage did not have marks indicative of the cutting of wires prior to the crash.

Figure 1 – Situation of the aircraft after the collision.

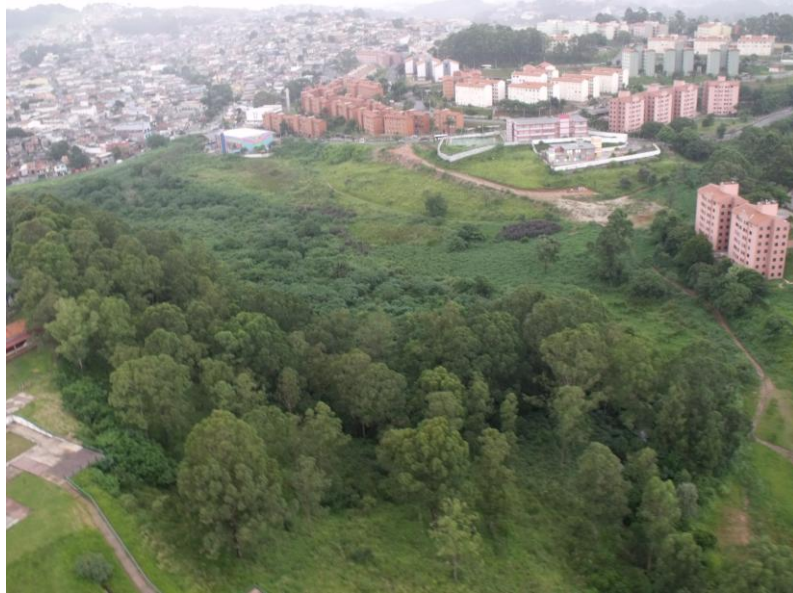
The analysis of photographs and videos recovered from the camera used by the front seat passenger revealed that the altitude of the flight was approximately 200ft above the ground.

Figure 2 – Photograph taken by the passenger sitting on the front left seat aboard the PR-JBN, moments before the impact.

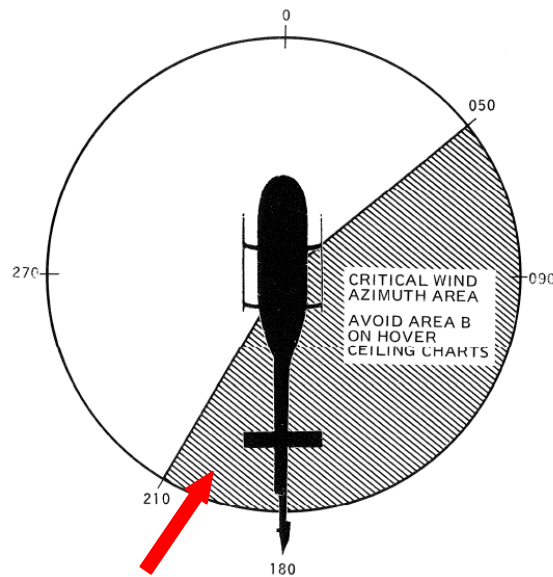
In the BELL 206 flight manual, the manufacturer warns of a critical wind quadrant relative to the plane of the main rotor.

According to the manual, the drag induced by the main rotor should be observed in relation to the prevailing wind, which would turn out to be a relevant circumstance if one considered a hover flight.

With the main rotor rotating in a counterclockwise direction, such quadrant was to the right of the aircraft, from the bearing 050° (relative to the aircraft heading) to the bearing 210°.

According to the passengers, in the last segment of the flight moments before the accident, the aircraft was flying in a northerly direction, and the pilot was asked by the team of passengers about the possibility of a better sighting of the terrain that had just been left behind and to the left. That was when the backward flight was executed.

Figure 3 - Bell 206B Flight Manual, with the critical wind quadrant.

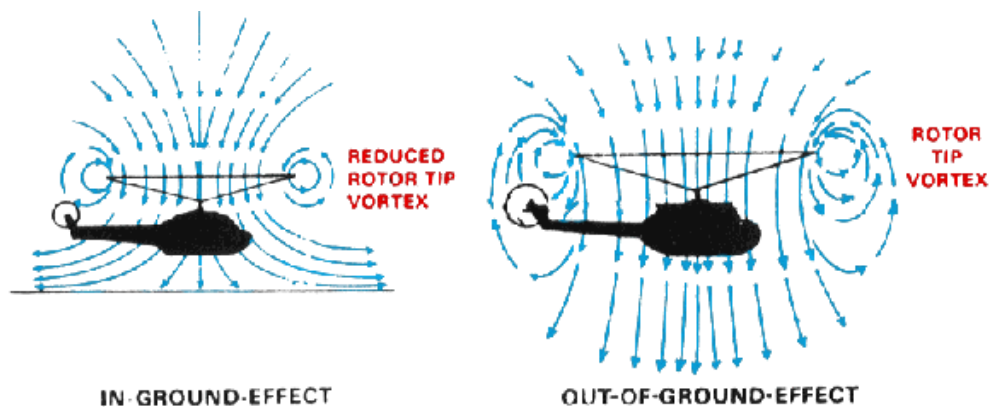
In this type of flight, one has to consider the ground effect issue since the aircraft was flying and would sometimes hover at an altitude of approximately 200ft, that is, outside the ground effect.

Therefore, the graphics to be consulted for the analysis of the helicopter performance are related to the out-of-ground-effect flight, in which lift tends to deteriorate if compared with a hover in-ground-effect flight.

Figure 4 – Helicopter in- and out-of-ground-effect.

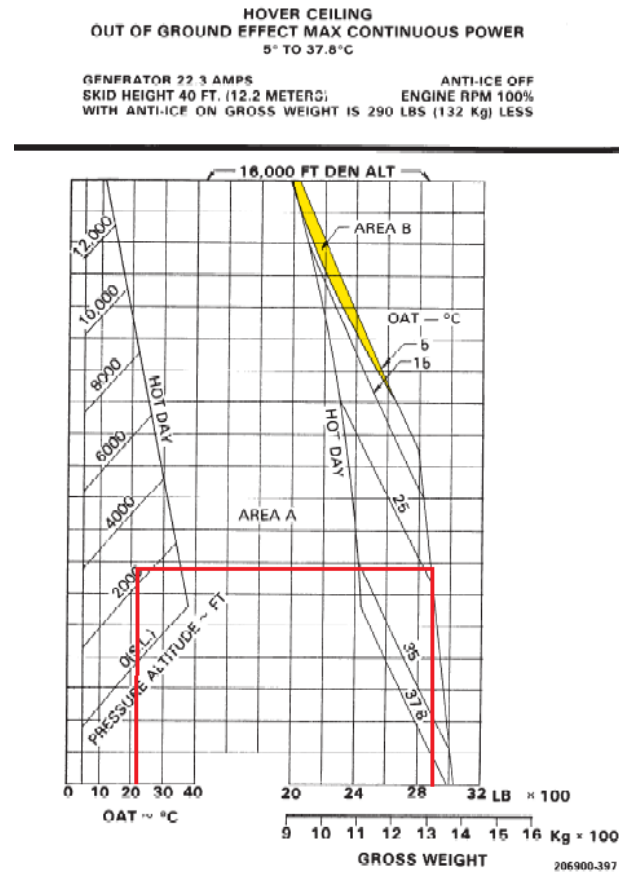
In hover flights with that profile, the following parameters would be observed at the time of the occurrence:

- 1) Estimate helicopter weight: 1,320kg (2,910lb);
- 2) Pressure altitude: approximately 2,500ft;
- 3) Outside air temperature: approximately 22°C.

By referring to the Flight Manual graph *Hover Ceiling – Out of Ground Effect*, it is possible to observe that the helicopter (weight of 2,910lb) was at its operational limit for a hover flight in those circumstances.

Figure 5 – Graph of a hover flight out of ground effect, with red lines indicating the situation of the PR-JBN.
