COMMAND OF AERONAUTICS
AERONAUTICAL ACCIDENT INVESTIGATION AND
PREVENTION CENTER

FINAL REPORT
A - 083/CENIPA/2013

<u>OCCURRENCE:</u>	ACCIDENT
<u>AIRCRAFT:</u>	PR-LJI
<u>MODEL:</u>	CESSNA 210L
<u>DATE:</u>	26 APRIL 2013

This is the Final Report of the 26 April 2013 accident with the Cessna 210L aircraft, registration PR-LJI. The accident was classified as inflight engine failure.

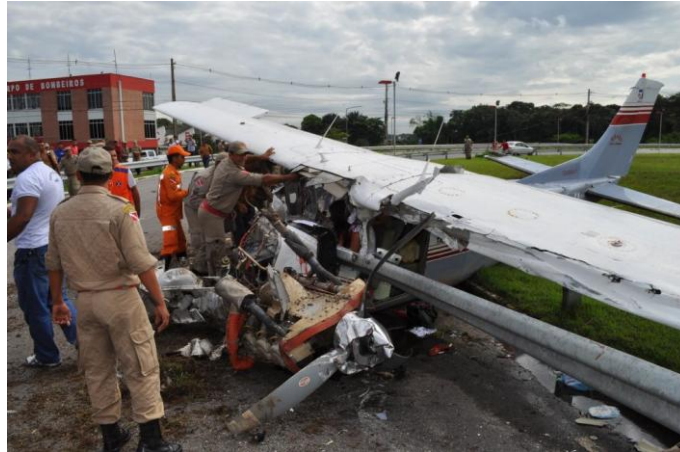
The impact of the aircraft with the ground was at a pitch-down angle of approximately 20 degrees, with a slight banking to the right.

It was also observed that the engine separated with the cradle of the aircraft firewall, and was found in an upside down position.

Figure 1 – Situation of the aircraft after the impact.

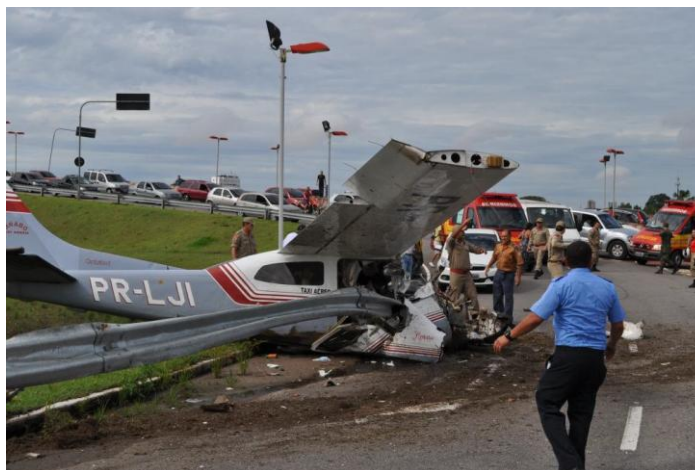
The left wing sustained substantial damage, mainly to its leading edge.

Figure 2 – Situation of the aircraft after the impact.
