COMMAND OF AERONAUTICS
AERONAUTICAL ACCIDENT INVESTIGATION AND
PREVENTION CENTER

FINAL REPORT
A - 042/CENIPA/2013

<u>OCCURRENCE:</u>	ACCIDENT
<u>AIRCRAFT:</u>	PR-TPL
<u>MODEL:</u>	AT-502B
<u>DATE:</u>	01 March 2013

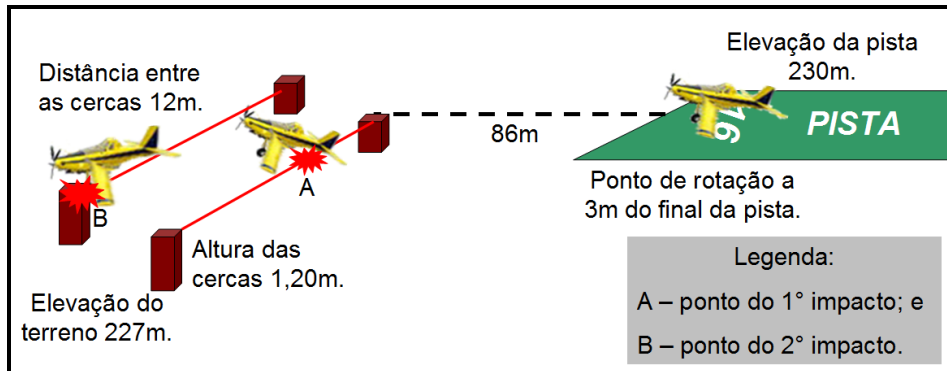
The first impact of the aircraft resulted from the rear landing gear hitting a fence located in the direction of departure at a distance of 86 meters from the end of the runway.

The elevation of the runway at the final point of the runway was 230m (altitude). The fence was 1.2 meters tall, and had been built where the terrain was at an altitude of 227 meters.

Figure 1 - Croquis showing the 1st and 2nd points of impact.

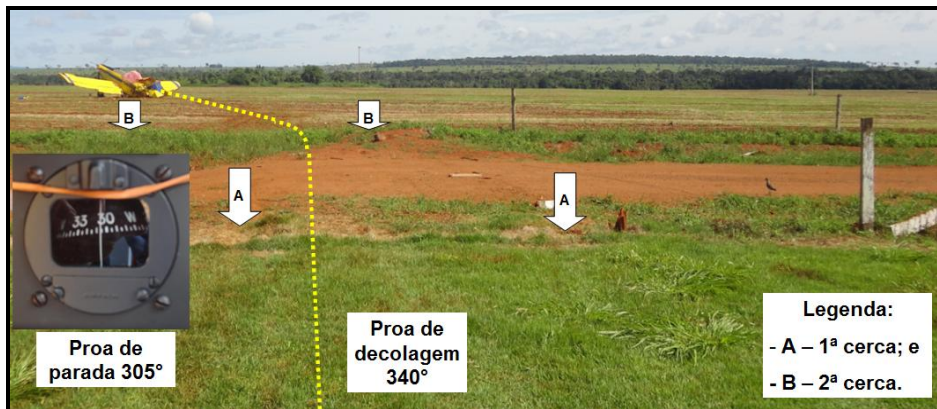
Figure 2 – View of the area of the 1st and 2nd impacts. The yellow line represents the projection on the ground of the trajectory of the aircraft, which went through the fences while still flying.

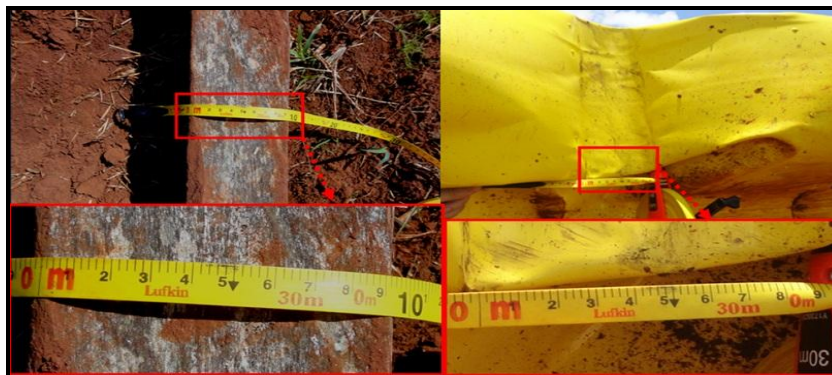
The second impact resulted from the collision between the left-wing leading edge with a post of the second fence located at a distance of 12 meters from the first fence (letter B in the picture).

Figure 3 – On the left, the fence post with a width of 9 cm. On the right, the mark left by the post on the left-wing leading edge (second impact).

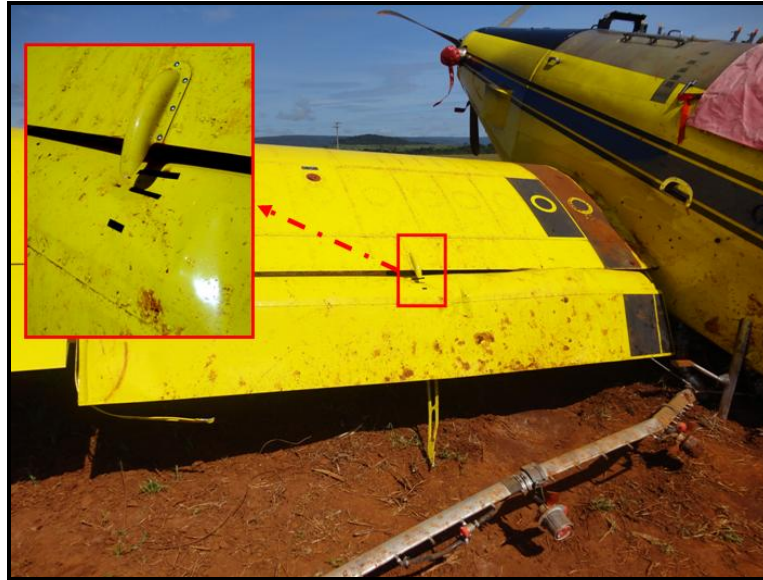
In the wreckage, it was possible to notice that the flaps were fully lowered (26°).

There is not an indicator on the panel. The information is obtained by visually observing the wing. The detail shown in Figure 4 (augmented on the left) was obtained from the pilot's line of sight, indicating flaps completely extended.

Figure 4 – Indicator of the left flap position.

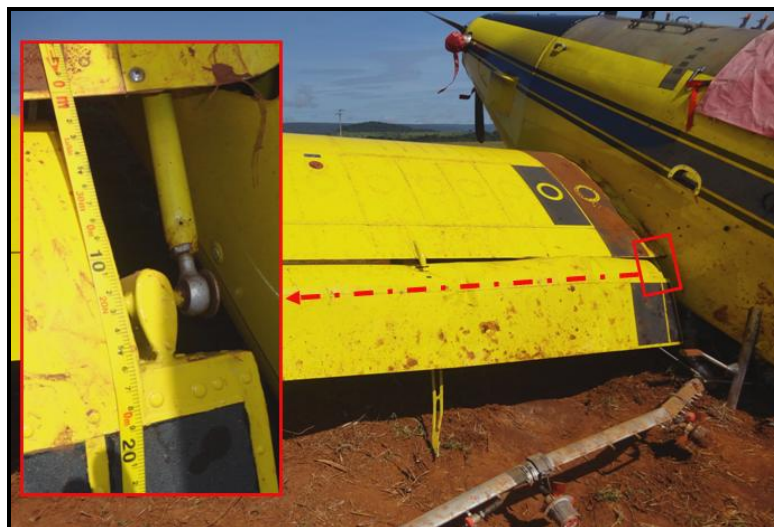
Since the surface of the flaps could have been hit with consequences to the indication, measures were taken close to the wing root, where the surface was intact and the attachment had no plays.

Figure 5 – Measurement made on the left-hand side flap panel, showing a distance of 17.7cm up to the rivets of the lower part.

Since the actuators were found intact and without 'play', the information of flaps at 26° proved reliable, through comparison of the flap measures obtained from the accident aircraft and from another undamaged one.

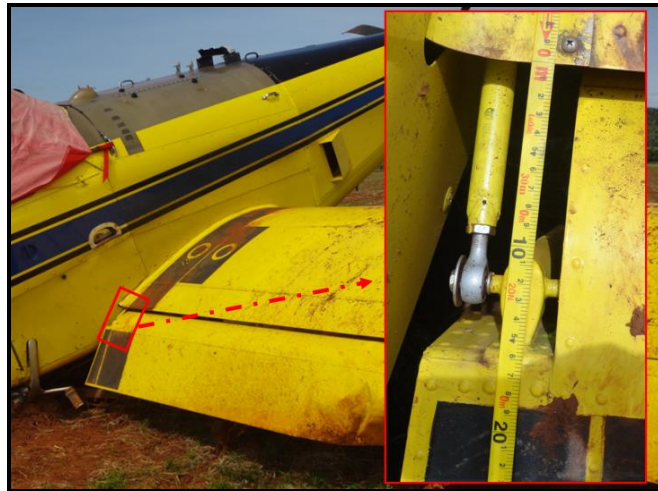
Figure 6 - Measurement made on the right-hand side flap panel, showing a distance of 17.7cm up to the rivets of the lower part.

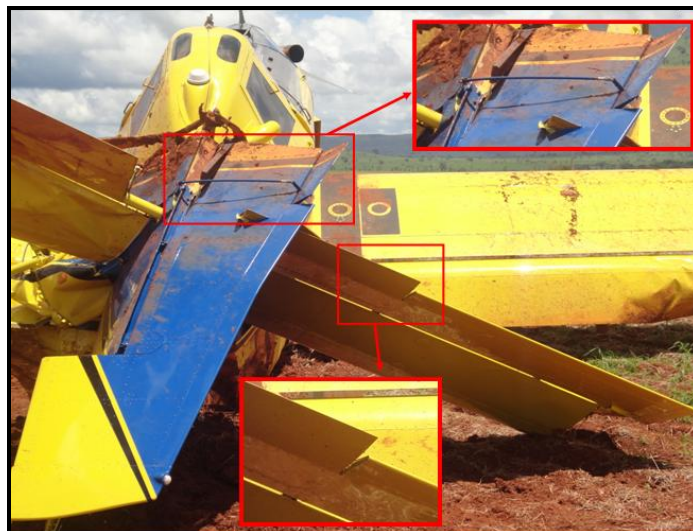
The elevator's and rudder's dampers were not in the neutral position, but their indications were considered not dependable on account of the impacts sustained.

Figure 7 – Position of the rudder and elevator trimmers.

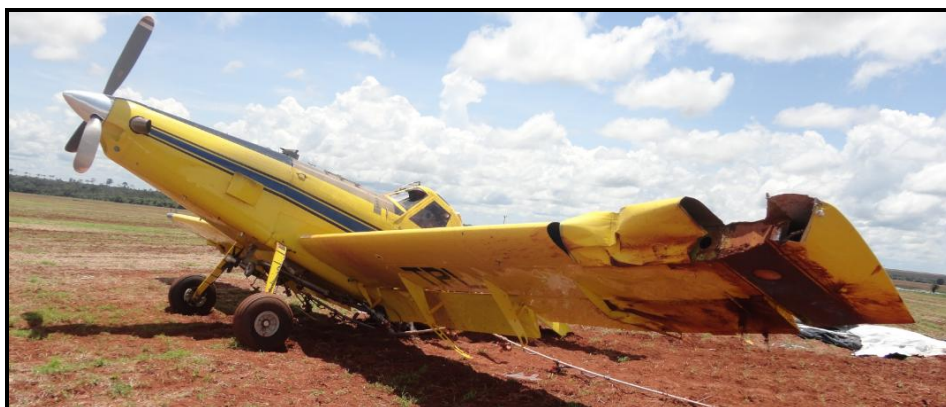
There was substantial damage to the leading edge of the left wing and to the empennage, as well as widespread damage to the remainder of the aircraft structure.

Figure 8 – Damage to the left-wing leading edge.

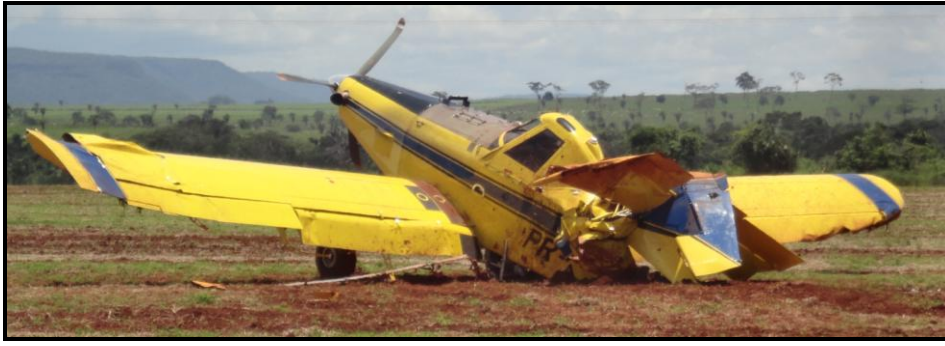
Figure 9 – Damage to the rear section of the aircraft.

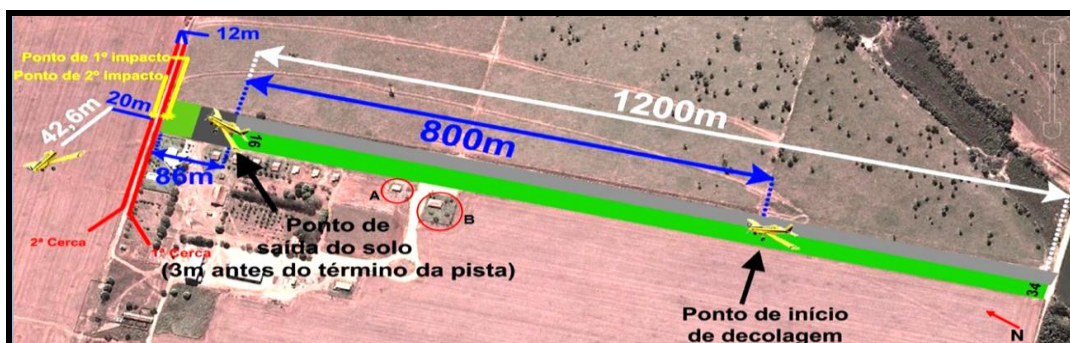
Figure 10 shows the place of refueling and parking of the aircraft (indicated by the red circle around letter “A”).

The administration office is indicated by letter “B”.

Figure 10 – The grass runway is represented in green. The fences are represented by the red lines (points of the first and second impacts).

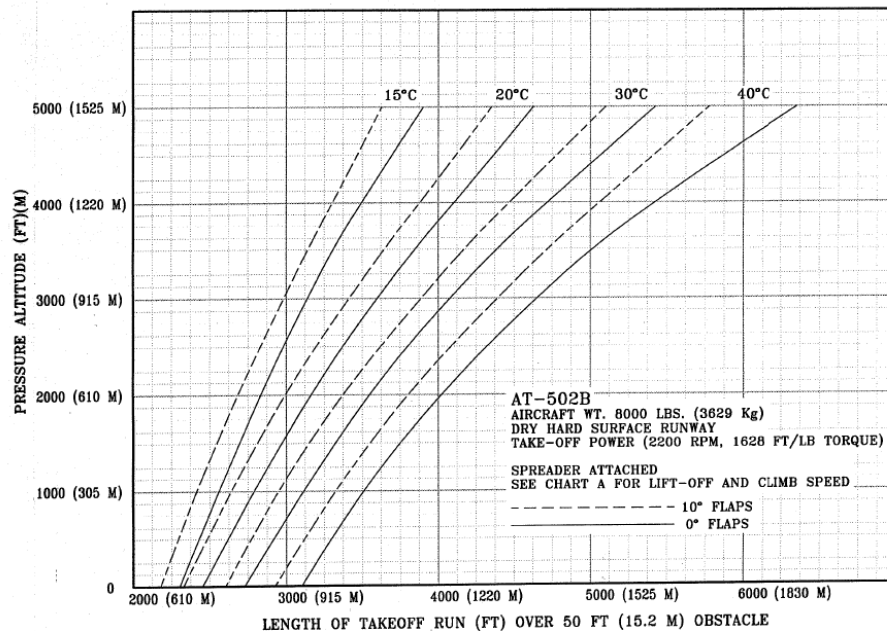
The Section 4 (Performance) of the *AT-502B Airplane Flight Manual Brazil* shows the graph for analysis of the takeoff run length necessary for the clearance of a 50ft obstacle.

The parameters utilized take into account a dry paved runway, with the aircraft at its maximum takeoff weight (3,629Kg), using flaps at 0° and 10°.

There is no availability of graph for analysis of an unpaved runway.

Figure 11 – Graph analysis of the takeoff run length needed for clearing an obstacle of 50ft.

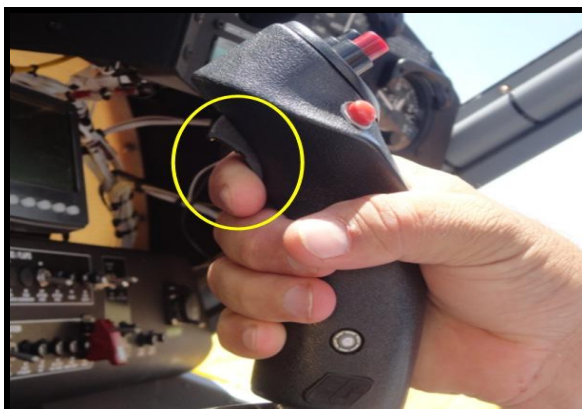
A possibility is considered that the flaps may have been inadvertently moved on due to the fact that the switch is not approved for the aircraft design (see figures 12 and 13).

During the initial action performed by the go-team, it was verified that the aircraft had a switch that had been installed on the stick for retracting the flaps.

Figure 12 – Command for flaps extension.

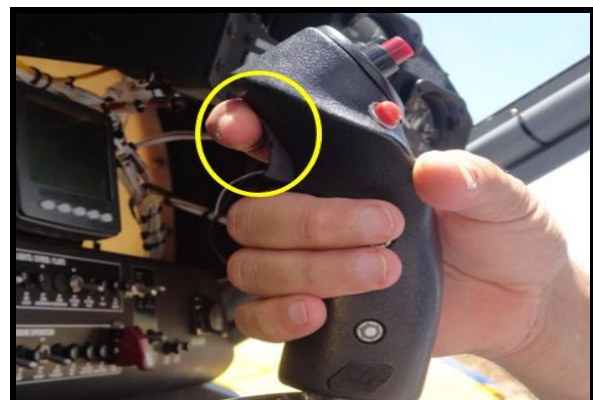
Figure 13 – Command for retracting the flaps.

According to the aircraft manufacturer’s statement, the flap control switch installed on the stick is not approved in the AT-502B design.

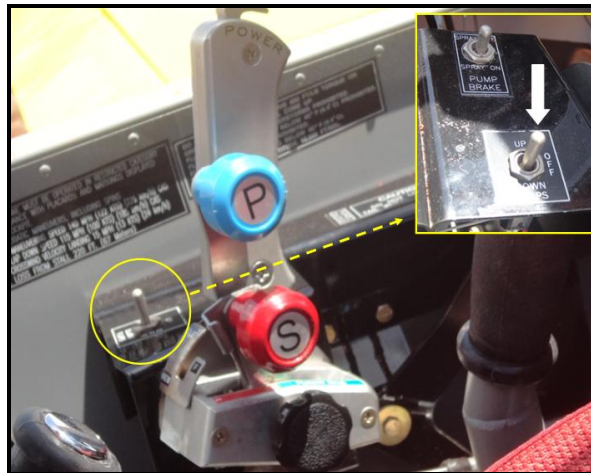
The *switch* in the original design is located close to the levers’ pedestal (figure 14).

Figure 14 – Flap control *switch* approved by the manufacturer, close to the levers’ pedestal.

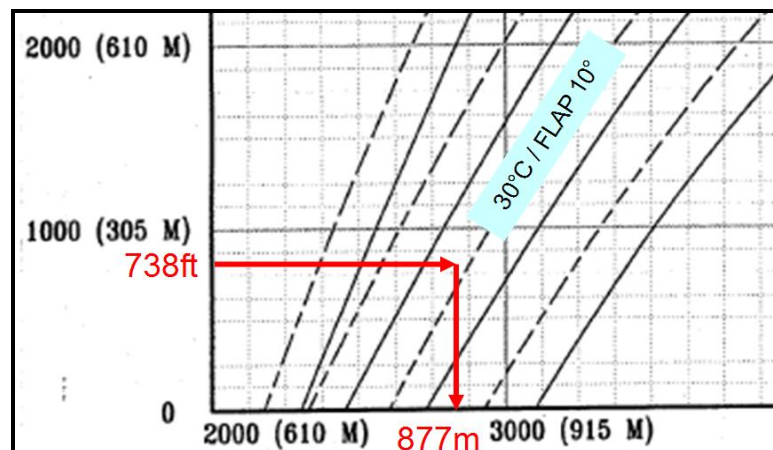
For analyzing the takeoff performance, it is necessary to utilize the data shown above. The temperature was 29°C, aerodrome altitude was 738ft, and takeoff weight was 3,061Kg.

Figure 15 – Calculation of the takeoff run distance to clear a 50ft obstacle, based on the graph presented in Figure 17.

The graph available in the aircraft flight manual presents the takeoff performance for a dry paved runway only. There is no specific graph for either an unpaved or wet runway.
