**COMMAND OF AERONAUTICS**  
**AERONAUTICAL ACCIDENT INVESTIGATION AND**  
**PREVENTION CENTER**

**FINAL REPORT**  
**A - 084/CENIPA/2013**

| <b><u>AIRCRAFT:</u></b> | <b>PR-VAR</b> |
| <b><u>MODEL:</u></b> | <b>AT-502B</b> |

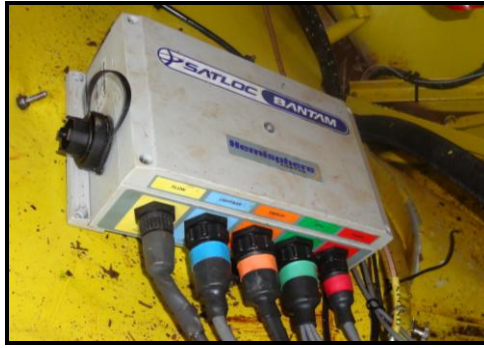
Figure 1 - CPU of the PR-VAR aircraft GPS.

During the investigation, the data recorded and stored in the non-volatile memory of the GPS was retrieved (altitude, heading and speed information of the flights of the day of the accident and of previous days).

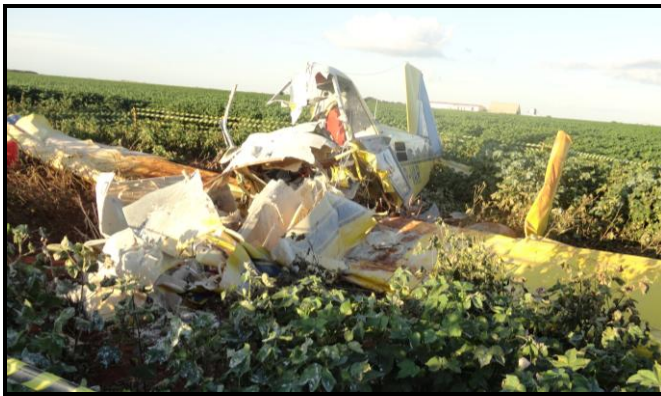
Figure 2 – Front view of the aircraft.

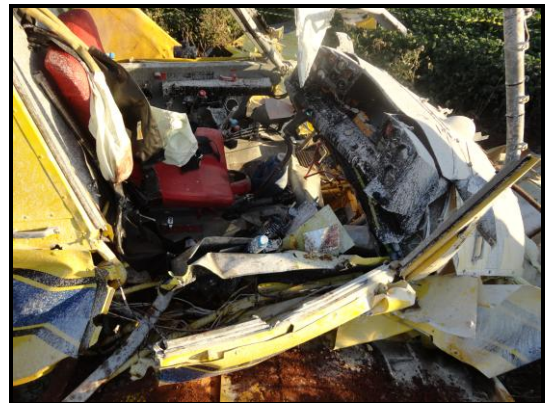
Figure 3 – Aircraft cockpit.

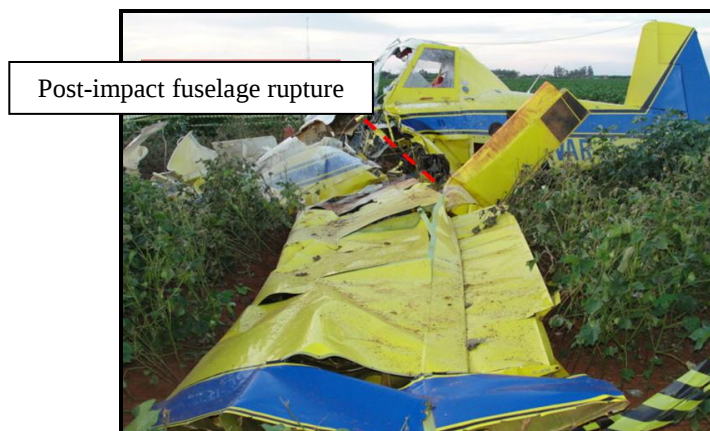
Figure 4 – Post-impact fuselage breakage.

On account of the angle of impact (approximately 60°), the front part of the aircraft got buried into the ground, and the fuselage structure sustained a rupture at a point ahead of the cockpit.

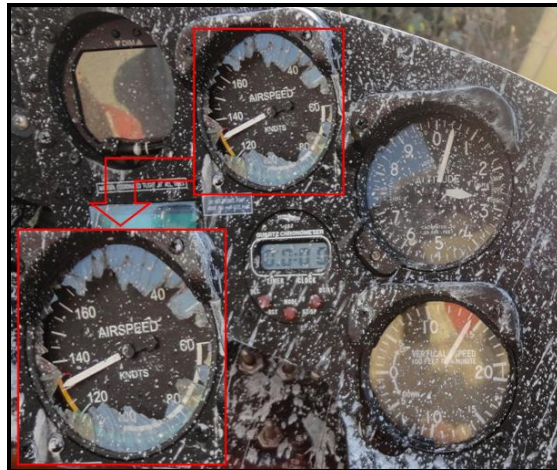
The ASI pointer was indicating 132kt.

Figure 5 – ASI with indication of 132kt.

The angle of impact, the damage to the aircraft, and the ASI indication of 132kt show correlation with the final result expected for the flight profile described by the witnesses.

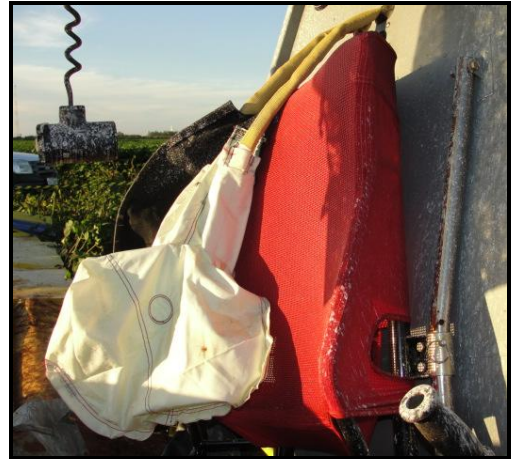
The airbag was activated at the moment of the aircraft impact with the ground, but the pilot received fatal injuries.

Figure 7 – Picture showing that the airbag of the PR-VAR was activated.

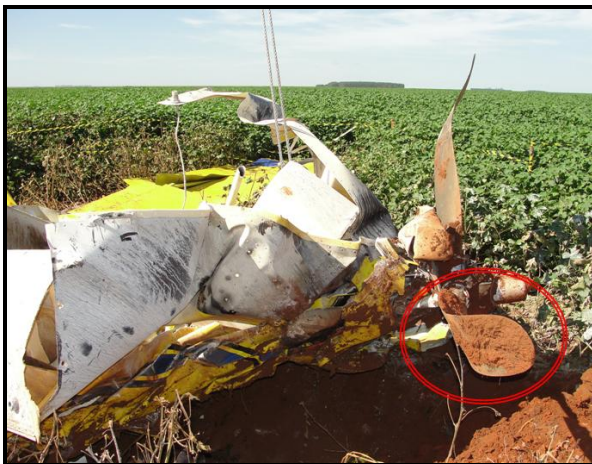
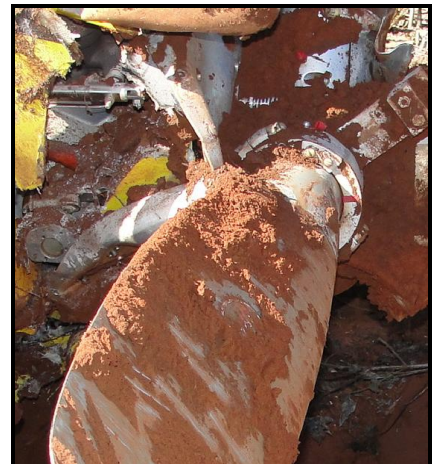
Besides, upon lifting the aircraft front part (which was buried), it was possible to verify from the forward bent of the propeller that, at the moment of the collision with the ground, the engine was operating with high power regime.

Figure 8 – Propeller blade highlighted by the red circle, indicating that the engine was developing high power at the moment of impact with the ground.

During the research conducted on the aircraft wreckage, it was verified that the propeller hub had not broken and that the propeller pitch setting was compatible with the developing of normal power by the engine.

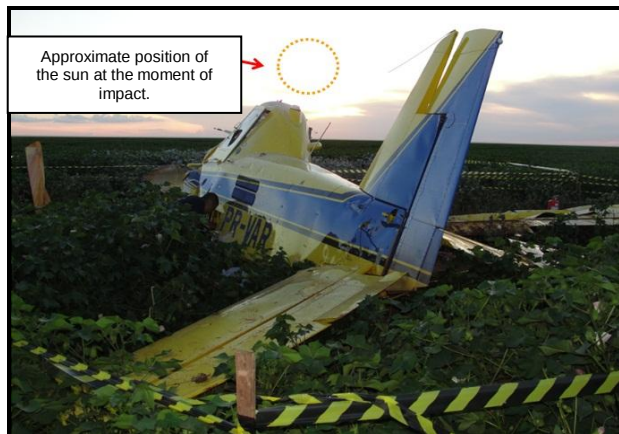
The aircraft control cables were inviolate, except for the one of the left elevator which broke as a result of the impact. The left horizontal stabilizer fixation tube broke and these components remained close to the aircraft.

Figure 9 – Breakage of the left horizontal stabilizer as a result of the impact.

At the moment of the impact of the aircraft with the ground, the left horizontal stabilizer attachment tube broke, causing the rupture of the left elevator control cable. All these components remained connected to the aircraft structure, indicating that there had not been detachments of the control surfaces in flight.

The loss of control was not a consequence of a failure of the cables, since they were found intact, with the exception of the left elevator cable, which broke as a result of the impact.

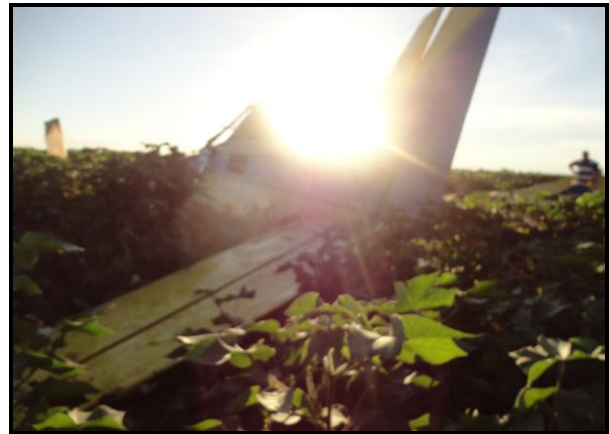
Figure 10 – Approximate position of the sun at the moment of impact.

If the pilot really performed a stall turn, he started the maneuver with the sun at 'six o'clock' and, after the reversion at the top of the maneuver the sun was ahead of him, next to the line of the horizon, and the pilot would be exposed to a glaring, which may have favored spatial disorientation.

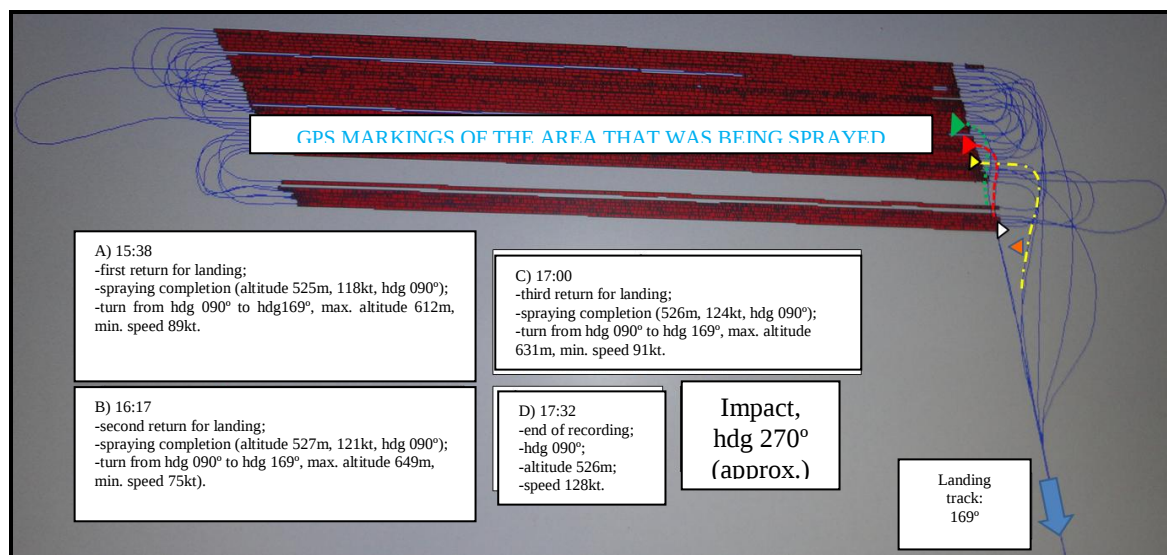
This time, in order to land, the aircraft made a turn to the right up to heading 169°. On the turn, the maximum altitude of the aircraft was 631 meters, and the minimum speed was 91kt, as highlighted in the profile in yellow of figure 11.

Figure 11 – Flight profile recorded in the GPS.

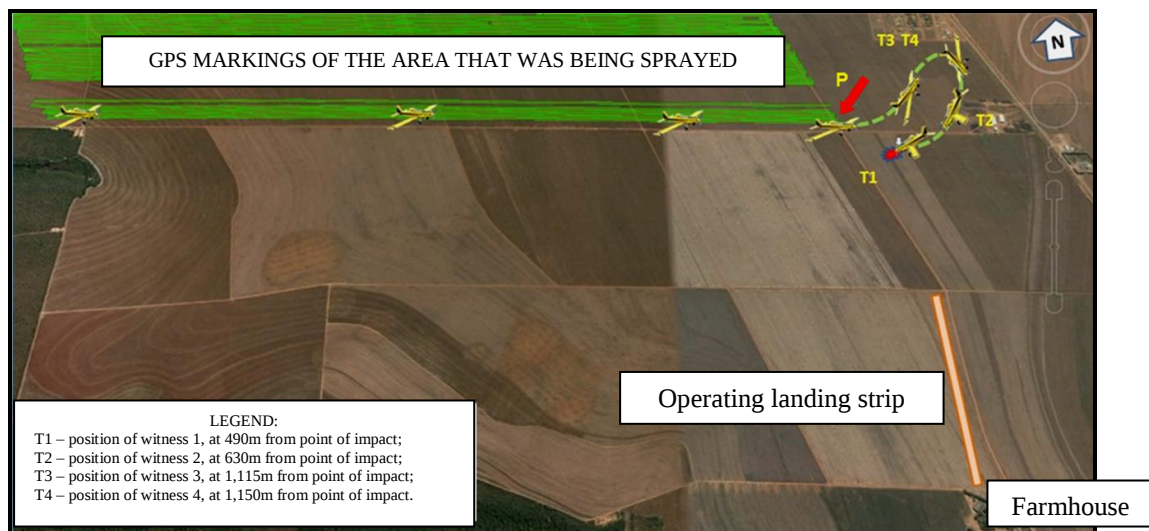
Four witnesses, at different locations (T1, T2, T3 and T4 – figure 12), observed the aircraft flight profile after completion of the last spraying pass. The interviews with these witnesses were held separately in different places and moments.

Figure 12 – Location of the witnesses. The flight profile after position “P” was obtained from reports.

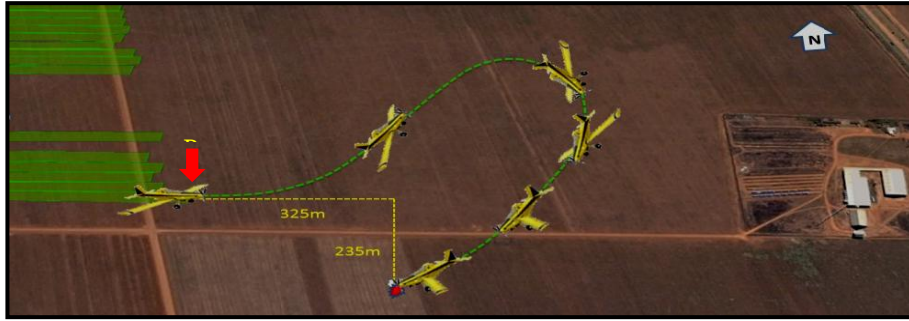
This hypothesis may be observed in the figure 14 below, as the rapid ascension would justify the fact that the aircraft finished the spraying at a heading of 090° and, with little forward movement, impacted the ground at an angle of approximately 60° at a heading of about 270°.

The maneuver described by the witnesses is similar to a stall turn. In this maneuver, the aircraft climbs almost vertically, and is taken to a stall condition, with a 180°-turn at the top, for a subsequent recovery with loss of altitude (figure 14).

Figure 14 – Aircraft maneuver as described by the witnesses.
