COMMAND OF AERONAUTICS
AERONAUTICAL ACCIDENT INVESTIGATION AND
PREVENTION CENTER

FINAL REPORT
A - 033/CENIPA/2013

<u>OCURRENCE:</u>	ACCIDENT
<u>AIRCRAFT:</u>	PT-AVK
<u>MODEL:</u>	D-35
<u>DATE:</u>	29 September 2011

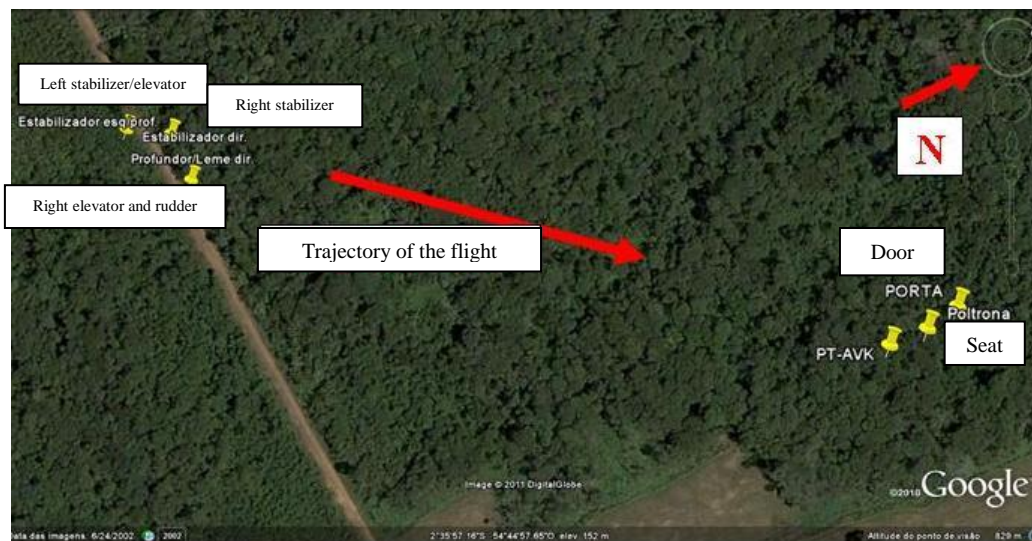
Figure 1 - Croquis of the aircraft wreckage distribution.

In the crash site, it was verified that the V-tail empennage had detached from the aircraft in flight.

The stabilizers and ruddervators were found along the trajectory of the aircraft, at a distance of 800 meters short of the concentration of the remainder of the wreckage.

The distribution of the wreckage was of a linear type, as can be seen in the figure below.

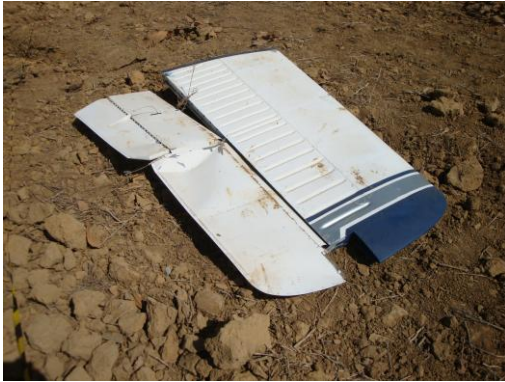
Figure 2- Left stabilizer and ruddervator.

It was observed that the three fixation points of the left stabilizer to the aircraft tail cone had broken. It was also possible to notice accentuated corrosion in this area of the aircraft.

By means of tests, it was possible to determine that there was a rupture of the left stabilizer, with fracture of the three points of fixation to the aircraft tail cone.

The fracture began in the front fixation point, due to a weakening caused by accentuated corrosion and the fact that the stabilizer root reinforcement kit had not been installed.

So, the initial rupture took place on the left side of the tail stabilizing surface, in the front fixation point, which presented accentuated corrosion, weakening its fastening to the fuselage.

The marks left on the painted surface of the tail cone coating confirm that there was torsion of the central longeron of the stabilizer, up to the point of its full detachment from the aircraft on account of overload.

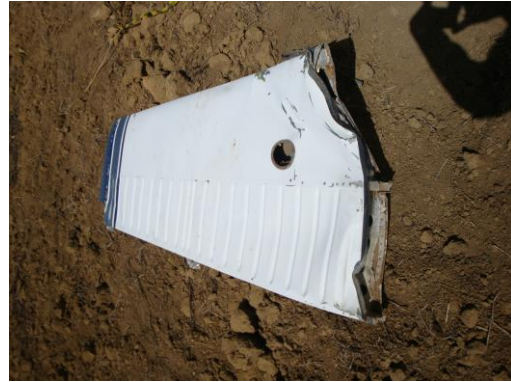
Figure 3 - Right-hand-side stabilizer.

The stabilizers and ruddervators were found along the downward trajectory of the aircraft at a distance of approximately 800 meters from the wreckage concentration.

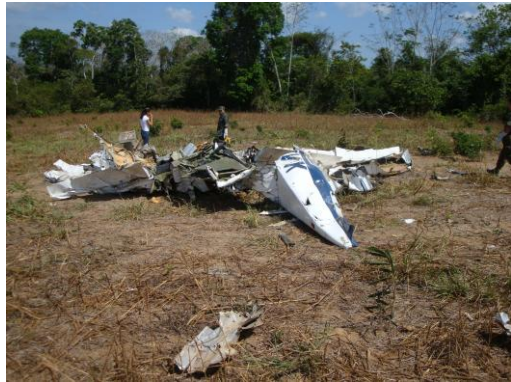
Figure 5 - Wreckage of the PT-AVK.

The aircraft collided with the ground on a pitch-down attitude of approximately 90 degrees.

Due to the large amount of energy of the impact with the ground, the aircraft was completely destroyed, and it was not possible to identify the position of the control surfaces, levers and indicators.

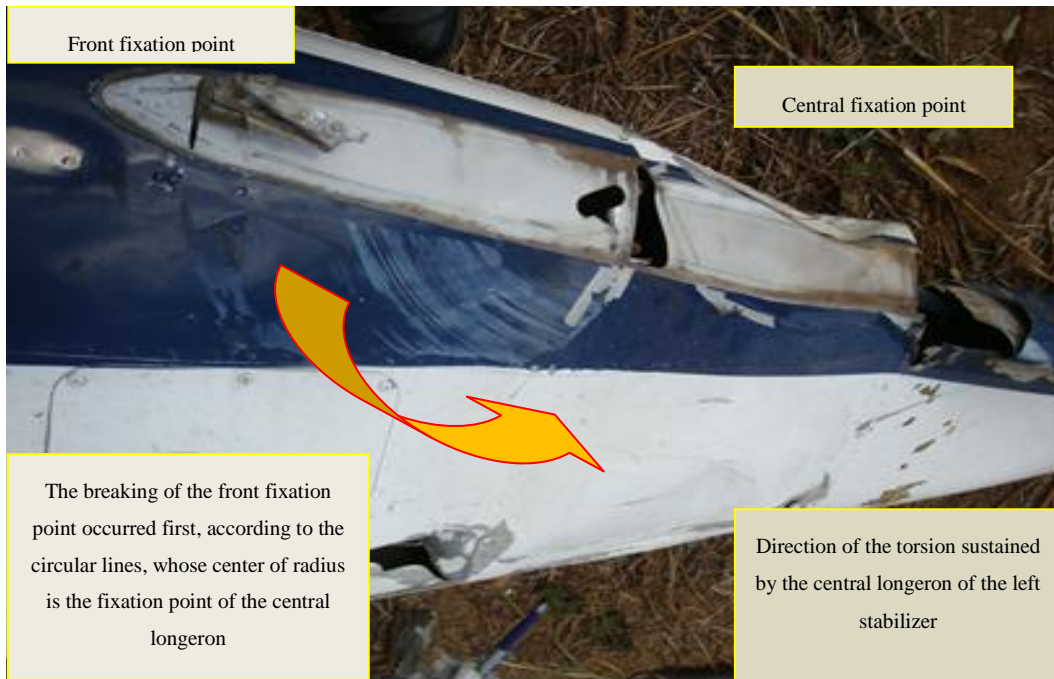
Figure 6 - Fixation points of the left stabilizer to the tail cone of the aircraft.

Since the point of fixation of the stabilizer to the tail cone was weakened on account of the corrosion, it broke due to a torsion effort around the central fixation point in the main longeron of the left stabilizer.

Thus, the commission concluded that the lack of full compliance with the Airworthiness Directive AD 94-20-04R2 (*Prevent structural failure of the V-tail*) and the non-incorporation of the MSB 2188 mandatory service bulletin contributed to the breaking of the front fixation point of the left stabilizer to the tail cone, causing fracture of the central longeron due to overload, resulting in its inflight detachment from the empennage assembly.

AD 94-20-04R2 also contained the mandatory service bulletin MSB 2188, which prescribed reinforcement in the root of the stabilizers in this model of aircraft.

The AD 94-20-04R2 also required compliance with the MSB 2188 mandatory service bulletin, which prescribed the installation of a reinforcement in the root of the stabilizer, something that was not done.

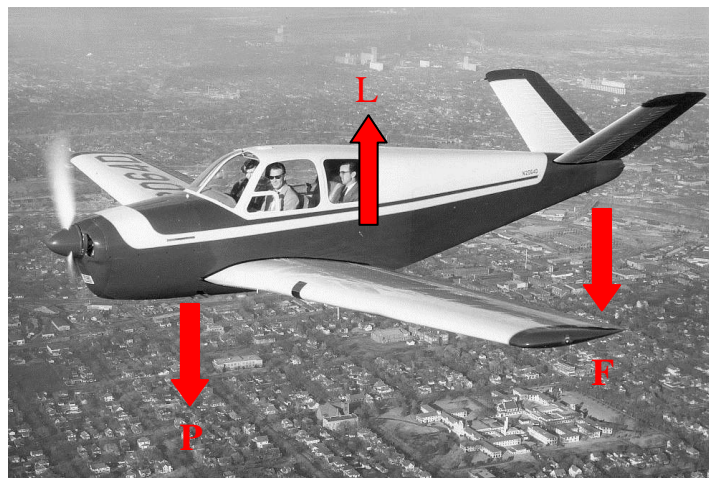
Figure 7 - Forces acting in flight.

The aerodynamic forces acting on the aircraft in flight show that the force exerted by the tail stabilizing surface (F) has a downward direction, in the same direction of the weight, and that both of them are balanced by the lift force (L), something that explains the direction of the torsion effort.

The aerodynamic forces acting on the aircraft in flight show that the force exerted by the tail stabilizing surface (F) has a downward direction, the same direction of the weight (P), and that these forces are balanced by the lift force (L), explaining the direction of the torsion effort.
