**COMMAND OF AERONAUTICS**  
**AERONAUTICAL ACCIDENT INVESTIGATION AND**  
**PREVENTION CENTER**

**FINAL REPORT**  
**A - 127/CENIPA/2013**

| <b><u>AIRCRAFT:</u></b> | <b>PT-HCH</b> |
| <b><u>MODEL:</u></b> | <b>BELL 206B</b> |

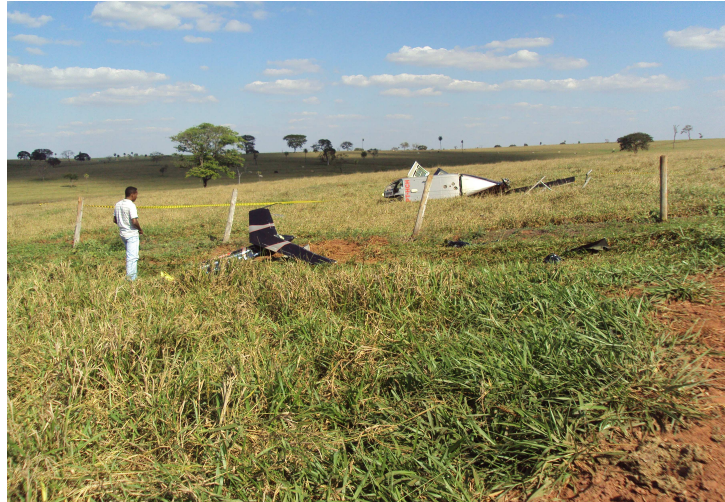
The first impact occurred at a high rate of descent, followed by a spin and collision of aircraft parts with a wire fence. The extremity of the tail boom was cut, with the aircraft tumbling on its right side. The main rotor blades and the aircraft skis were broken. There was extensive damage to the cabin and fuselage.

There was no fuel leak. The wreckage remained concentrated, with the exception of the tail, which collided with the fence.

Figure 1 – Situation of the wreckage.

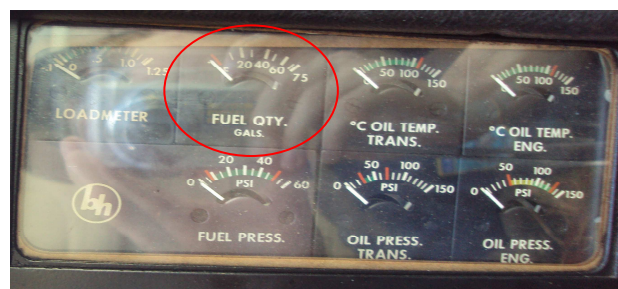
The fuel gauge, in addition to not having indication of low fuel, had a red mark for the condition of empty tank, as shown in picture 2.

Figure 2: Fuel gauge installed in the aircraft.
