**COMMAND OF AERONAUTICS**  
**AERONAUTICAL ACCIDENT INVESTIGATION AND**  
**PREVENTION CENTER**

**FINAL REPORT**  
**A - 162/CENIPA/2013**

<b><u>OCCURRENCE:</u></b>	<b>ACCIDENT</b>
<b><u>AIRCRAFT:</u></b>	<b>PT-HNL</b>
<b><u>MODEL:</u></b>	<b>HB-350B</b>
<b><u>DATE:</u></b>	<b>01 July 2008</b>

<b>AIRCRAFT</b>	<b>Model:</b> HB-350B <b>Registration:</b> PT-HNL <b>Manufacturer:</b> EUROCOPTER	<b>Operator:</b> <i>HAP Participações Ltda.</i>
<b>OCCURRENCE</b>	<b>Date/time:</b> 01 July 2008 / 21:45 local time <b>Location:</b> Heliponto Helicidade (SIBH) <b>Lat.</b> 23°32'48"S – <b>Long.</b> 046°44'13"W <b>Municipality – State:</b> São Paulo – SP	<b>Type:</b> Inflight engine failure

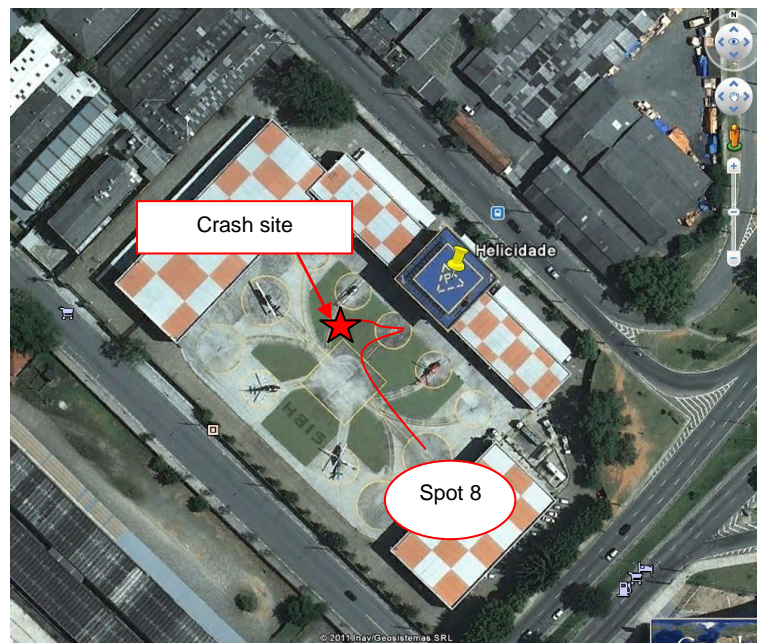
Figure 1 – Aerial photograph of the Helicidade helipad.

The operational procedure adopted by Helicidade helipad was: takeoff from spot number 8, taxi toward the central spot, and climb to the helipad located at a height of approximately 15 meters AGL.

From the images generated by the helipad security cameras, it was possible to see that the aircraft, after lifting off, started an accentuated vertical climb, and flew over the central spot on a turn to the right.

When the aircraft reached a height of approximately 15 meters, at a lateral distance of 2 meters from the elevated helipad, there was a sudden yaw to the right concomitant with a big abnormal quantity of white smoke getting out of the engine exhaust.
