COMMAND OF AERONAUTICS
AERONAUTICAL ACCIDENT INVESTIGATION AND
PREVENTION CENTER

FINAL REPORT
A - 055/CENIPA/2013

<u>OCCURRENCE:</u>	ACCIDENT
<u>AIRCRAFT:</u>	PT-OFD
<u>MODEL:</u>	F90
<u>DATE:</u>	8 FEB 2012

This is the Final Report of the 8 February 2012 accident with the F90 aircraft, registration PT-OFD. The accident was classified as Fuel Exhaustion/Starvation.

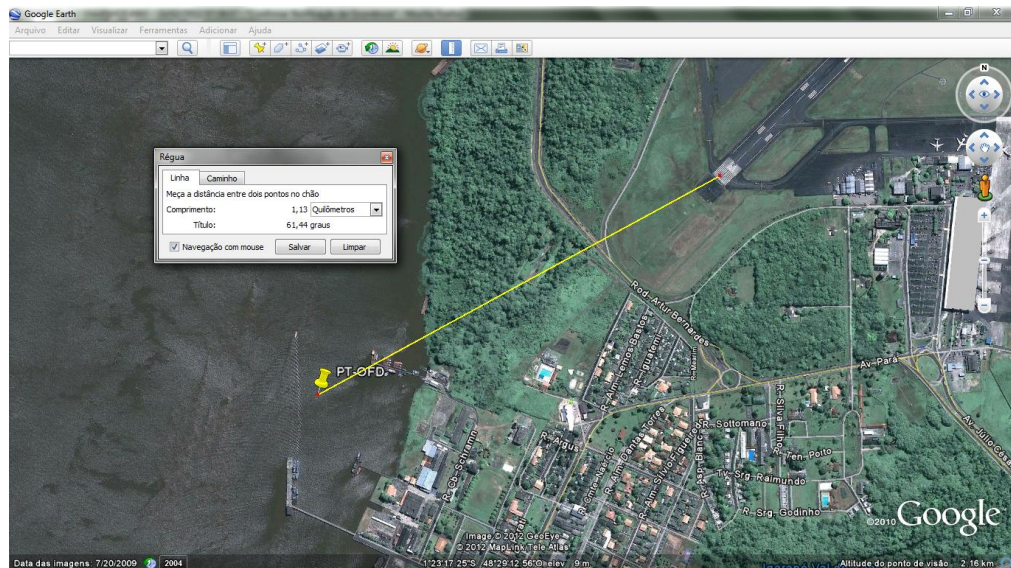
On the final approach for landing in SBBE, the right engine stalled, and the aircraft captain managed to feather its respective propeller. Shortly thereafter, the left engine began to present problems due to lack of fuel, but the pilot did not have enough time to perform the feathering procedures.

Figure 1 – Point at which the aircraft touched the waters near the banks of Guajar Bay, not far from the threshold of runway 06 of SBBE.
