COMMAND OF AERONAUTICS
AERONAUTICAL ACCIDENT INVESTIGATION AND
PREVENTION CENTER

FINAL REPORT
A - 108/CENIPA/2013

<u>OCCURRENCE:</u>	ACCIDENT
<u>AIRCRAFT:</u>	PT-SUL
<u>MODEL:</u>	AT-502B
<u>DATE:</u>	07 JUNE 2013

This is the Final Report of the accident with the AT-502B aircraft (registration PT-SUL) on 7 June 2013. The accident was classified as loss of control on the ground.

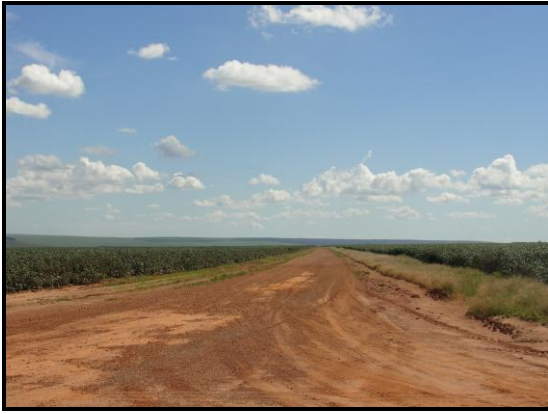
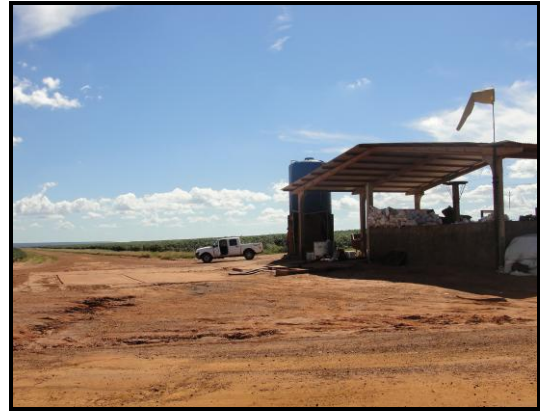
It was a gravel runway, thresholds 15/33, measuring 910m x 13.4m, at an elevation of 751 meters (2,463ft).

Figures 1 and 2 - Runway 33 threshold, and station for aircraft refueling/supply of agricultural products, located near the threshold.

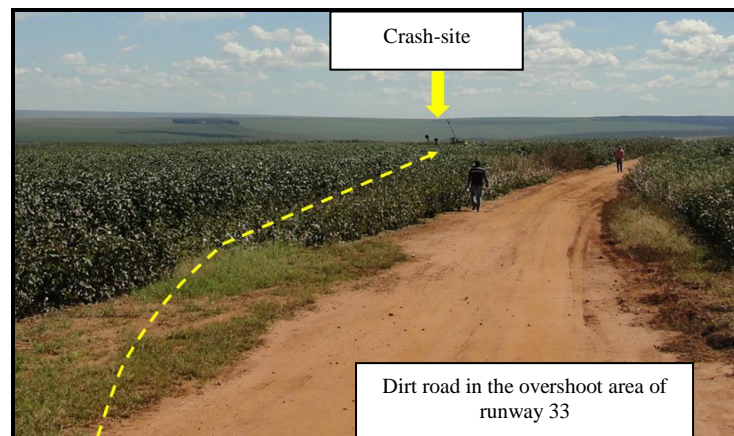
After moving along the entire runway without getting airborne, the aircraft entered a cotton plantation on an uneven terrain with declivity to the left.

In this area, the aircraft capsized and stopped at a distance of 157 meters from the runway 15 threshold.

Figure 3 - Trajectory of the aircraft after exiting the contingent landing area (yellow dotted line).

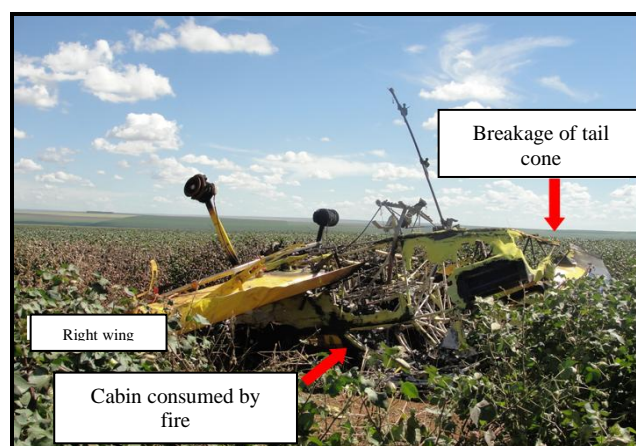
Figure 04: Situation of the aircraft after capsizing.

After the aircraft came to a stop, a post-impact fire spread. The material for combustion was the aircraft fuel, but it was not possible to identify the source of ignition.

The fire began in the left wing, and moved towards the pilot's cabin, consuming a large part of the instrument panel and pilot seat.

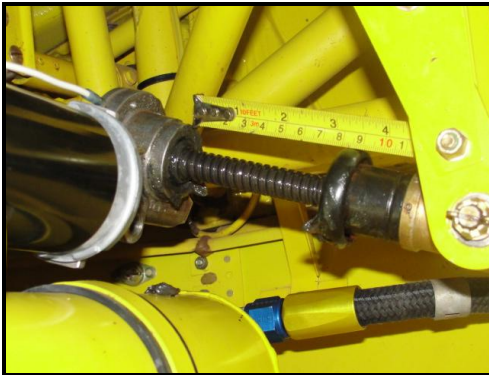
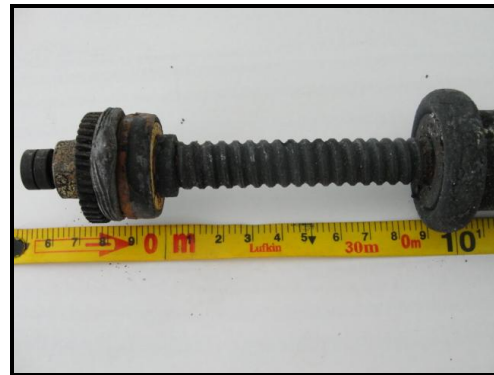
Figures 5 and 6 - Comparison between the endless screw of the flap in an aircraft with fully extended flaps and the endless screw of the accident aircraft.

At the initial action by the go-team, it was verified, by means of comparison between the endless screw of the accident aircraft and the one of another aircraft, that the flap of the former was completely extended (full).

The takeoff was made with the flaps at 26° (full).

- Under no circumstance, is it recommended to take off with the AT-502B using full flaps; and
- For a takeoff from a short field with a fully loaded hopper, one has to utilize flaps at 10°, as prescribed in the aircraft flight manual.

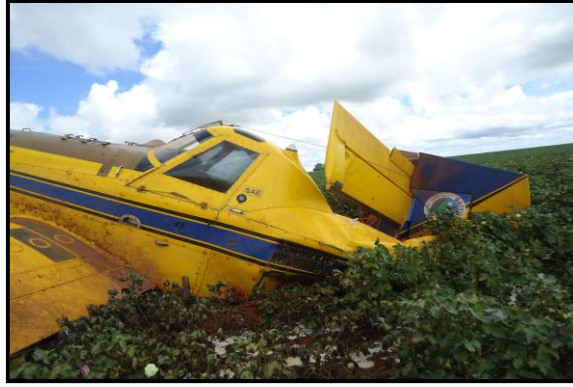
a) PR-FMM – 08 APRIL 2011: During the takeoff roll, the aircraft ran over the departure end, and collided with obstacles (stones and holes) located at 150 meters beyond the runway, sustaining substantial damage. The pilot got out uninjured.

Figure 8 - PR-FMM after the crash.

Calculations indicated that the operation took place outside of the operational limits.

The takeoff failure was a result that should have been expected. The estimated takeoff weight was 5,112kg, well above the MTOW of 3,629kg.

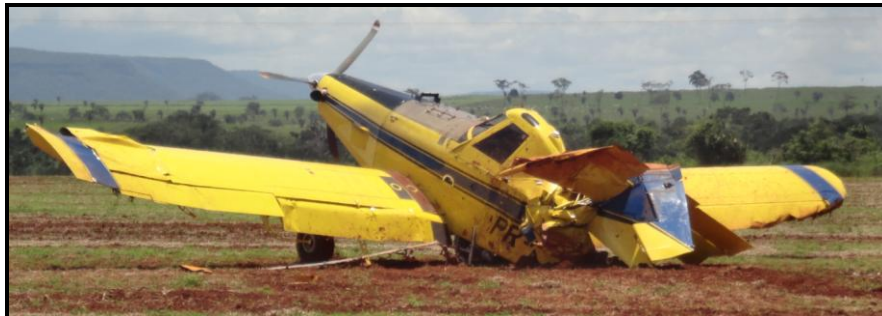
b) PR-TPL – 01 MARCH 2013: The aircraft got airborne only three meters short of the departure, lost altitude, and collided with two fences located at 86 meters and 98 meters from the runway.

Figure 9 - PR-TPL after the crash.

Calculations indicated that the operation took place with the aircraft outside of its operational limits. The pilot utilized 800 meters of the runway, instead of the 878 meters that were necessary. An unsuccessful takeoff should be considered as the expected result.

The pilot informed that he had started the takeoff with flaps at 10°. However, in the wreckage, the indication was of fully extended flaps.

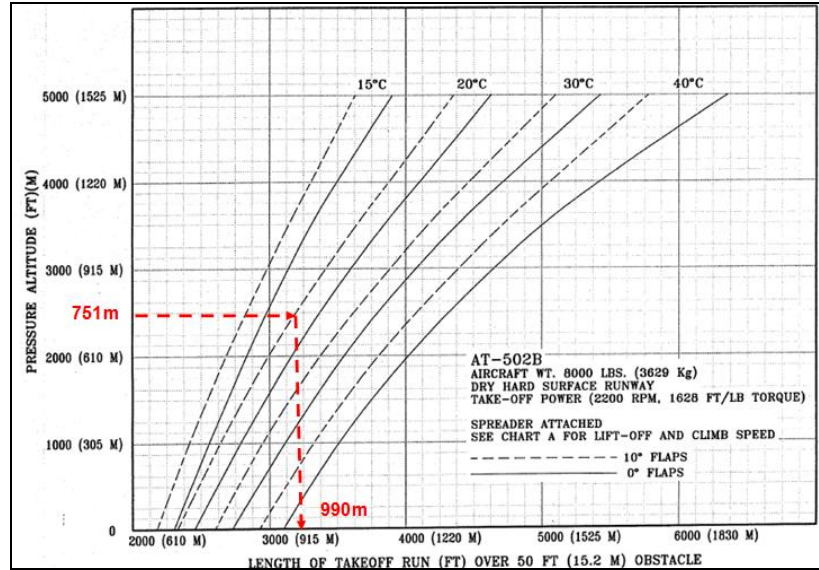
Based on these pieces of information, and taking the MTOW and a temperature of 20°C, it is possible to calculate the length of the takeoff run necessary to clear an obstacle of 50ft by means of the graph contained in the airplane flight manual.

Thus, the takeoff from a gravel runway with a length of 910 meters was not viable, since 990 meters were necessary for clearing an obstacle of 50ft during the takeoff roll, with a dry, paved runway, with the aircraft at the MTOW (3,629kg.)

Figure 10 - Analysis of the takeoff roll distance to clear an obstacle of 50ft.

Additionally, the calculation of the takeoff weight indicated that the aircraft had a weight of 823kg above the MTOW, that is, even the 990 meters of runway would not be enough for such condition.
