COMMAND OF AERONAUTICS
AERONAUTICAL ACCIDENT
INVESTIGATION AND PREVENTION CENTER

FINAL REPORT
A – N 67/CENIPA/2009

AIRCRAFT **PR - MBK**

MODEL **AIRBUS A-320**

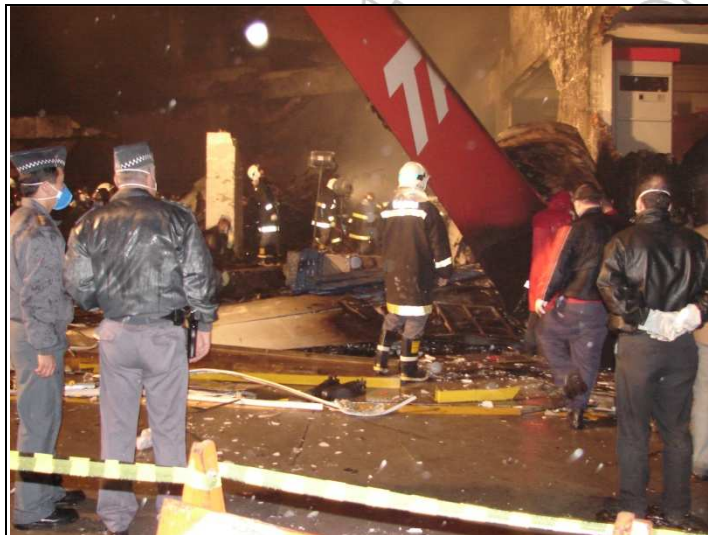
Figure 3 - Wreckage of the aircraft at the site of impact.

The collision of the aircraft occurred at a ground speed of 96 kt, at an angle of 7° roll to the left and a 7° positive pitch. With the impact, the aircraft was completely destroyed and the wreckage was concentrated in an area of about 100 m².

The retractable type landing gear was locked in the extended position, and the flaps were also completely extended (landing configuration).

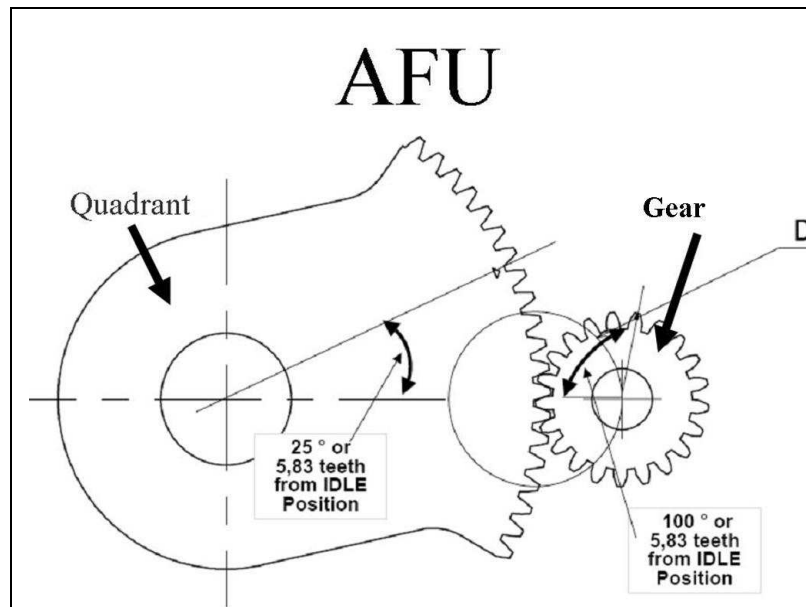
Figure 6 - Quadrant and gear of the AFU.

The aluminum structure of the units was found melted due to the heat of the post-accident fire. In the midst of the melted aluminum mass were the gears and the quadrants made of steel.

Initially, the wreckage of the AFUs was sent to the General Command of Airspace Technology (CTA), in São José dos Campos, São Paulo State, where the X-ray exams were conducted. These exams did not reveal any evidence that could allow identifying the position of the thrust levers at the moment of the impact.
