FINAL REPORT
A - 124/CENIPA/2016

OCCURRENCE:	ACCIDENT
AIRCRAFT:	N1001R
MODEL:	AT-602
DATE:	21SEPT2016

This is the Final Report of the 21SEPT2016 accident with the AT-602 aircraft model, registration N1001R. The accident was classified as “[SCF-PP] System/Component Failure or Malfunction Powerplant – Engine Failure in Flight”.

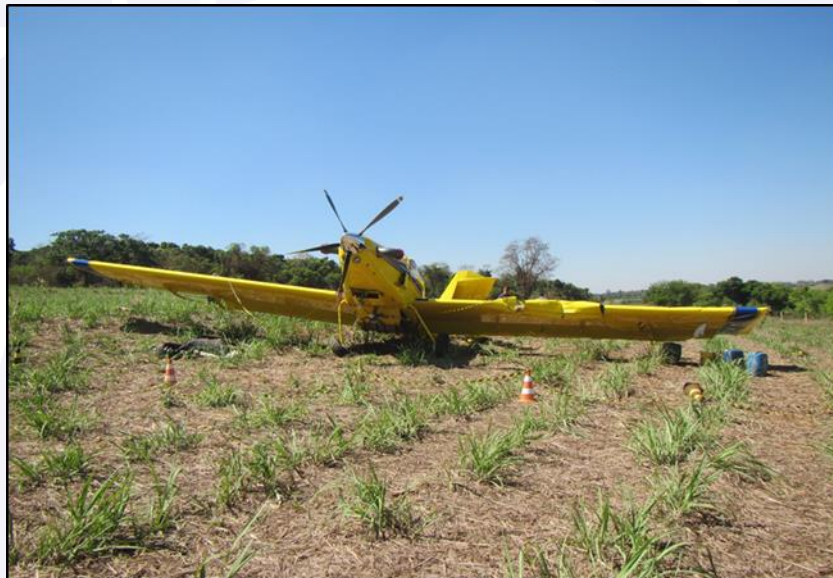
The landing gear, of the fixed type, had substantial damage on its right side. The flaps were also extended.

The left wing had substantial damage, mainly on the leading edge, indicating that it was possibly the part of the aircraft that absorbed most of the first impact against the vegetation.

Figure 1 - Aircraft after the occurrence.

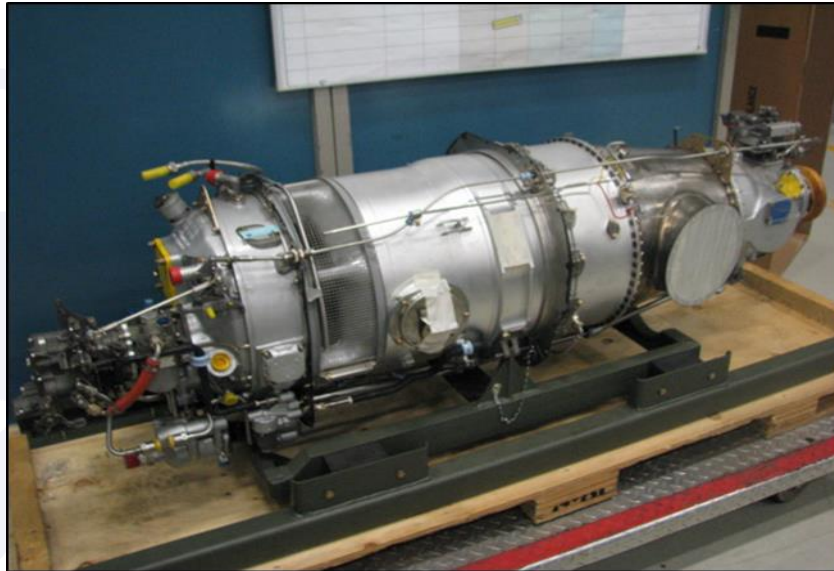
Figure 2 - Aircraft engine before testing.

After the heating period, an attempt was made to accelerate the engine, which was unsuccessful. In order to identify the problem, the FCU that was installed at the time of the accident was replaced.

After replacing the FCU, the engine could be accelerated and did not show any malfunctions in its operation, showing that the occurred failure was restricted to this component.

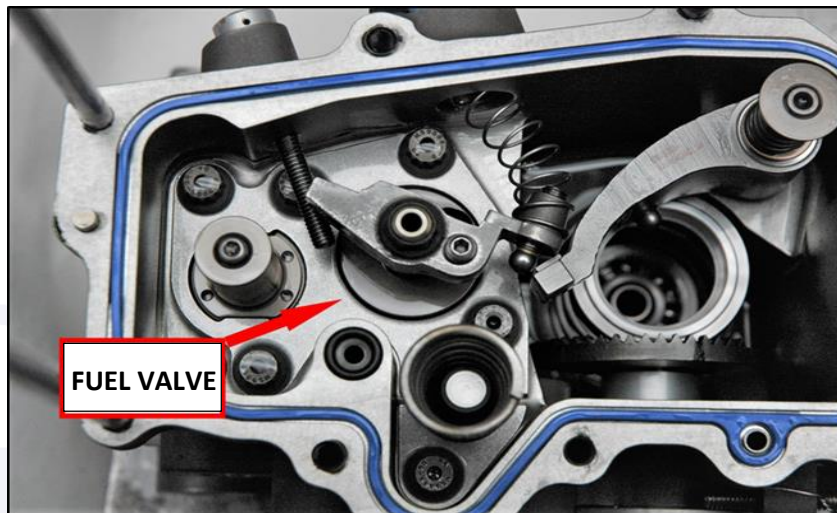
Subsequently, the FCU was disassembled and debris was found in the fuel valve. Subsequently, the residues of the FCU screens were analyzed and particles of glass and ferrous fibers, calcium and chlorinated rubber were identified.

Figure 3 - Internal view of the FCU.

Tests on the crashed engine, carried out on the bench, confirmed the malfunction and identified debris in the fuel valve of the FCU PNR 8063-645, SN 19613248.

In the sequence of tests, the contaminated FCU was replaced by another one in good condition. The engine was tested again and presented expected performance on bench. Thus, it was inferred that the identified contaminants interfered with the correct functioning of the FCU PNR 8063-645, SN 19613248, as tested by the technical report issued by the component manufacturer.

Act with the US Civil Aviation Authority - FAA, so that the Air Tractor Inc., before dispatching its aircraft for transfer flights using the hopper as a fuel tank, make sure that the auxiliary and temporary fuel system installed is in compliance with Drawing 50280 and in perfect conditions of cleaning and use, aiming to prevent aeronautical occurrences.

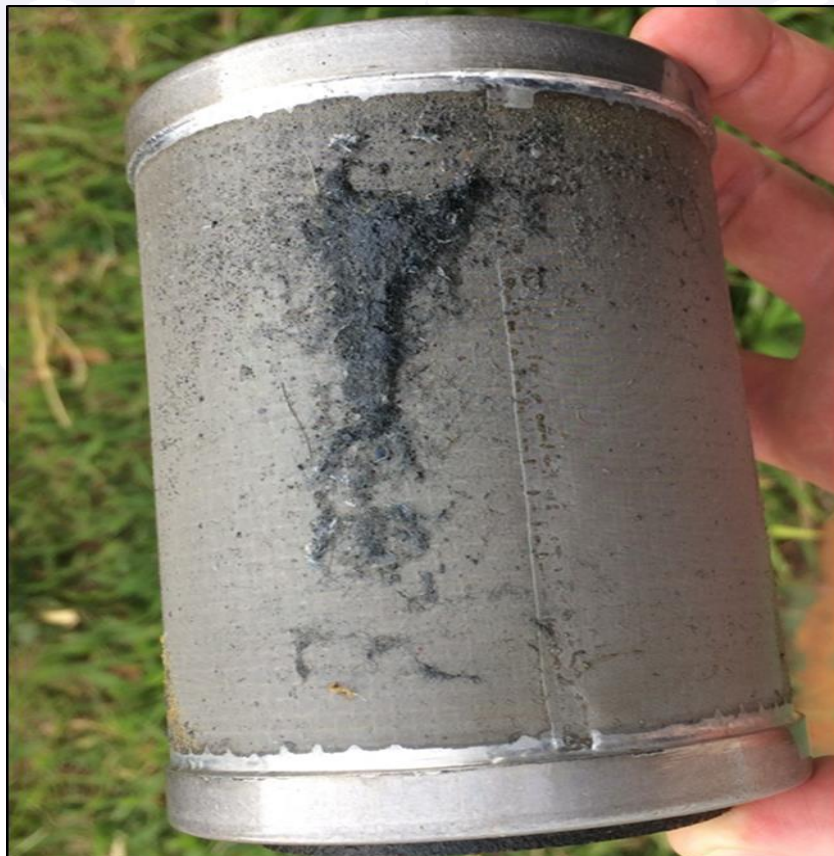
Finally, the contaminant found in the aircraft fuel airframe filter was analyzed. The results indicated the presence of aromatic material, cellulose, polypropylene, zinc stearate and amine compounds with aliphatic groups (Figure 4).

Figure 4 - Debris found in the fuel airframe filter.

It should be added that the fact that the contaminants were found in the FCU, in the fuel pump inlet net and, even in the fuel filter of the airframe, in the latter, in a much higher amount than expected, indicated that the contamination came from the system of fuel for the engine system.

The fact that fiberglass and zinc stearate was found reinforces the possibility that the contamination originated from the hopper, since the first contaminant can be used as a material for manufacturing and the second as a release agent.

In addition, because an amine compound with aliphatic groups has been found, there is a possibility that the hopper was previously used to apply fertilizer or another product for agricultural use.
