FINAL REPORT
A - 139/CENIPA/2017

OCCURRENCE:	ACCIDENT
AIRCRAFT:	N154KQ
MODEL:	KODIAC 100
DATE:	10NOV2017

This is the Final Report of the 10NOV2017 accident with the KODIAC 100 aircraft model, registration N154KQ. The accident was classified as “[SCF-PP] System/Component Failure or Malfunction Powerplant – Engine Failure in Flight”.

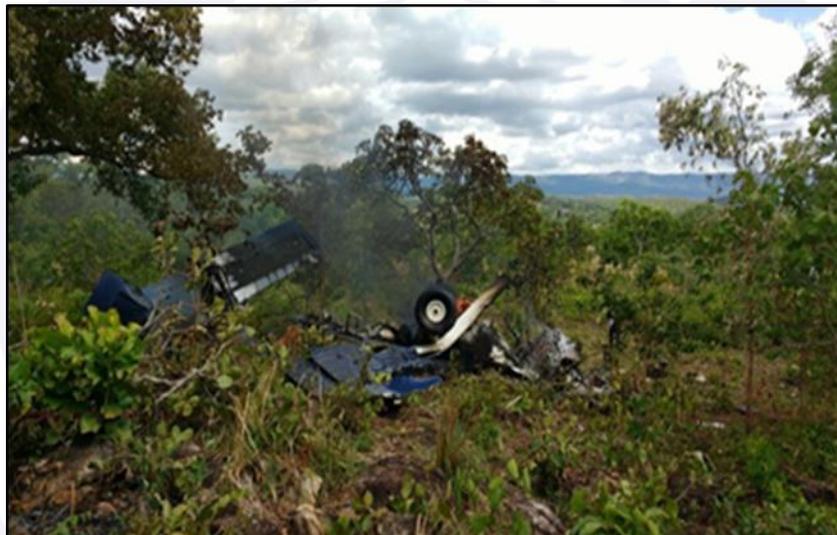
Figure 1 - View of the aircraft wreckage with the fire not yet extinguished.

The aircraft was destroyed by the fire. The pilot suffered serious injuries and the three passengers suffered minor injuries.

The aircraft was destroyed by the fire after crashing against the ground.

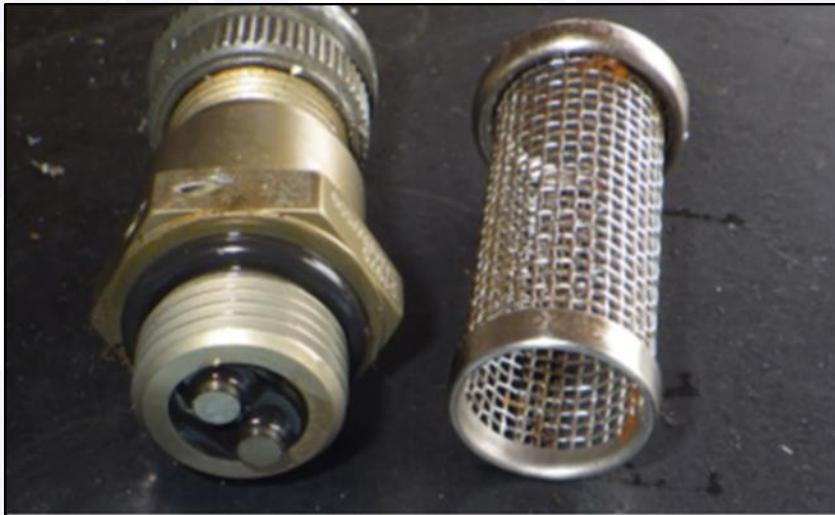
The front part of the engine was not affected by the fire, making it possible to inspect the filings detector and the oil return filter of the reduction box. They were clean and without contamination (Figure 3).

Figure 3 - Filings detector and oil filter in the engine reduction box without the presence of filings.

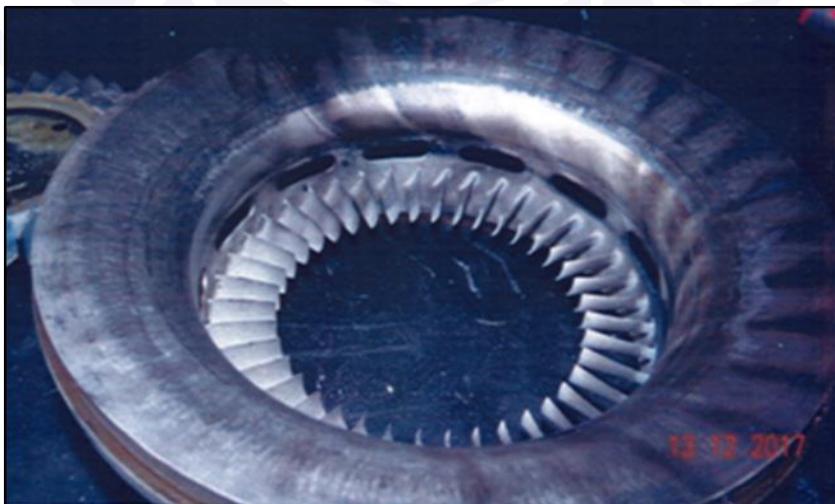
Rubbing marks were found in the turbines, both in the compressor drive and power drive, which were indications that the hot engine section was operational at the moment of impact (Figures 4 and 5).

Figure 4 - View of the centrifugal impeller housing with light rubbing marks.

- r) there were marks of rubbing on the compressor driving turbine and on the power turbine;
- s) the characteristics found in the blades indicated that the Powerplant developed low power at the moment of the impact;

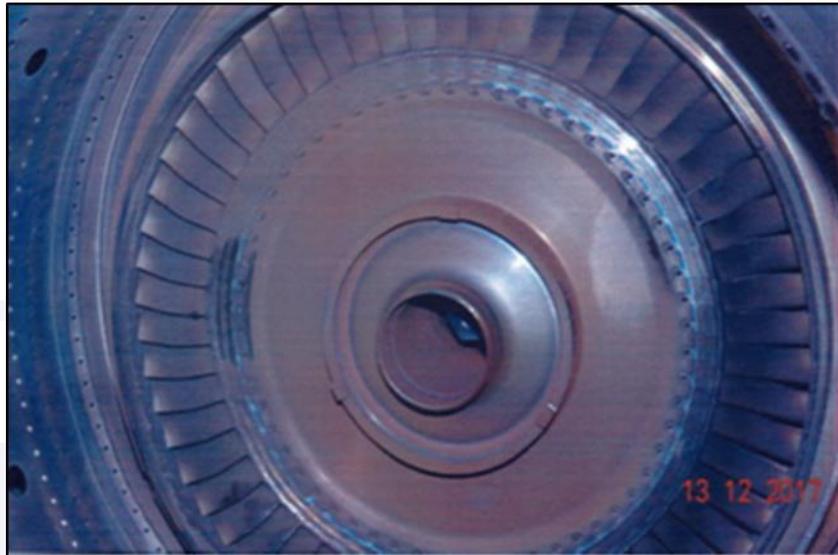
Figure 5 - Rubbing marks on the rotor of the compressor drive turbine, rear side.

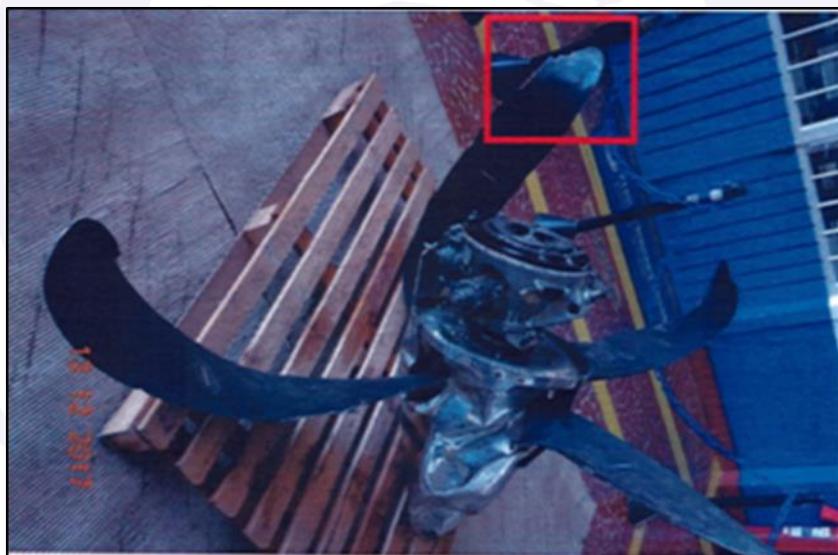
During the analysis of the propeller, it was observed that one of the blades had a small fracture in its tip and folding facing forward. The others had folded backward at the half of their length. These deformations were consistent with the development of low power by the Powerplant at the time of the impact of the aircraft (Figure 6).

Figure 6 - General view of the propeller. The highlight shows one of the blades folded forward. The rest were backward.

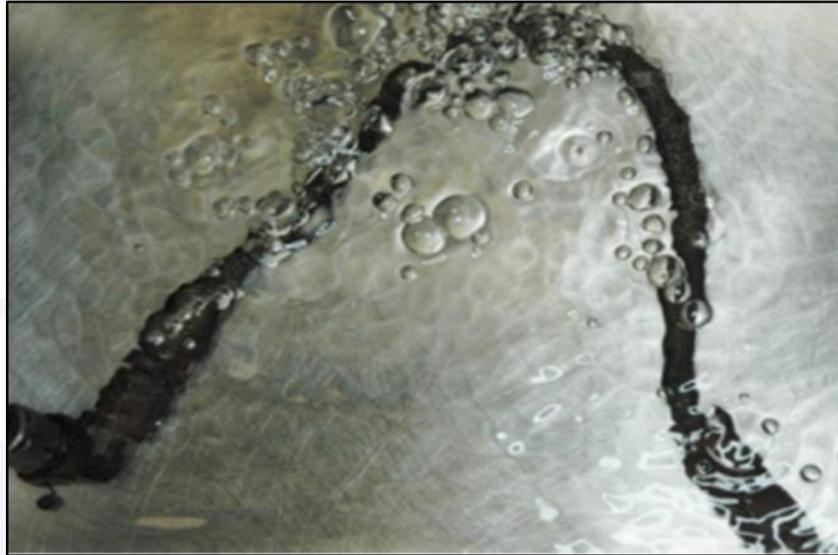
When analyzing the engine P3 hose, it was observed that the connection was damaged by the fire and, during the low-pressure leak test, in which it was submerged in water and subjected to low pressure, several bubbles were observed. The severe action of the fire may have been responsible for the damages that caused the leaks observed in the test (Figure 7).

Figure 7 - Bubbles observed in the engine P3 hose during the low pressure leak test.

Thus, the doubt related to the nature of the fault, fell on the fuel supply system and pneumatic lines of the engine, since any abnormal leakage in the pneumatic section could have caused the loss of engine power experienced in this event.

It is worth mentioning that, although the bubbles observed in the engine's P3 hose, during the low pressure leak test, are due to the severe action of the fire, it cannot be said what the component's pre-existing condition was.

- t) the engine's P3 hose was damaged by the fire;
- u) the forced landing was made on a rough terrain;
- v) the aircraft caught fire after the forced landing;
