**COMANDO DA AERONÁUTICA**  
**CENTRO DE INVESTIGAÇÃO E PREVENÇÃO DE**  
**ACIDENTES AERONÁUTICOS**

**FINAL REPORT**  
**A - 503/CENIPA/2021**

| <b>AIRCRAFT:</b> | <b>PP-BRJ</b> |
| <b>MODEL:</b> | <b>AS-350B3</b> |

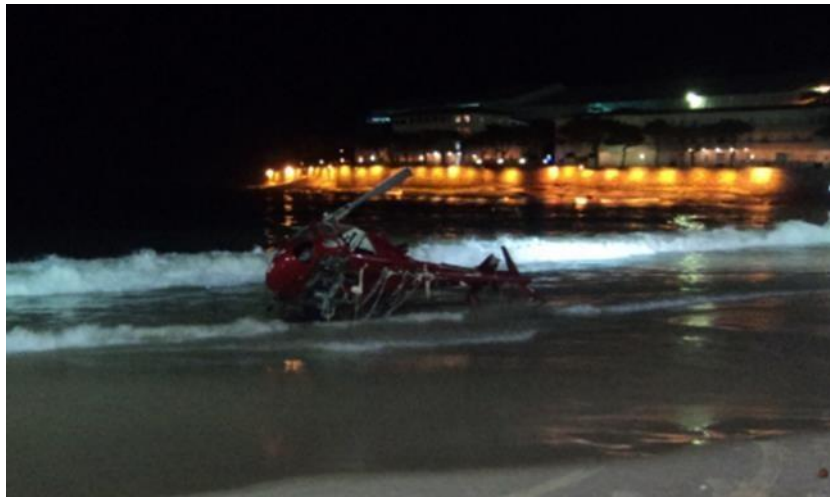
Figure 7 - Aircraft wreckage concentrated after removal from the sea.

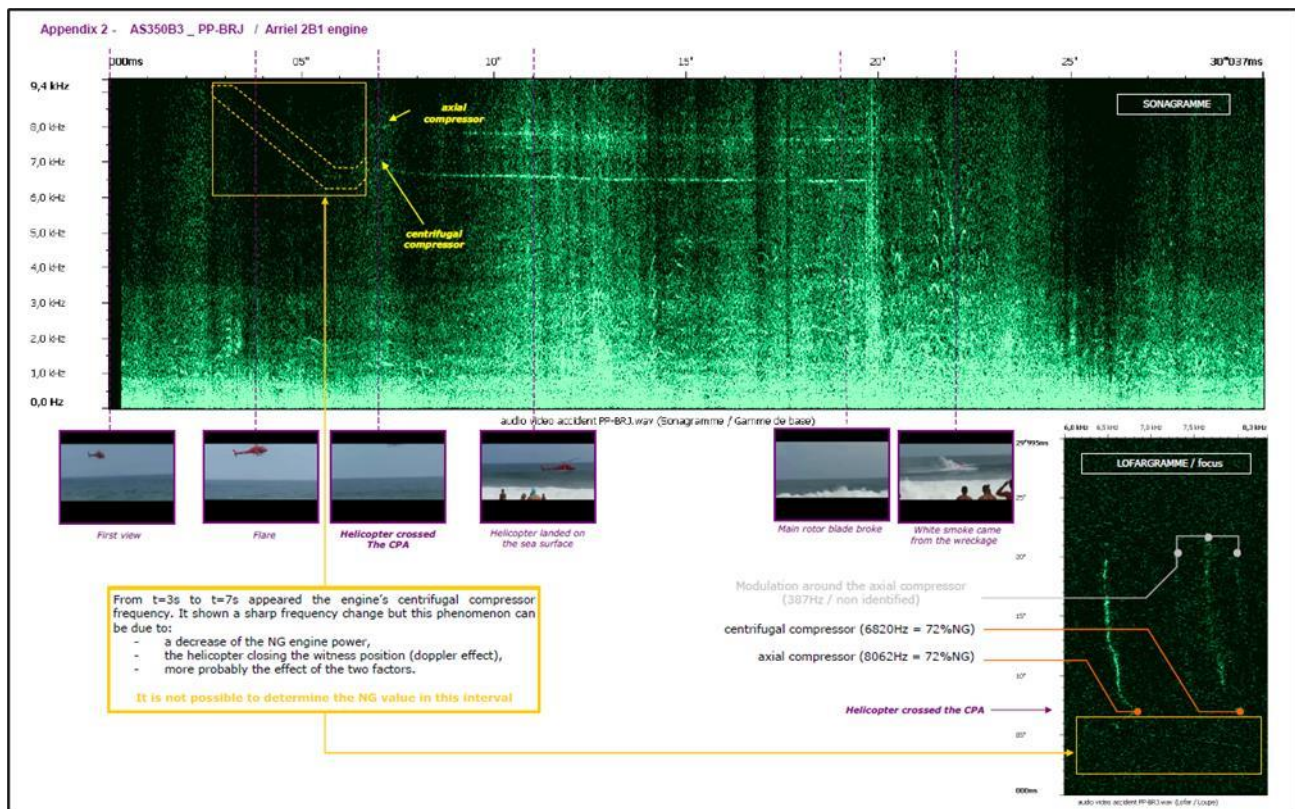
The spectral analysis revealed that the two frequencies compatible with the axial and centrifugal compressors of the engine indicated that its power was established at 71.5% of nominal NG, four seconds before landing at sea, which corresponded to a value close to that of an engine operating with the TWIST GRIP in the IDLE position.

Figure 8 - Spectral analysis of the accident video audio.

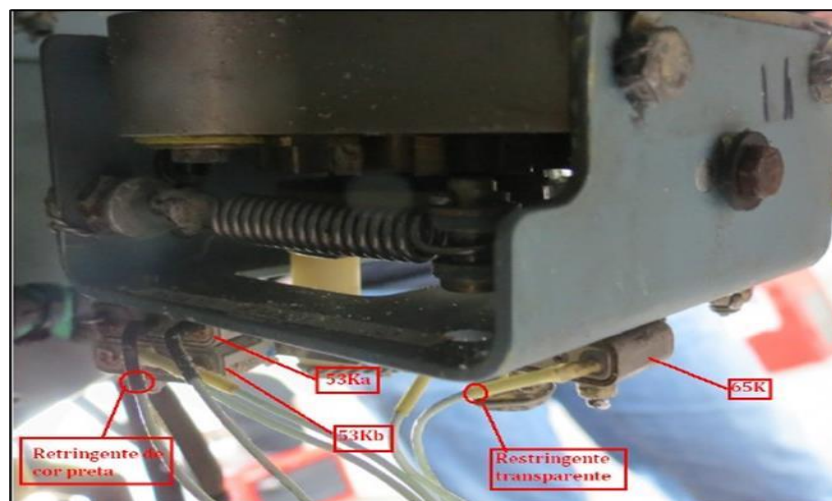
Figure 9 - Restrictive term used in the wiring of the 53Ka microswitch different from the original.

The wires close to the place where the black restrictor term was applied were moved without changing the continuity of the system. The same checks on wires with transparent thermo-restricting were performed without showing different results.

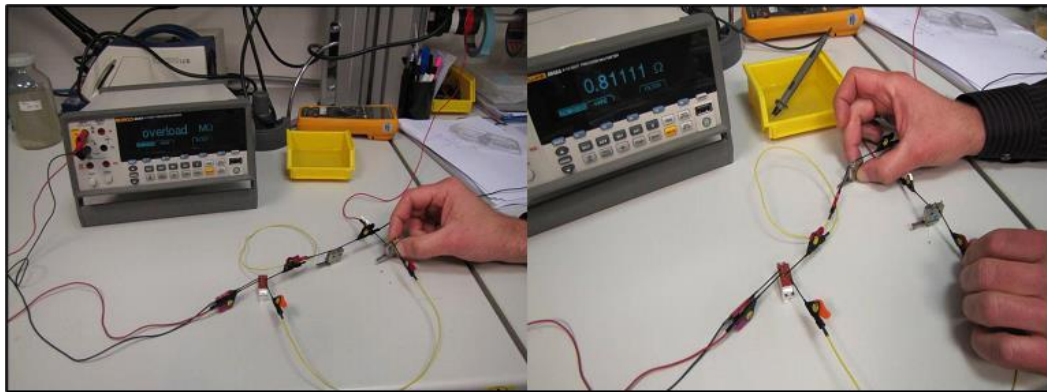
Figure 11 - Functional test of the TWIST GRIP electrical circuit using new microswitches (53Ka, 53Kb and 54K relay) and with salt water.

After the use of salt water drops and the occurrence of electrolysis, the impedance between pins C, NO, the housing decreased, and the current reached 22mA, when the 54K relay could be energized and closed.

The researchers also observed the occurrence of electrolytic corrosion in the 53Ka and 53Kb microswitches, at the time of the test, due to the oxidation of the metal and the generation of small gas bubbles in the hydrosaline solution.

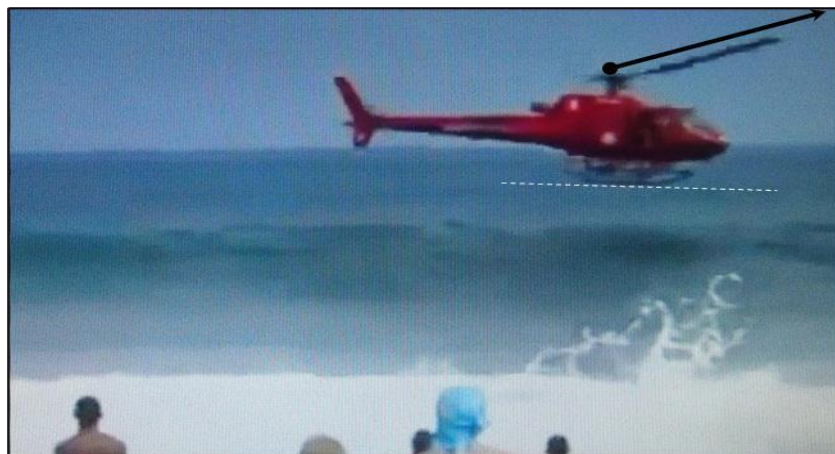
Through the analysis of a video recorded at the location, it was possible to perceive the increase in the "cone effect" in the main rotor from the moment when there was a loss of engine power and rotation of the main rotor until the landing in the water (Figures 12).

Figure 12 - Moment of landing of the aircraft at sea, highlighting the increase in the "cone effect" in the main rotor.

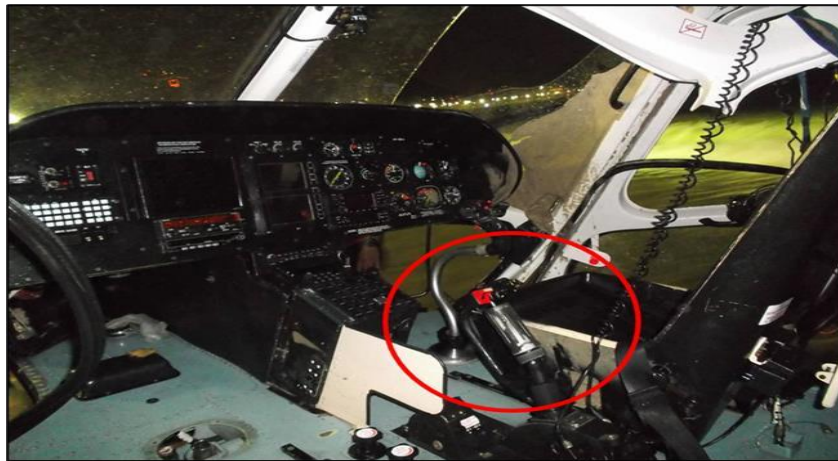
Figure 13 - Image of the cabin, shortly after removing the aircraft from the sea, highlighting the collective control in the fully pulled position.

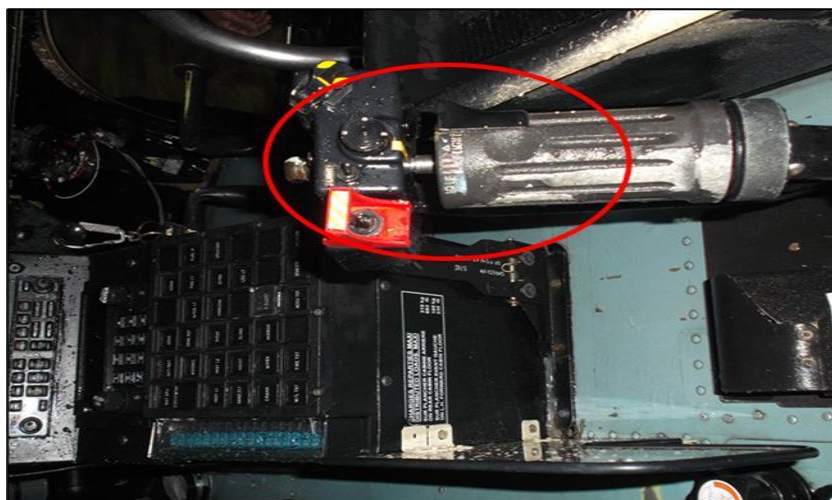
Figure 14 - Image of the cabin, shortly after removing the aircraft from the sea, highlighting the TWIST GRIP in the FLIGHT position.

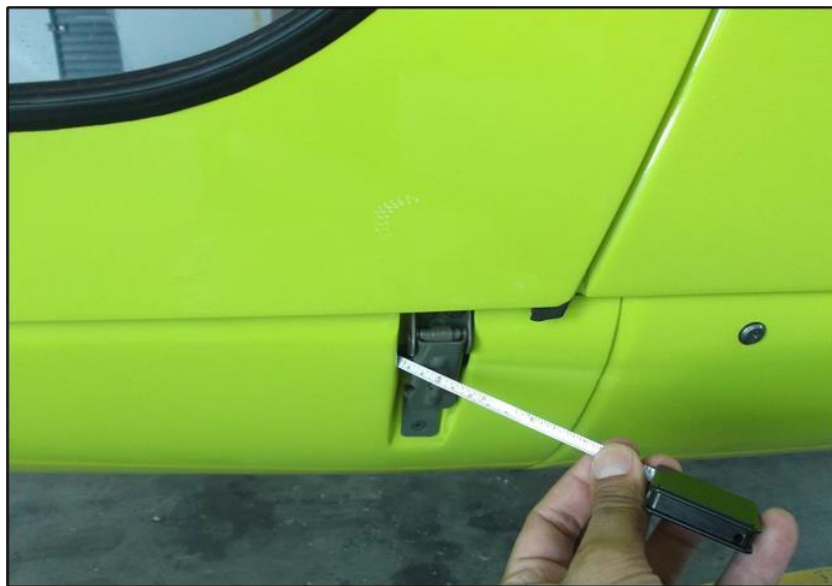
In addition, the opening and closing latch of the lower fairing was located in a slot exactly aligned with the microswitch box, more precisely, with one of the fixing screws (Figures 15 to 17).

Figure 15 - Bottom fairing latch crack (photo of a helicopter of the same model).

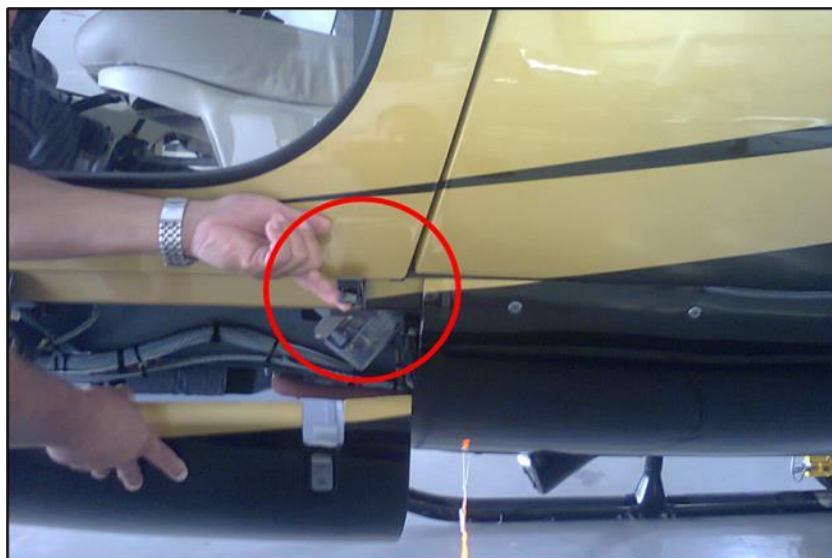
Figure 16 - Alignment of the lower fairing latch crack with the acrylic housing of the TWIST GRIP microswitches (photo of a helicopter of the same model).

It was also found that the opening and closing latch of the lower fairing was located in a crack exactly aligned with one of the fixing screws of the microswitch box. Droplets of salt water in suspension, deposited on the surface of the aircraft, especially those deposited on the left door, flowed downwards, until they found the crack of the lower fairing lock, entering the compartment when they began to drip on the fixing screw, without sealing, of the acrylic box.

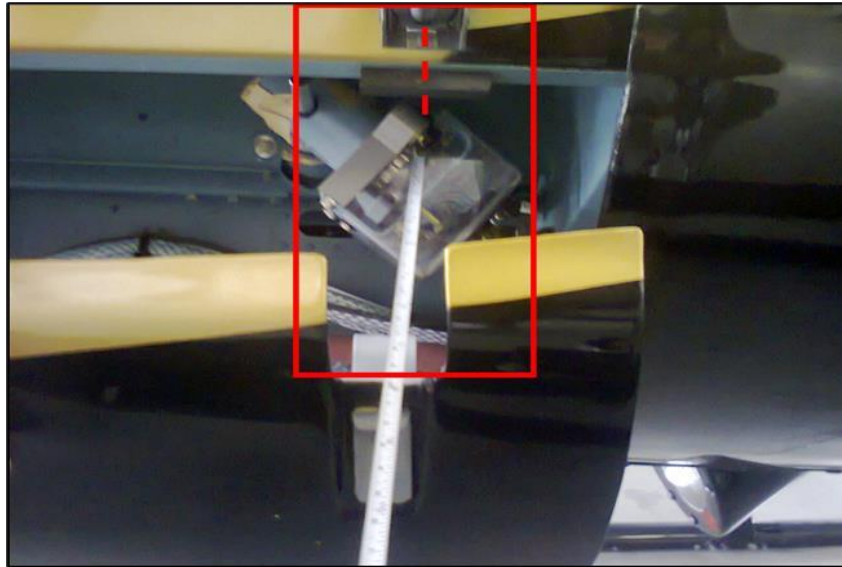
Figure 17 - Alignment of the lower fairing latch crack with one of the TWIST GRIP microswitches' acrylic box mounting screws (photo of helicopter of the same model).

The location of the opening and closing latch crack of the lower fairing, in line with the microswitch box of the aircraft's TWIST GRIP system, along with the lack of sealing at the acrylic box attachment points, allowed saltwater ingress and act in its microswitches, during operation over the sea, which may have caused contact closure between the pins and the housing of the 53Ka, 53Kb and 65K microswitches, thus sending an IDLE electrical signal to the DECU, regardless of the position of the TWIST GRIP.

- the circuit logic of the TWT GRIP system and the electrical connections of its microswitches were modified, mitigating the possibility of inadvertent loss of engine power due to the TWIST GRIP system;
  - improvement was implemented in the insulation and sealing of the microswitch terminals, including the application of varnish; and
  - the maintenance program was modified regarding the functional checks of the system and the periodic verification of the seal.
- Airbus provided a new set of 53ka, 53kb and 65k microswitches protected against corrosion from the environment (MOD 074782). These microswitches will be the subject of a new mandatory ASB for installation.
