FINAL REPORT
A-043/CENIPA/2022

OCCURRENCE:	ACCIDENT
AIRCRAFT:	PP-CRE
MODEL:	AT 402B
DATE:	06ABR2022

This Final Report pertains to the April 6, 2022, accident involving the AT 402B aircraft of registration marks PP-CRE. The occurrence was typified as "[LOC-G] Loss of Control on the Ground" and "[RE] Runway Excursion."

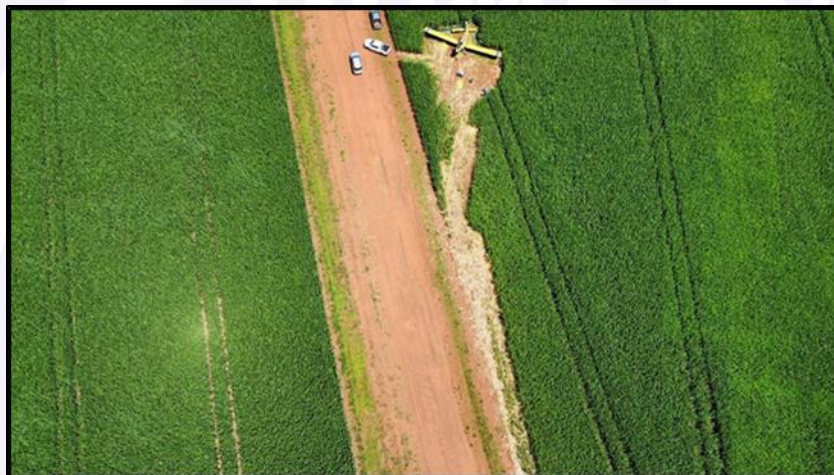
According to physical evidence at the impact site, the airplane deviated from the takeoff axis, veering laterally to the right, where its wingtip made contact with the tall cornfield, which exhibited an advanced growth stage.

Subsequently, the aircraft lost control, exiting the runway completely, and entering the cornfield.

Figure 1 - Aerial view of the landing area and the aircraft's final position in the cornfield.

One observed that the tail cone of the airplane was significantly damaged, exhibiting lateral twisting to the right, a typical characteristic of damage in conventional landing gear aircraft (ground loop).

The tips of the propeller blades showed plastic deformation in the direction of rotation, which is indicative of low power at the time of contact with the crop.
