**FINAL REPORT**  
**IG - 114/CENIPA/2016**

| <b>OCCURRENCE:</b> | <b>SERIOUS INCIDENT</b> |
| <b>AIRCRAFT:</b> | <b>PP-EJK</b> |
| <b>MODEL:</b> | <b>AS 350 B2</b> |

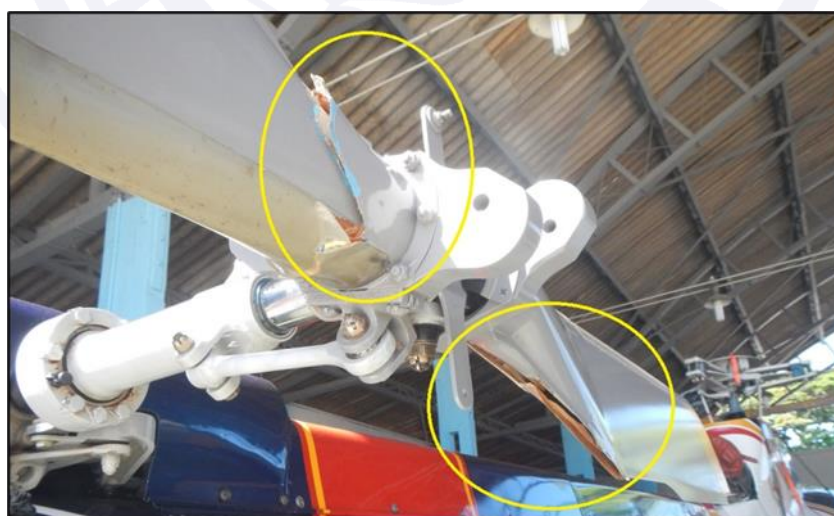
The aircraft had substantial damage to the gearbox, rear camshaft, and tail rotor assembly due to impact against the lagoon surface (Figure 1).

Figure 1- Detail of damage to the tail rotor assembly.

The impact occurred in Lagoa dos Ingleses, in Nova Lima - MG. After the aircraft abruptly lost altitude, the tail rotor touched the water surface, and which caused substantial damage to the aircraft.
