COMANDO DA AERONÁUTICA
CENTRO DE INVESTIGAÇÃO E PREVENÇÃO DE
ACIDENTES AERONÁUTICOS

FINAL REPORT
A-073/CENIPA/2022

| AIRCRAFT: | PP-GEJ |
| MODEL: | AB-115 |

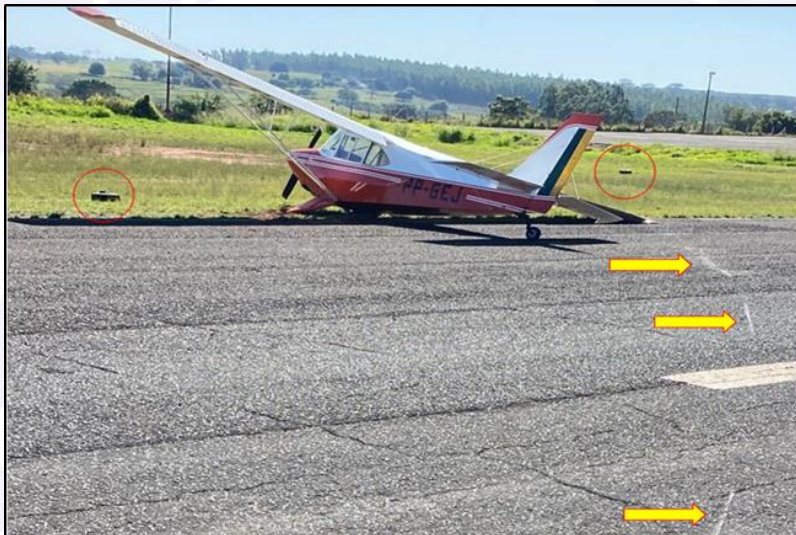
The two main gear wheels separated from the aircraft. One of them stopped approximately 3 m ahead of the aircraft, and the other one at a distance of 30 m (Figure 1).

Figure 1 - Highlighted in the two red circles is the final position of the main gear wheels. The yellow arrows show the marks left on the asphalt by the right-hand wing tip.

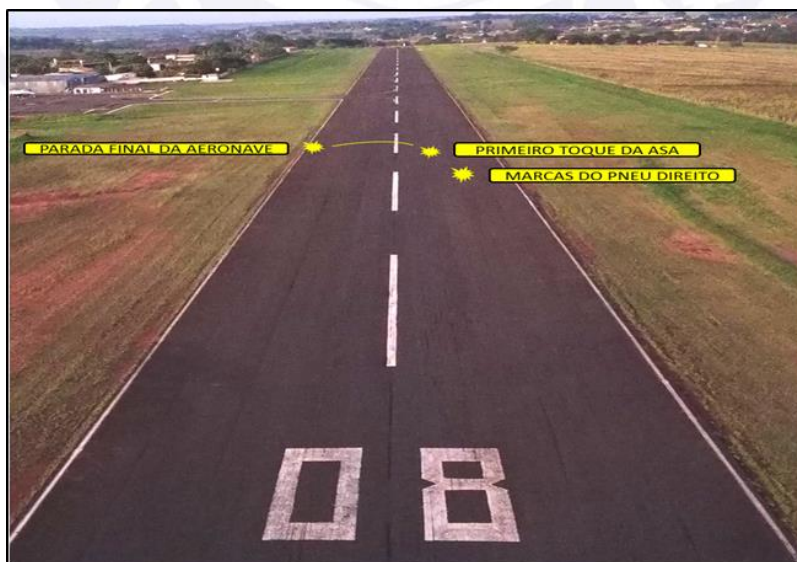
It was possible to observe that the marks of the right-hand tire of the aircraft's main gear were located approximately 5 m away from the right-hand edge of the runway (Fig. 2).

Figure 2 - Position of the rubber mark on the right main gear tire, and first touch of the wing on the runway.

Corroborating with this fact, the marks left by the tire of the right main gear on the pavement were approximately 5 m from right-hand edge of the runway.

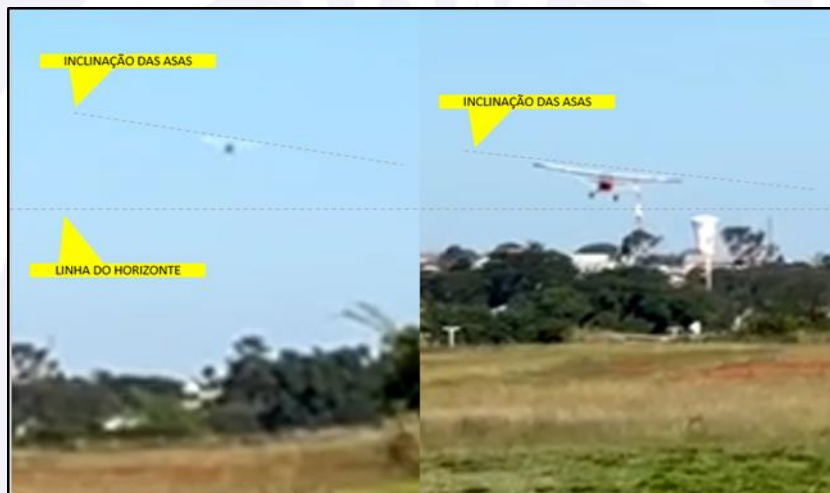
It was possible to observe that, throughout the final leg, the aircraft was misaligned with the approach axis, and the AL lowered the left-hand wing several times for correction of the misalignment. The aircraft performed such correcting maneuver in the segment from the long final up to the short final (Figure 3).

Figure 3 - In detail, the aircraft corrections to maintain alignment with the runway axis.

The aircraft kept the left wing "low" throughout the final approach.

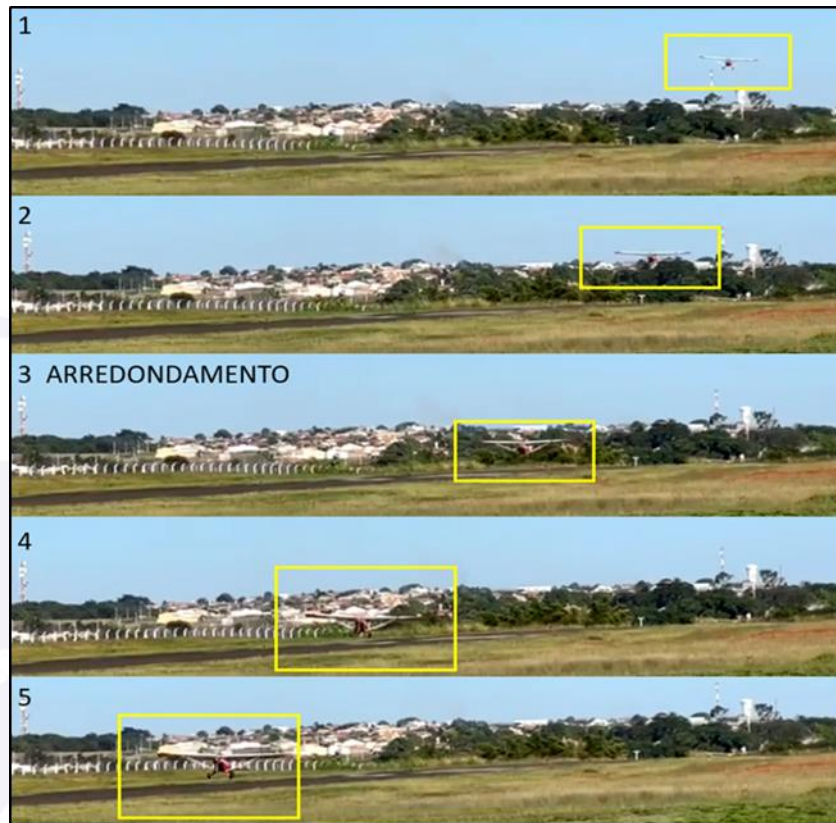
Close to the vertical of the threshold, the AL performed the flare, and allowed the aircraft to float. He then touched the ground with the tailwheel, just after the runway's threshold markings, and rose again. There was also a second touchdown with the tail-wheel on the runway, followed by another subsequent rise (Figure 4).

Figure 4 - Approach, flare, and floating over the runway.

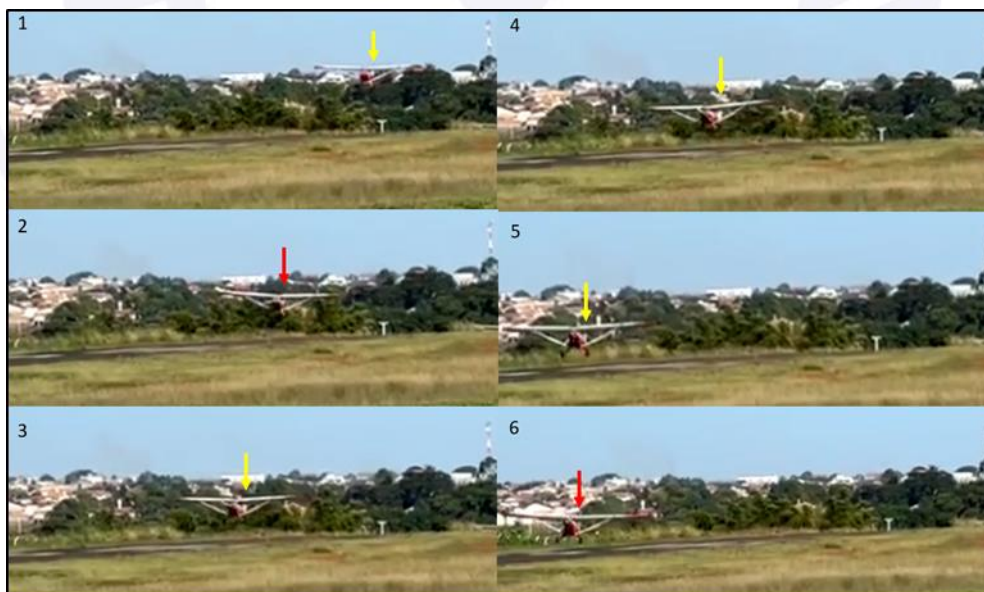
The images revealed that the AL tried to correct the alignment by applying the left-hand pedal, since he was in a position to the right of the runway centerline. Through analysis of a video of the occurrence, one observed that the directional rudder appears and disappears several times while the airplane touched the runway, showing that the AL attempted to correct the positioning of the aircraft with direct inputs on the pedals, as shown in the frames of Figure 5.

Figure 5 - Applying the left-hand pedal. The yellow arrows indicate the visible directional rudder and, in red, the hidden/semi-hidden directional rudder behind the fuselage.

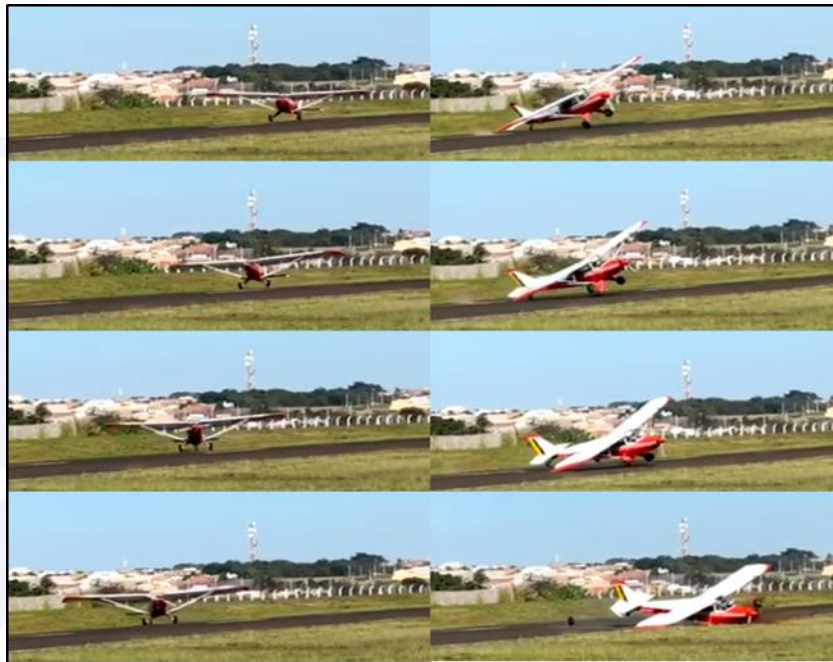
At this moment, the tail of the aircraft quickly turns 90° to the left. Immediately thereafter, the tip of the right wing touches the asphalt, the main landing gear breaks, and the propeller blades touch the ground until the aircraft comes to a complete stop, in a position between the runway and the grassy area on the left-hand side of the runway.

Figure 6 – Tail-turn performed at the final landing.
